**STATEMENT OF ENVIRONMENTAL EFFECTS**

# Chisholm Chapel

Development of a new School Chapel facility for existing Primary School and High School use in Chisholm, NSW

**PROJECT NO. 3655**

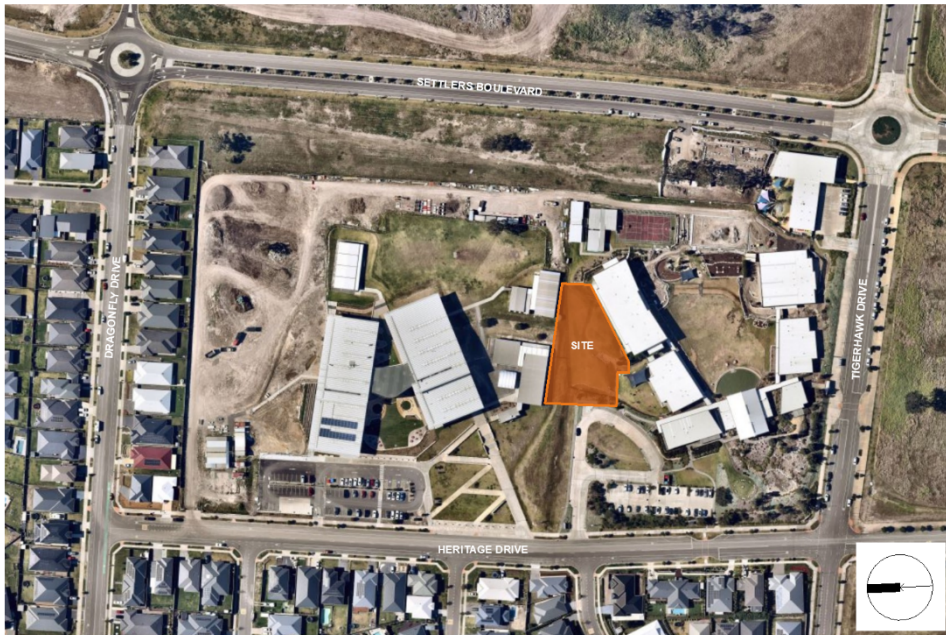
*Image courtesy of Nearmaps – edited by SHAC*

The area of site proposed for the development of Chisholm Chapel is currently an undeveloped portion of land between the two existing schools. The proposed development includes the new construction of a single-storey chapel building and associated landscape & gardens for use by students and staff of St Bede's Catholic College and St Aloysius Catholic Primary School. The chapel will include a narthex (entry), sanctuary with altar, ambo and chair, sacristy, vestry, store and an accessible WC and cleaner's room. A small mezzanine is also provided within the space. The large open floor plate provides a capacity for 200 seats.

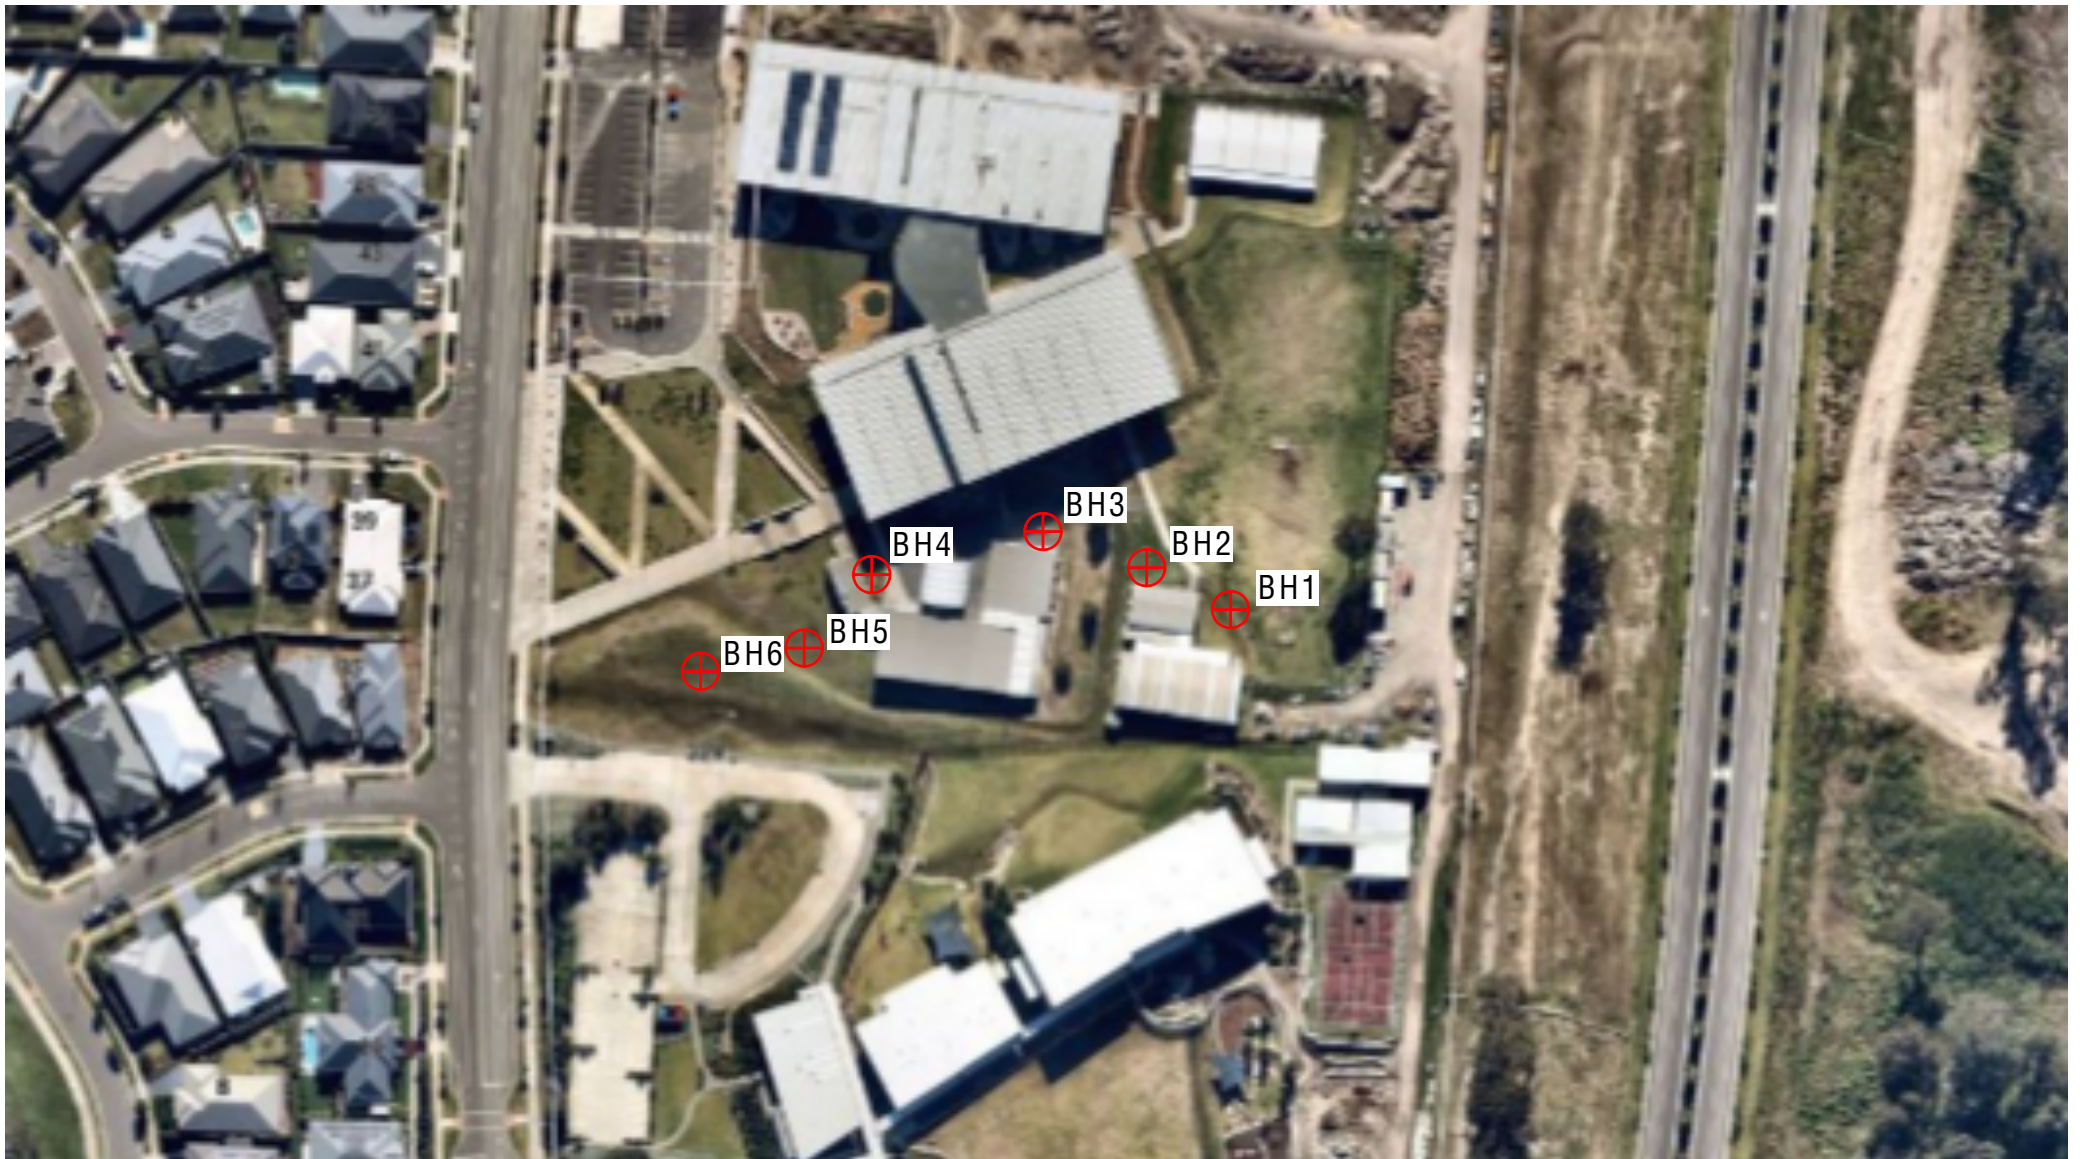
**Figure 1: Site Plan**

Borehole Location

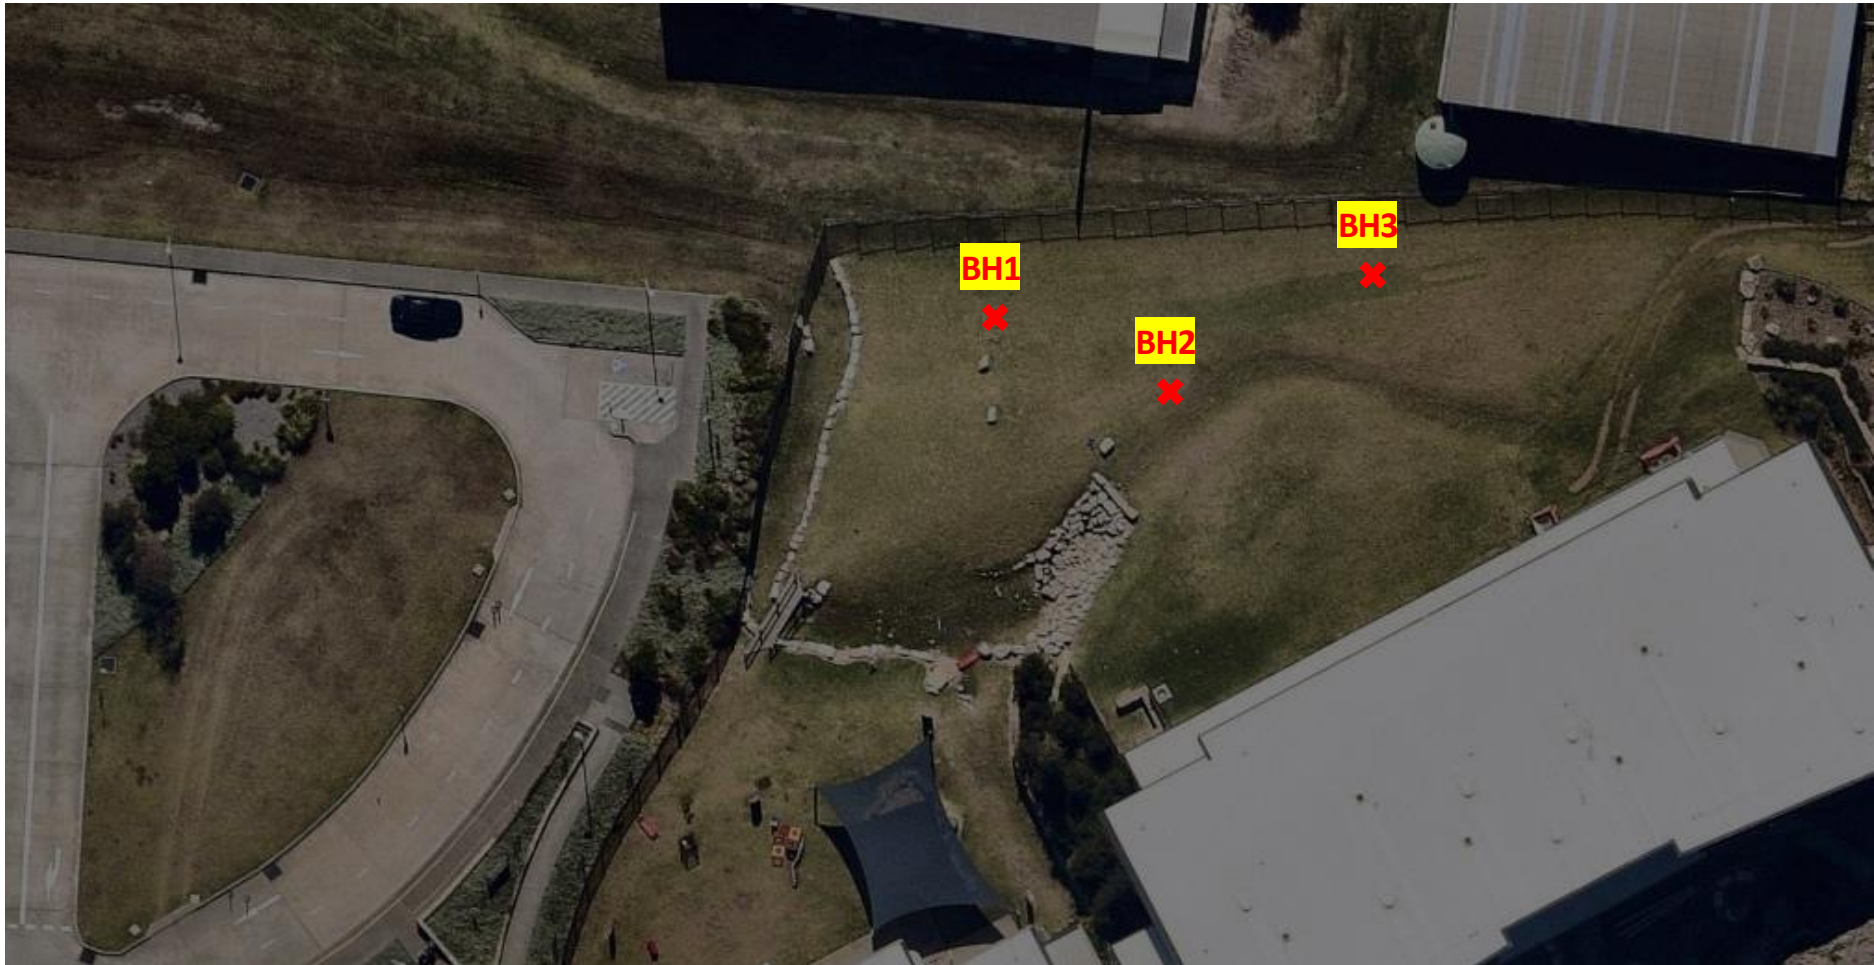
**Figure 1** – Plan of the Proposed Chapel Development at 24a Heritage Drive, Chisholm showing the approximate location of the Geotechnical boreholes.

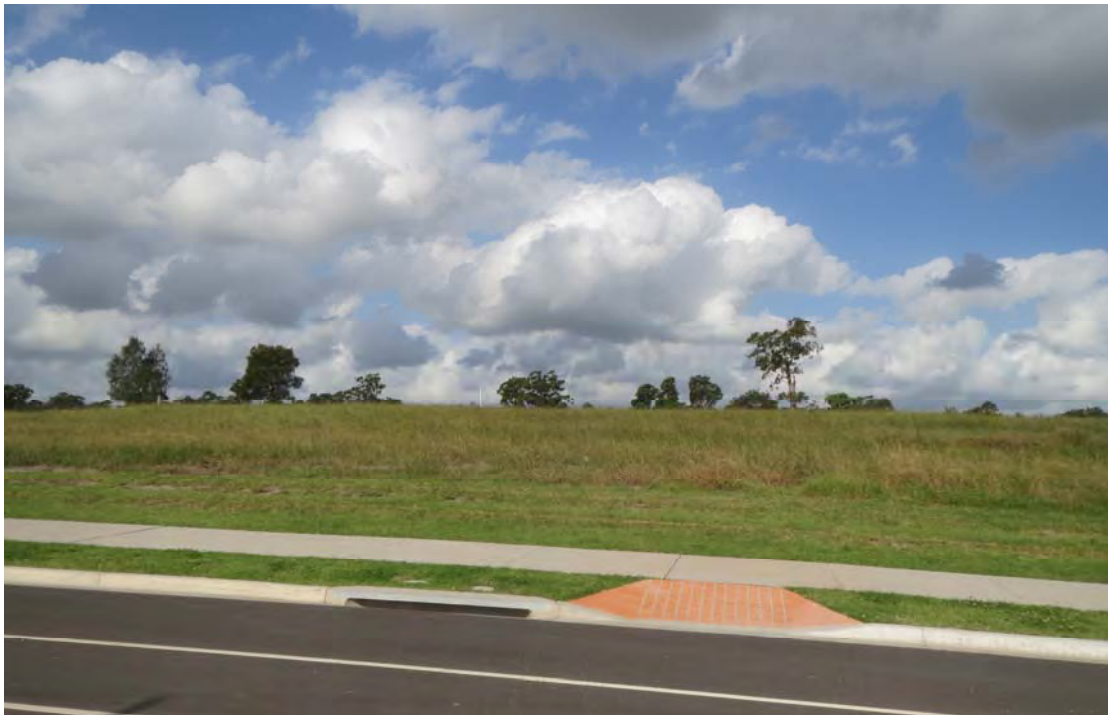
PHOTOGRAPH 1 – SITE PHOTO

View of the proposed development site. The site presently contains grass with an existing primary school occupying the southern portion of the site. Significant residential development and a playground surround the site.

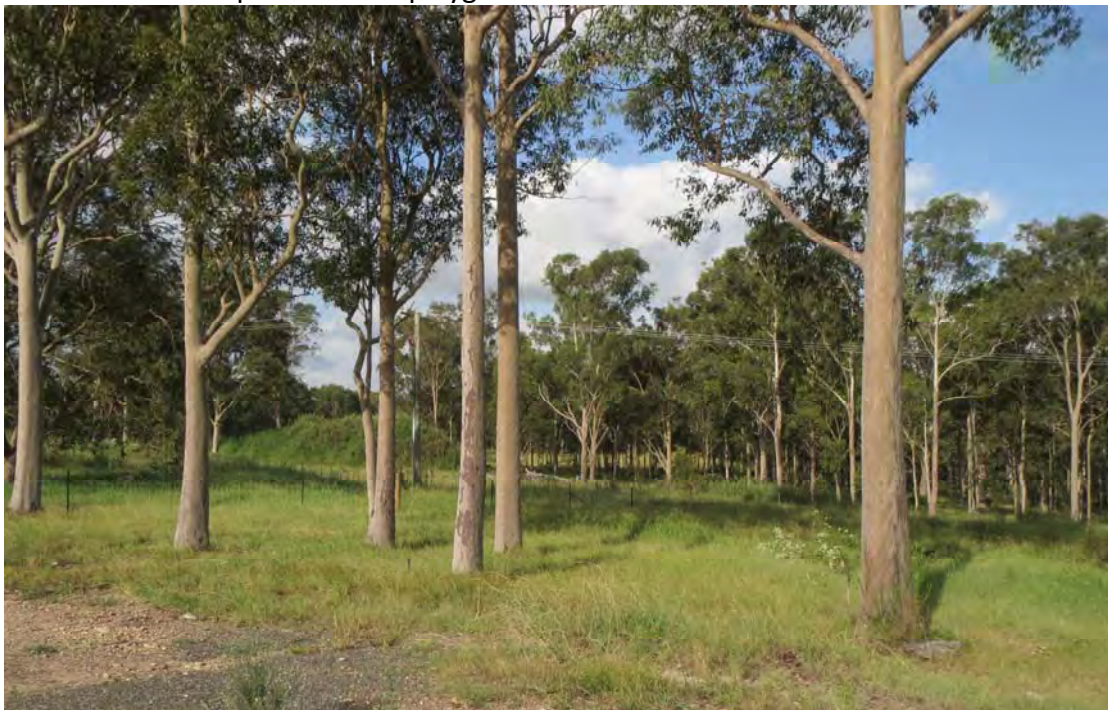
PHOTOGRAPH 2 – VEGETATIVE THREAT

View of remnant vegetation in the foreground interfacing grassland. Dry sclerophyll forest is visible in the distance. Eucalypts dominate the upper stratum with a low density shrub layer of native shrubs. This vegetation will be significantly reduced by future development.

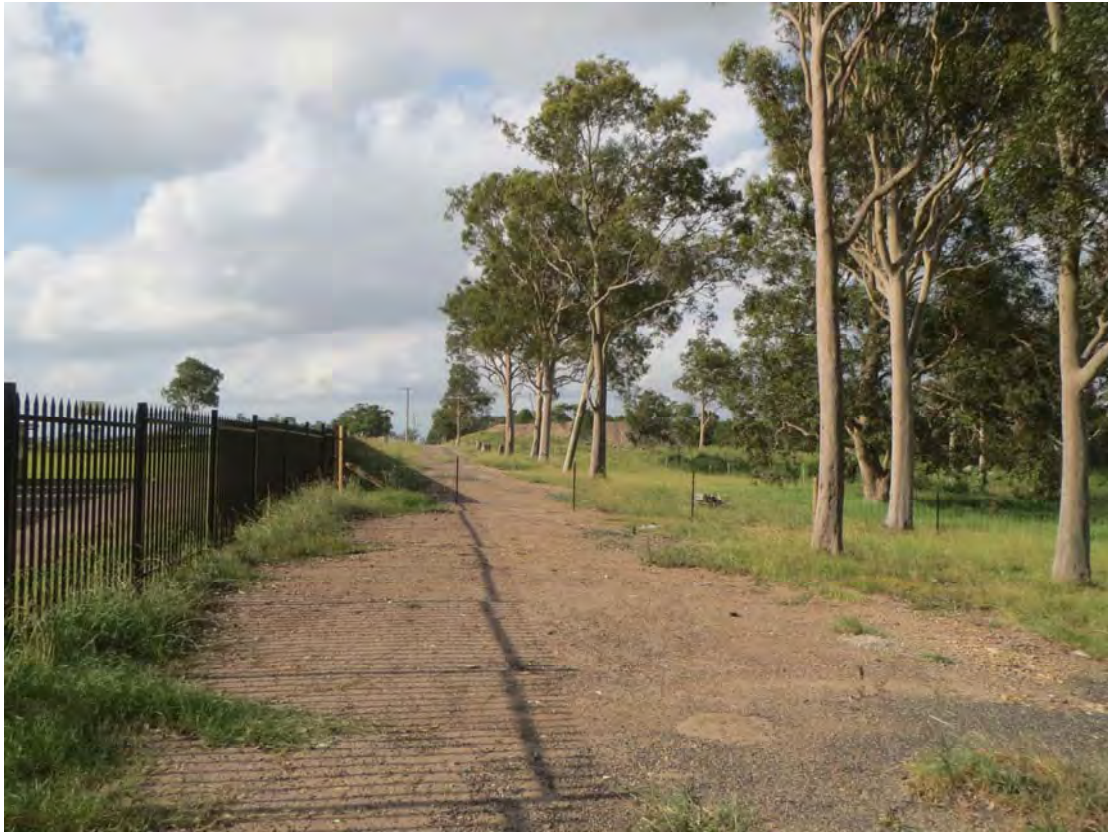
PHOTOGRAPH 3 – SITE ACCESS

View of existing unformed access located on the eastern boundary of the site which will support parallel and direct firefighting efforts within the adjacent vegetation. Future road network and residential properties will ameliorate the vegetation that is visible in this photograph.
