Preliminary Geotechnical Assessment

507 Raymond Terrace Road, Chisholm, NSW

Prepared for: Allam Property Group
EP1977.002 7 April 2021

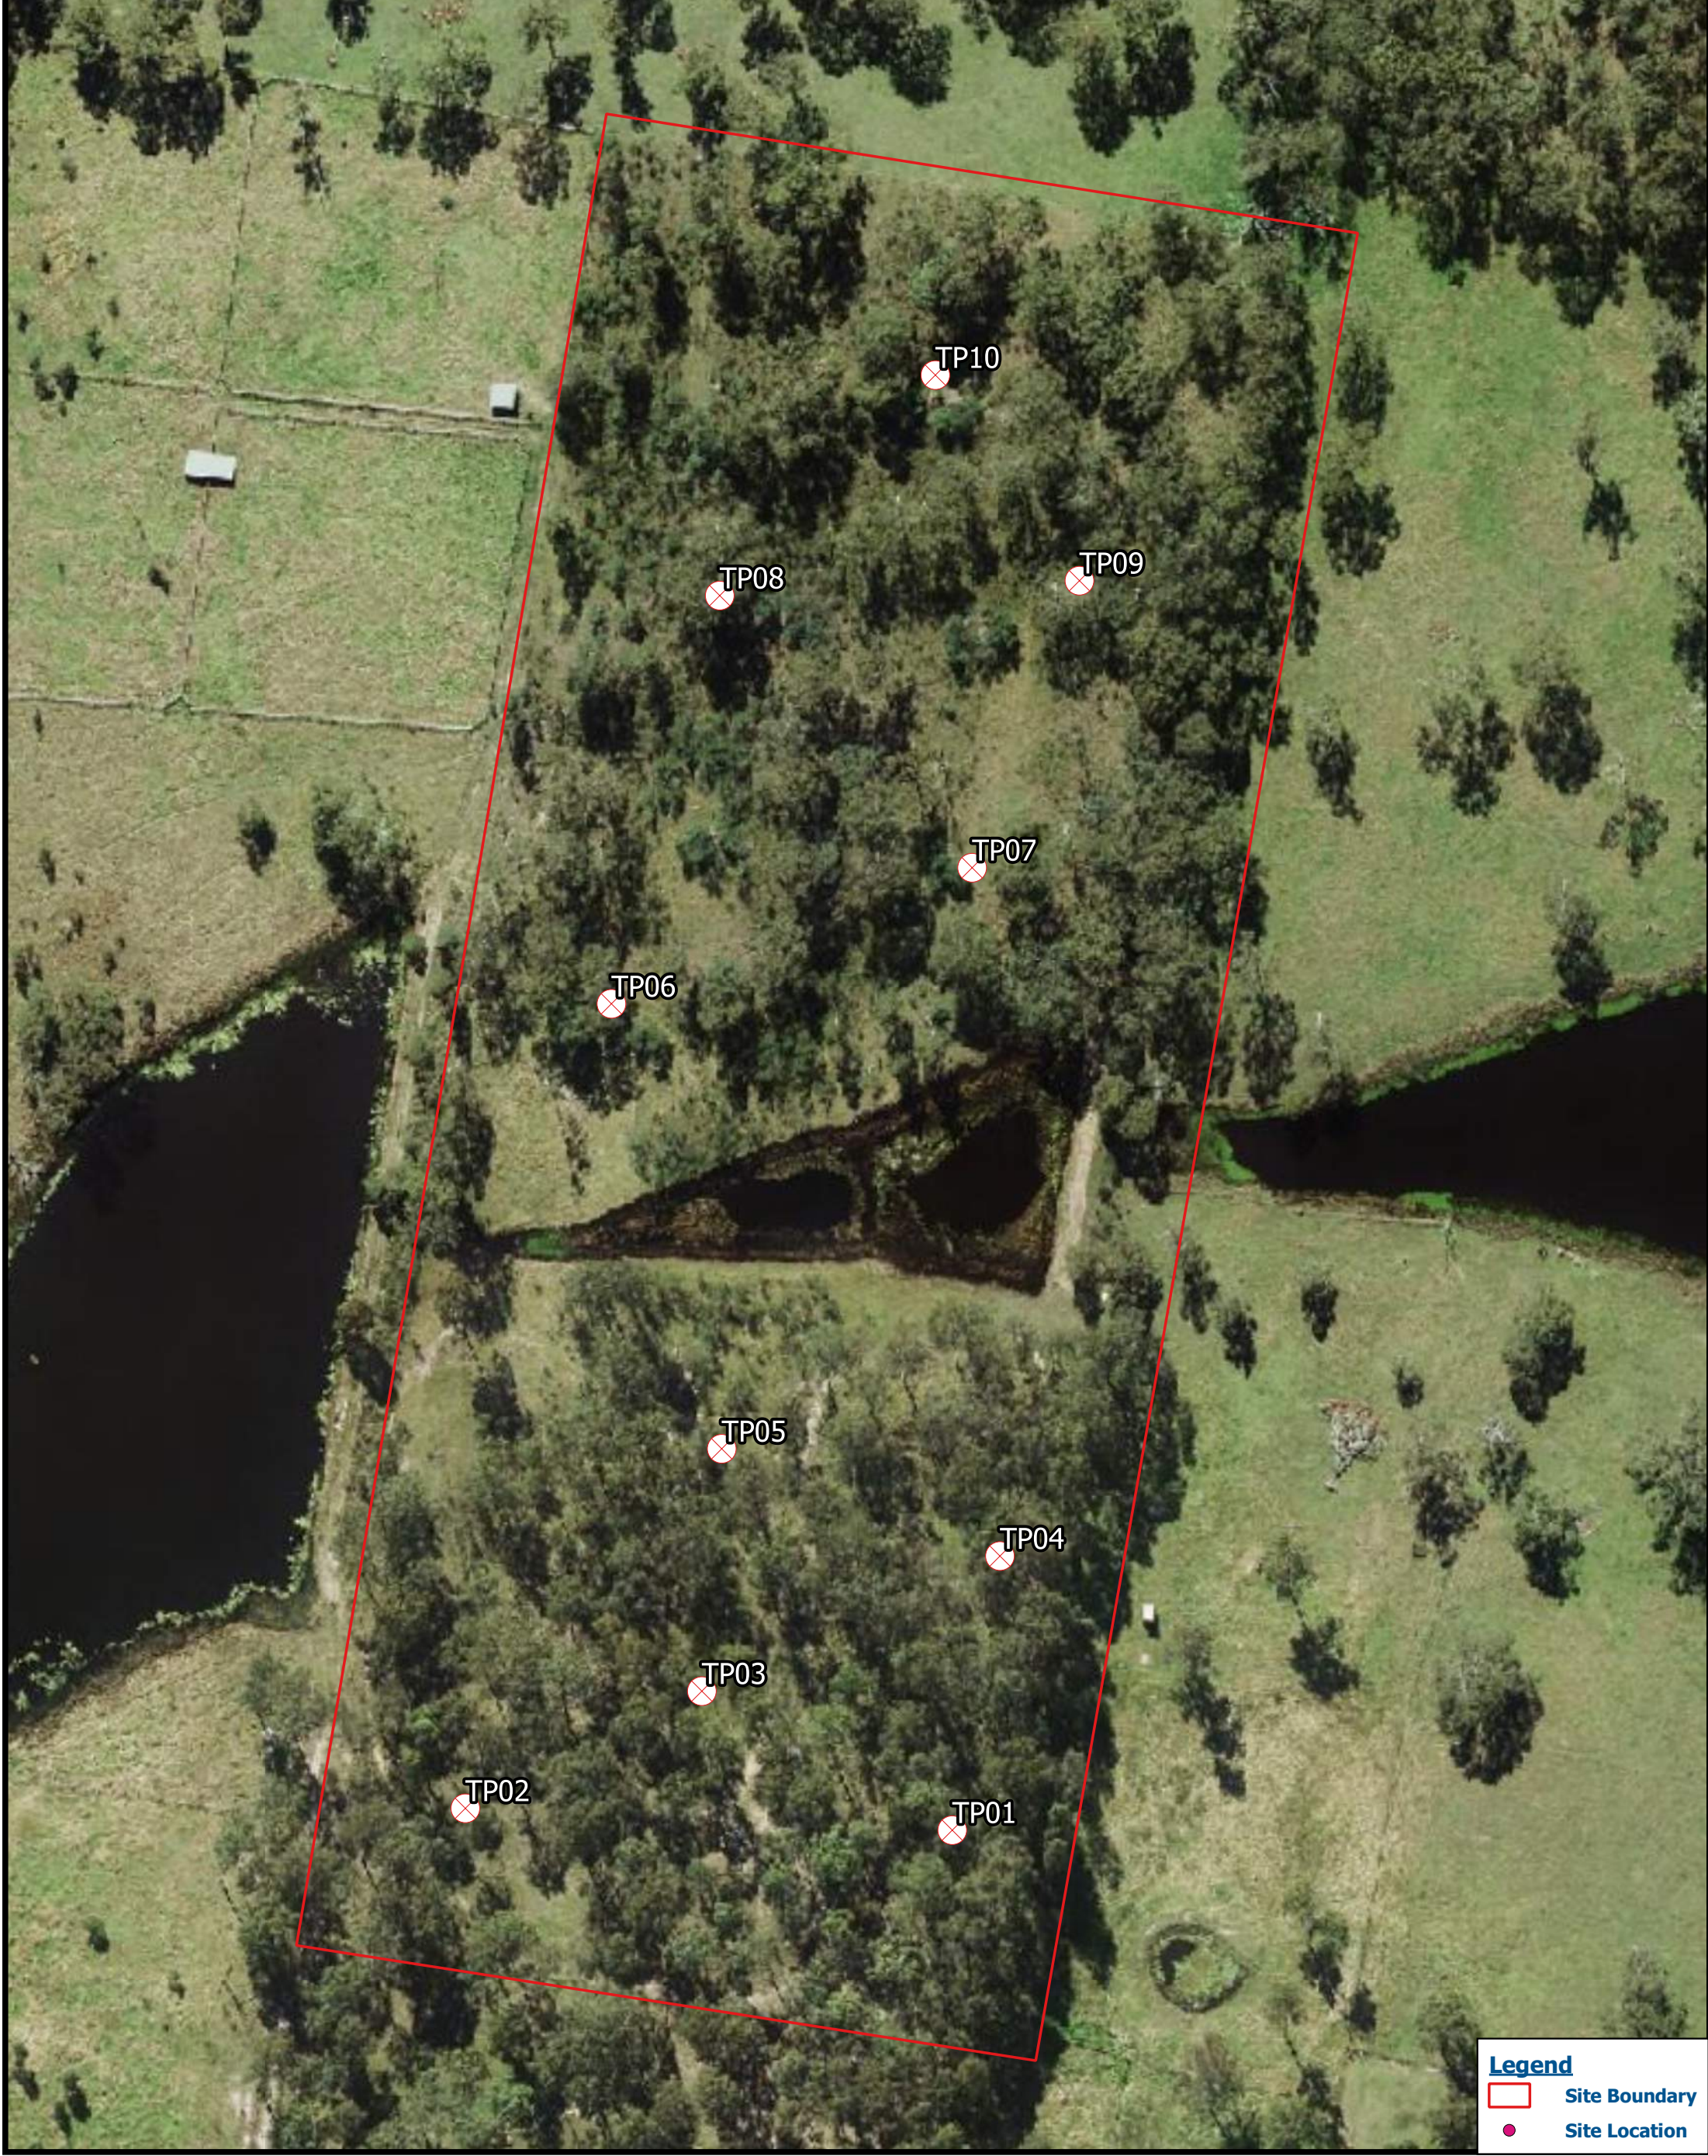
Figure 2 - Test Pit Locations

All fieldwork including logging of subsurface profiles and collection of samples was carried out by and in the presence of a geotechnical engineer from EP Risk. Test pits were located by handheld GPS from a KMZ file and the approximate locations are shown on **Figure 2**.

The subsurface conditions encountered in the test pits advanced across the Site are detailed in the report log sheets, attached in **Appendix B** with locations shown on **Figure 2**. A summary of subsurface conditions is presented in **Table 2**. In general, the subsurface can be summarised as follows:
