ARBORIST'S REPORT

PROPERTY OF THE PROPOSED DEVELOPMENT:	22 Eurimbla Street, Thornton
TREES TO BE REMOVED:	All Trees
DATE OF REPORT:	19 June 2023
REQUESTED BY:	Advantage Building Design

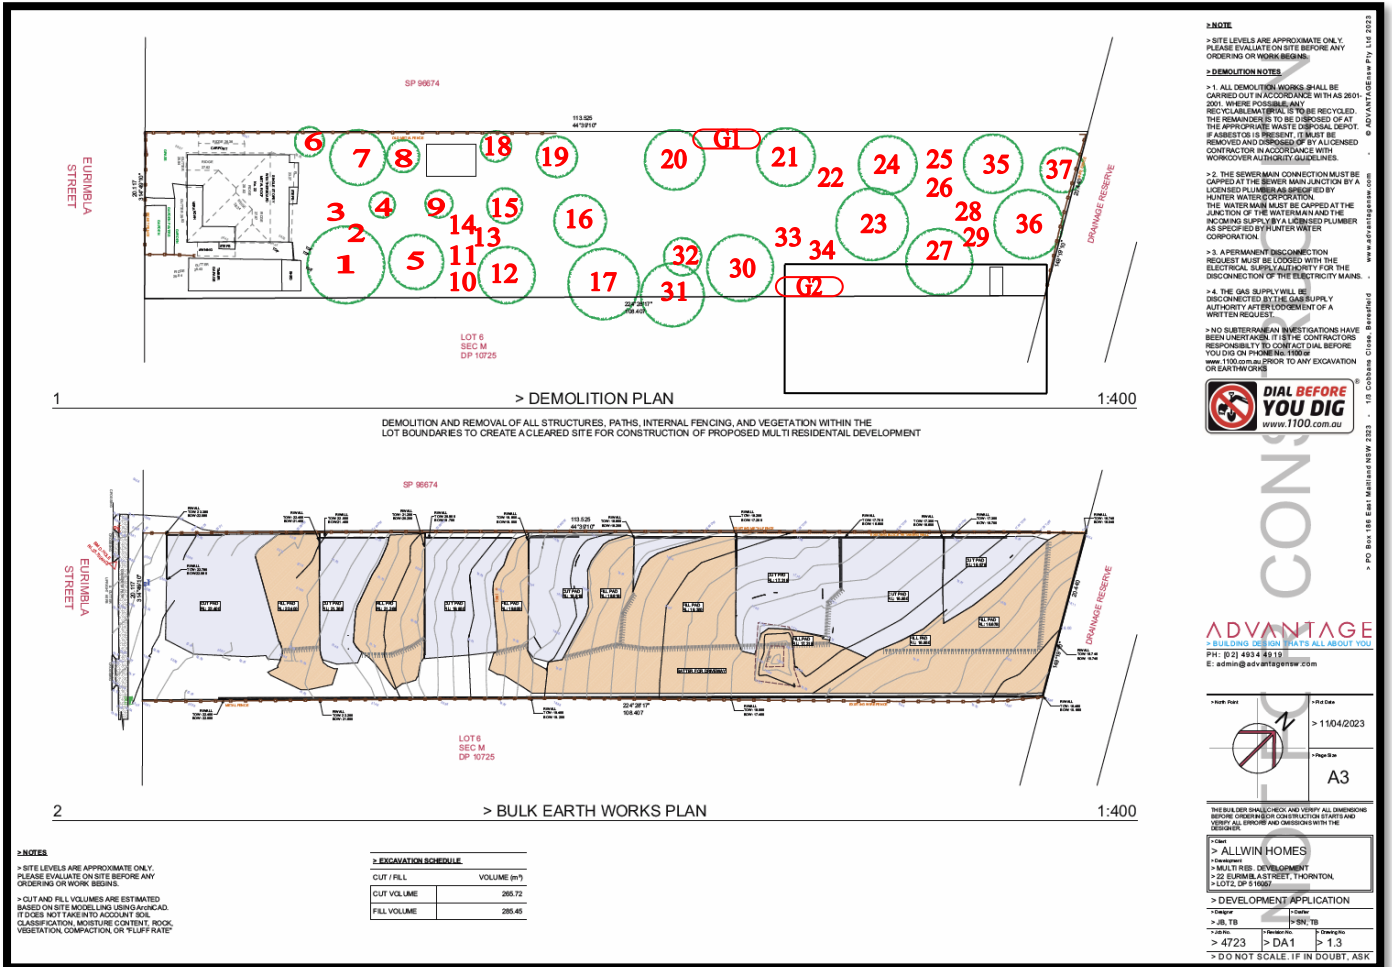
A supplied survey showing some of the trees. Smaller trees are not indicated by green circles (approximate positions shown as uncircled numbers).
