# Arboricultural Impact Assessment

Site Address: 19 Bungaree St Maitland

Client: Eagers Automotive Group Pty Ltd

Date: February 2024

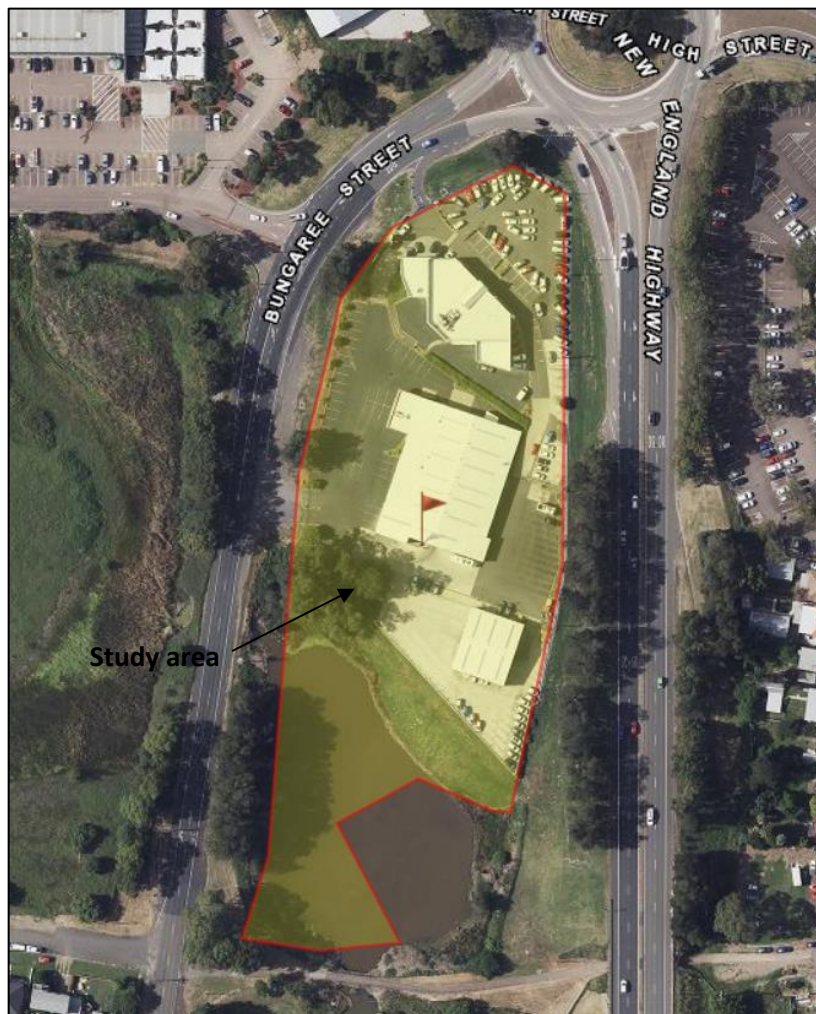
Figure 2 Subject Site (Sixmaps, 2024)

According to climate data from the Tocal AWS, which is approximately 11 kilometres from the site, the district experiences prevailing winds from the West to North-west, with infrequent occurrences of winds above 40km/h (Willy Weather, 2024). The subject trees are somewhat protected due to their close grouping.

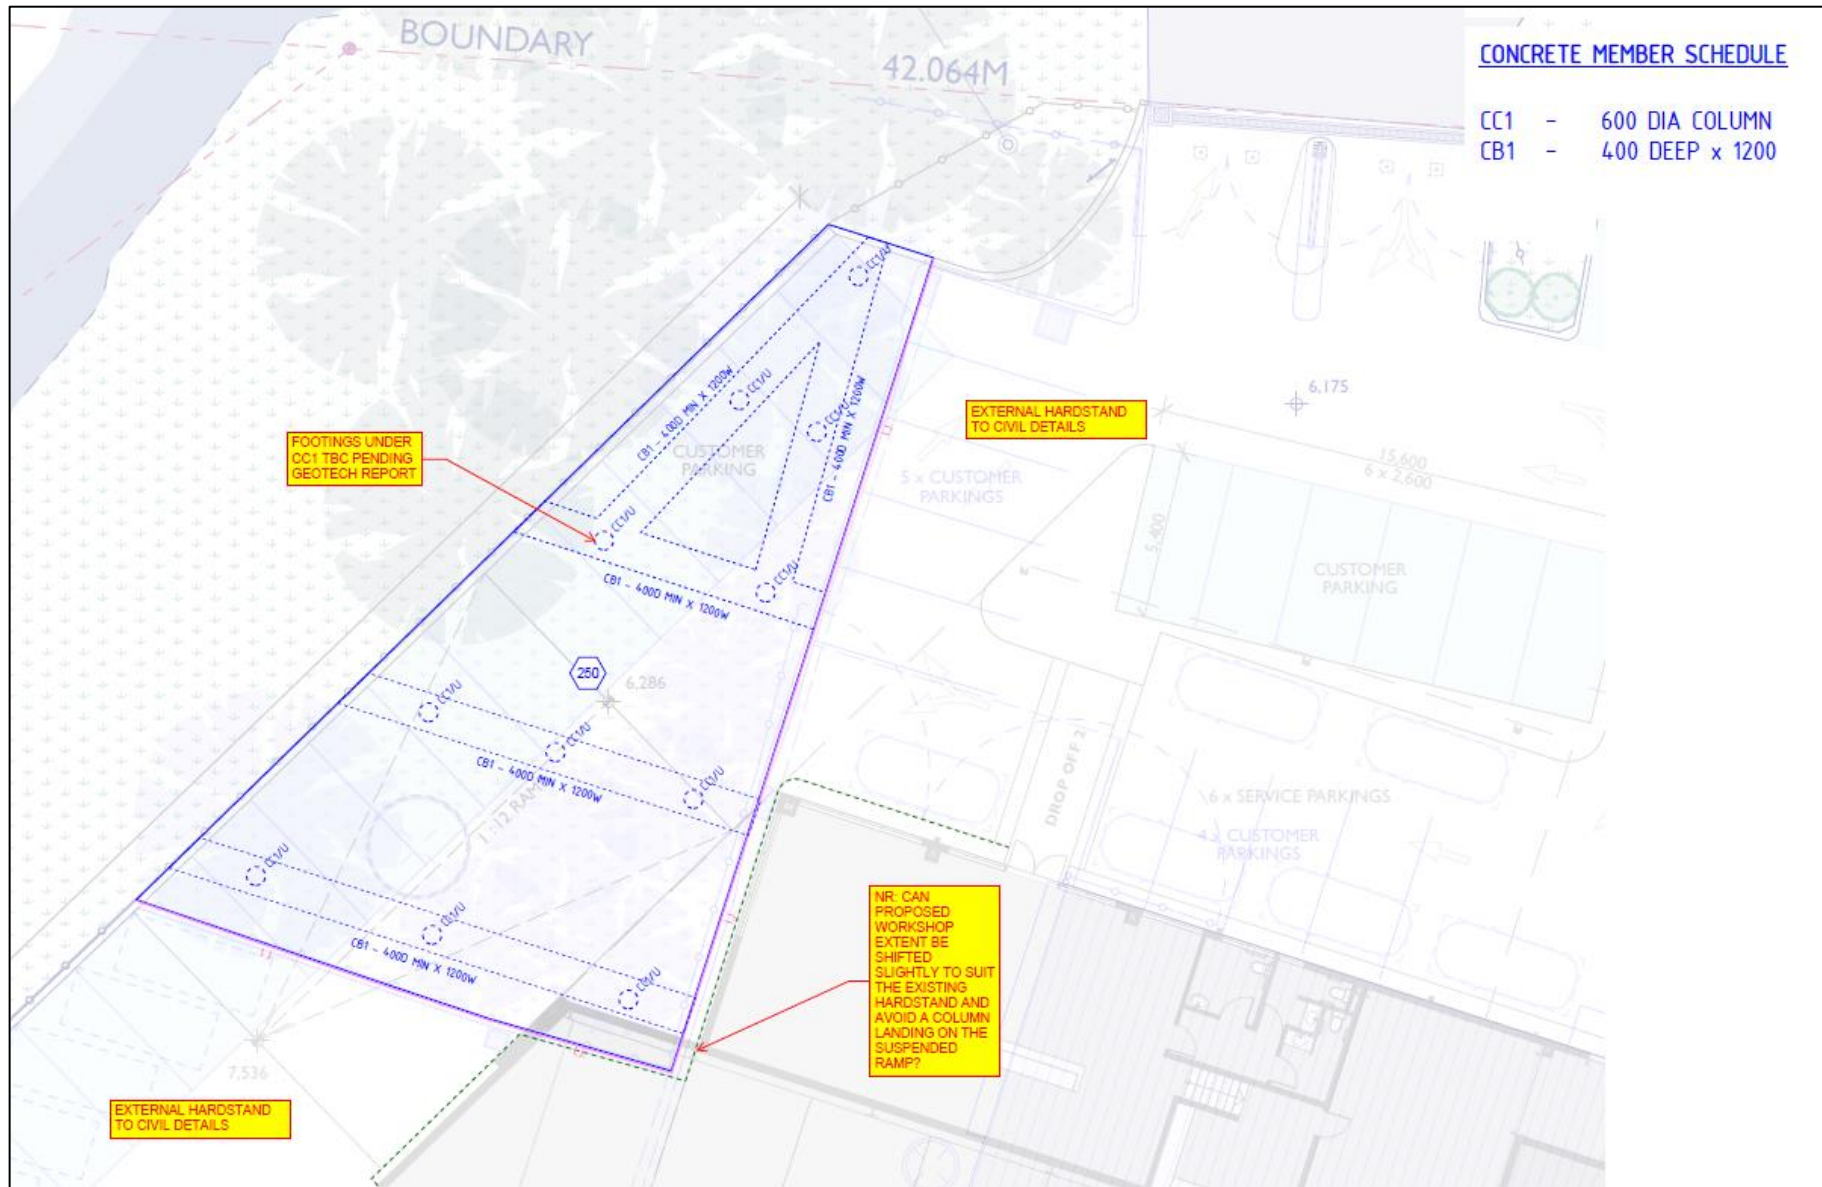
11.4 Structural Ramp Plan (extract)

The proposed pier and beam design will cause minimal impact outside of the plan area allowing retention of Trees 1 *Fraxinus griffithii*, 4, 5, 24 and 25 *Casuarina glauca* and 23 *Glochidion ferdinandii* which are setback from the works.
