ARBORIST REPORT

ALL SAINTS COLLEGE

***Corner of Hunter Street and Odd Street
Horseshoe Bend***

***PREPARED BY
TATTERSALL LANDER
PTY LTD
DEVELOPMENT CONSULTANTS
February 2022***

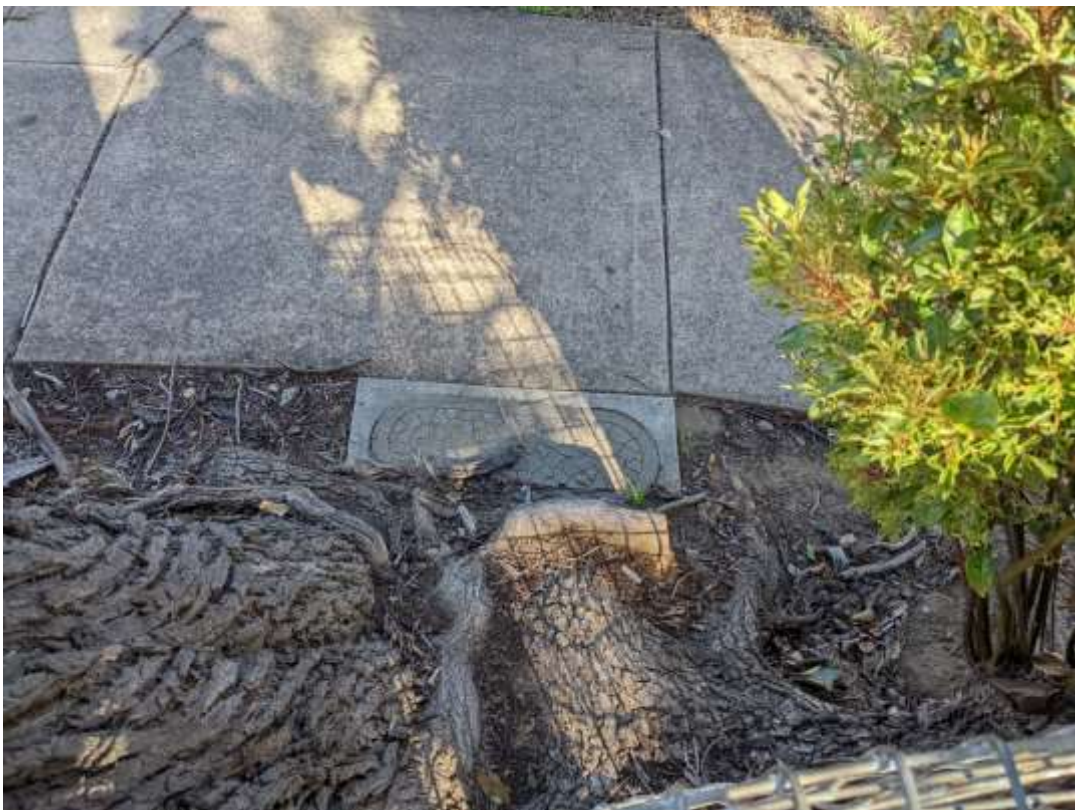
Photograph 10 – Tree 3 and comms pit

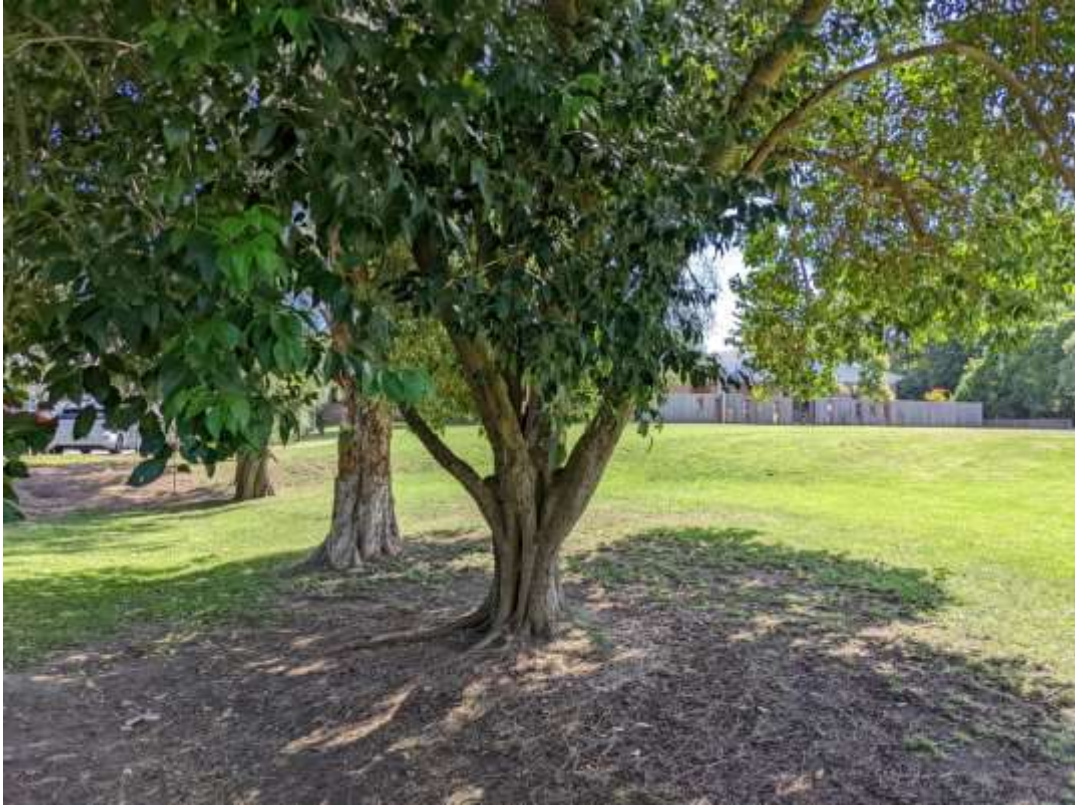
Photograph 29 – Tree 15

5	Mature – exceptionally old, probably over 100 years. Excellent vigour except for one small dead patch. Roots are exposed and have significant inclusions. It is noted that this tree is not included on the significant tree register and there are no known historical associations relating to this tree. Weed Species.
6	Mature. Good vigour. Small Deadwood. Some/minimal decay in trunk. Asymmetrical. Poor form. Brushes against adjacent building.
7	Mature. Good vigour. Large break approx. half way up trunk. Asymmetrical. Poor form.
8	Mature. Good vigour. Suppressed by Tree 7.
9	Mature. Average vigour. Some small deadwood.
10	Juvenile. Average vigour. Slightly asymmetrical.
11	Mature. Some small deadwood. Very minor dieback.
12	Mature. Excellent vigour. Excellent specimen.
13	Mature. Excellent vigour. Excellent specimen.
14	Mature. Good vigour. Top broken out.
15	Mature. Excellent vigour. Excellent specimen.

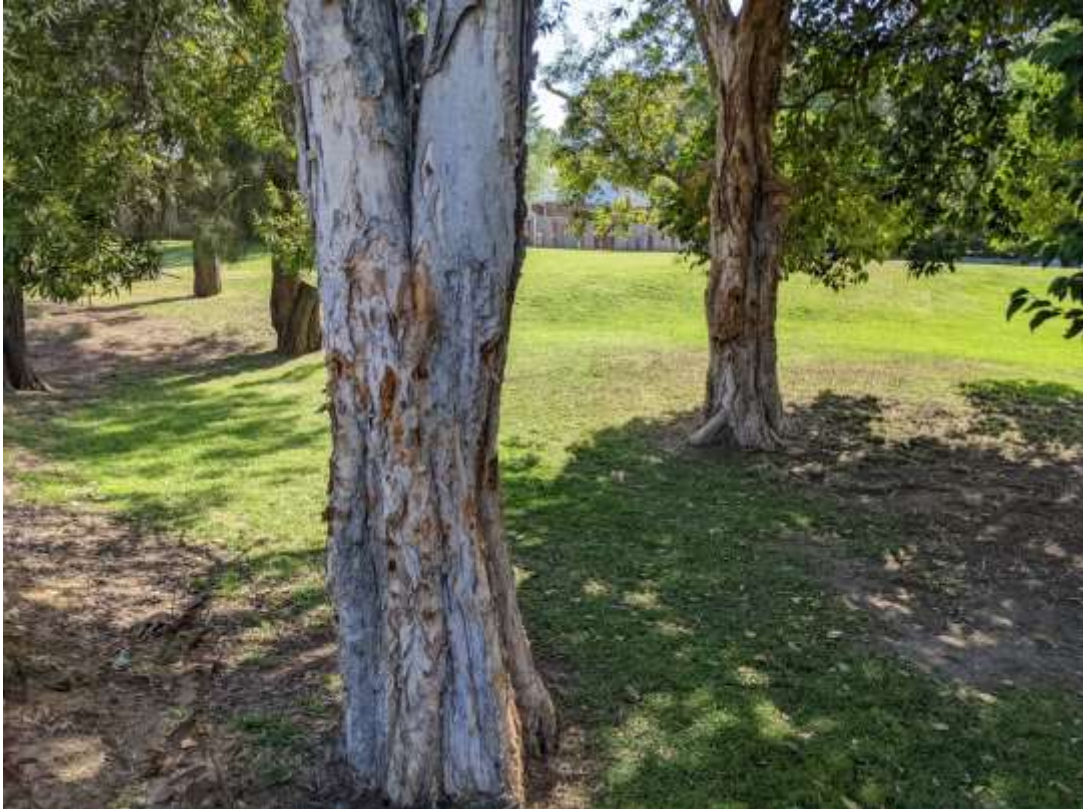
Photograph 30 – Tree 16 (centre) and Tree 17 (right)

16	Mature. Excellent vigour. Excellent specimen BUT significant weed species.
17	Mature. Average vigour. Slightly suppressed by Tree 16. Appears healthy though.
18	Mature. Average vigour. Medium deadwood. Some branch failures. Poor form.
19	Mature. Co-dominant trunks. Excellent vigour.
20	Mature. Average/good vigour
21	Juvenile. Excellent vigour and form.
