Geotechnical Investigation

Proposed Commercial Development Cnr Tyrell Street & Kenneth Street, Tenambit

Report Ref: G0237-GI-001-Rev0

10 August 2023

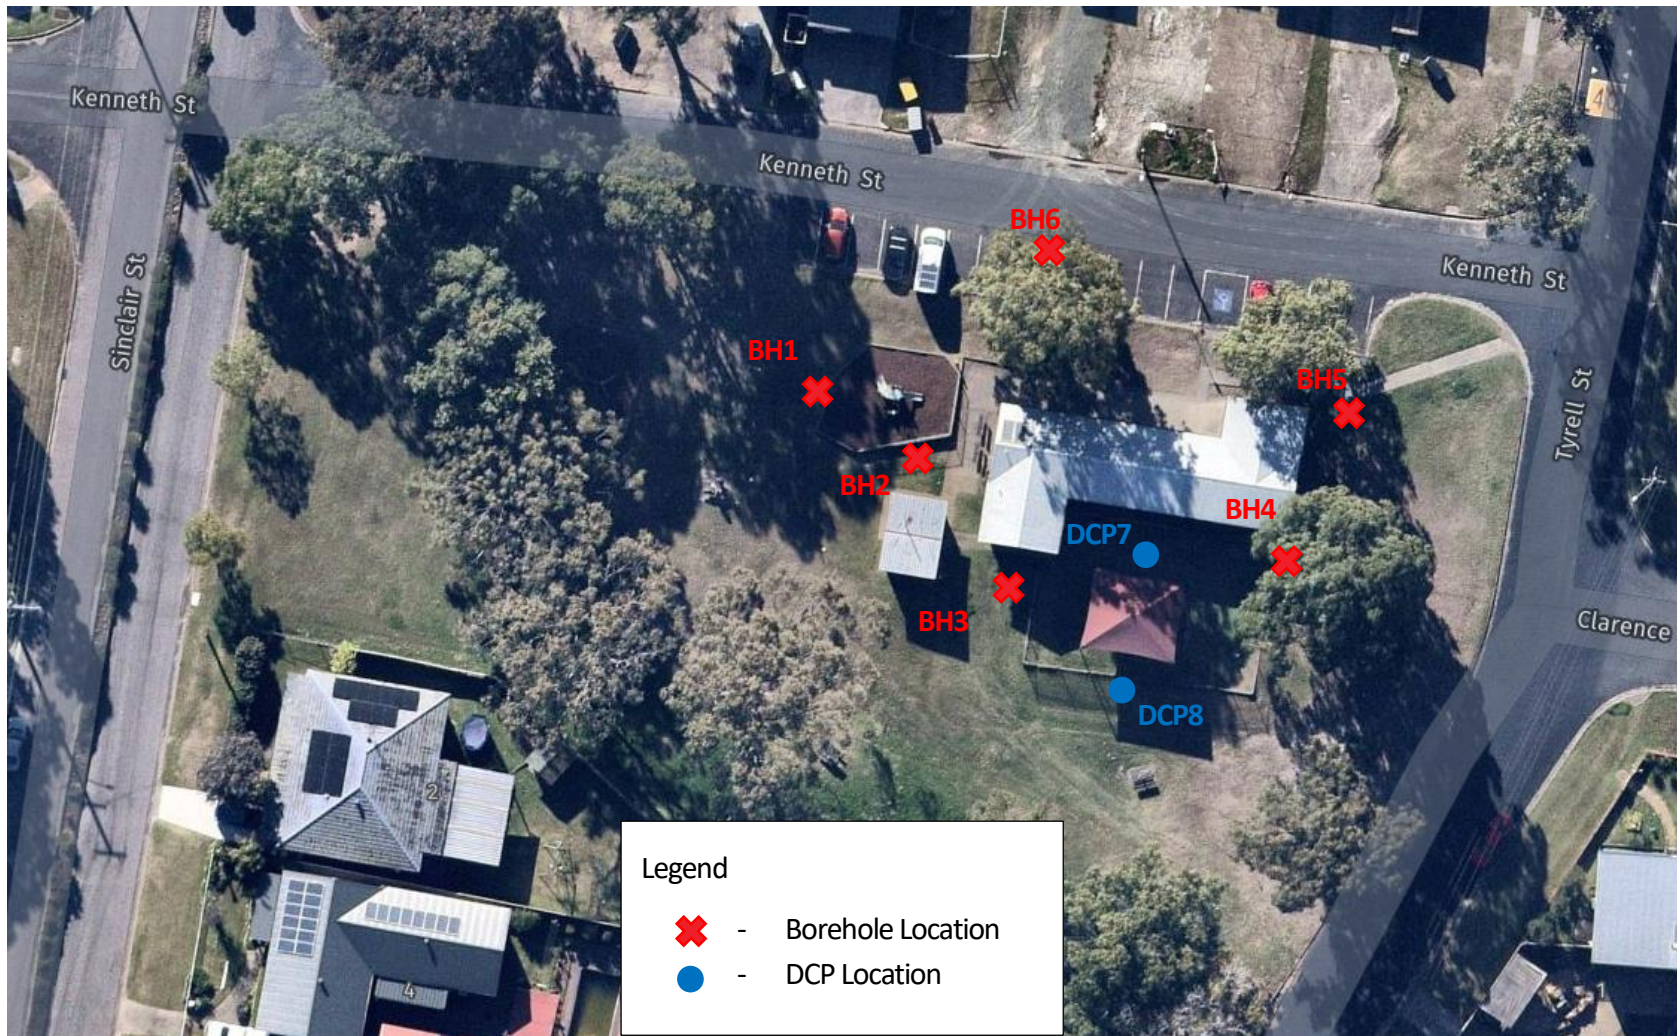
Borehole Location Plan

Figure 1 – Overhead image of the Corner of Tyrell Street and Kenneth Street showing the approximate location of the Geotechnical boreholes & DCP tests.
