# **Preliminary Site Investigation**

## **Maitland Gaol Redevelopment**

Prepared for Maitland City Council

E221249 RP1

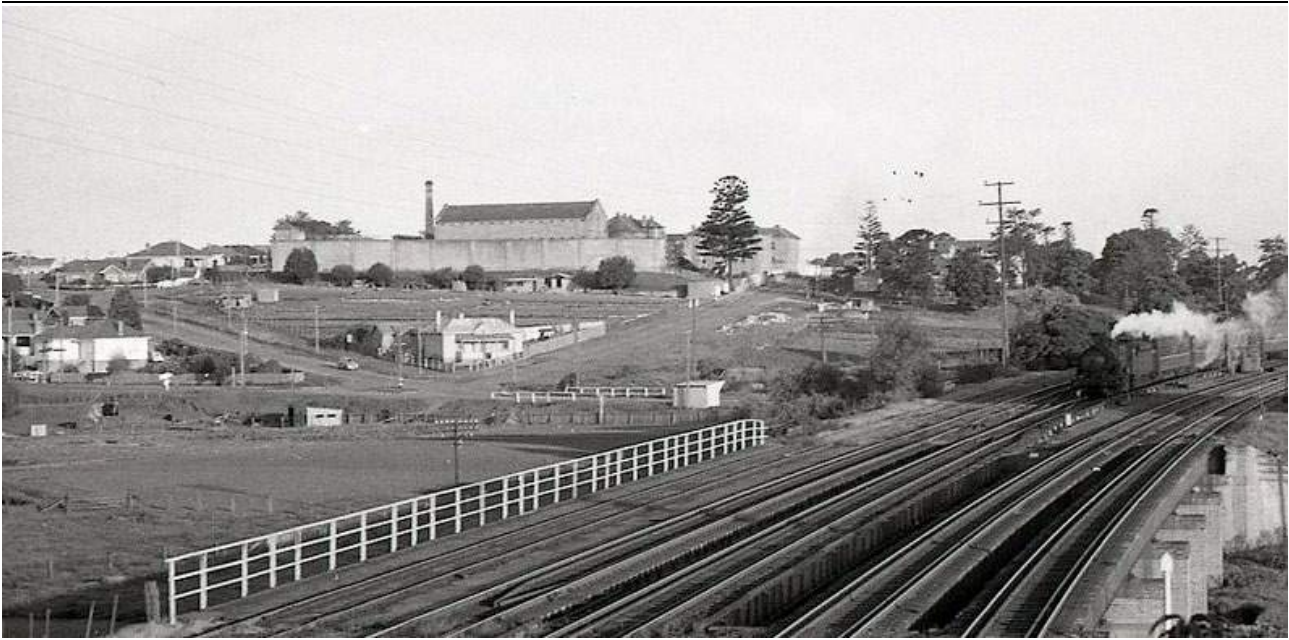
**Photo 1**

Photograph 1 shows the Site viewed from the west. Building 14 and Building 22 are not present however several smaller buildings are present within the north-west portion of the Site.

View from west of Maitland Gaol looking east. Photo taken from near current Pitnacree Road overpass of Main Northern Railway

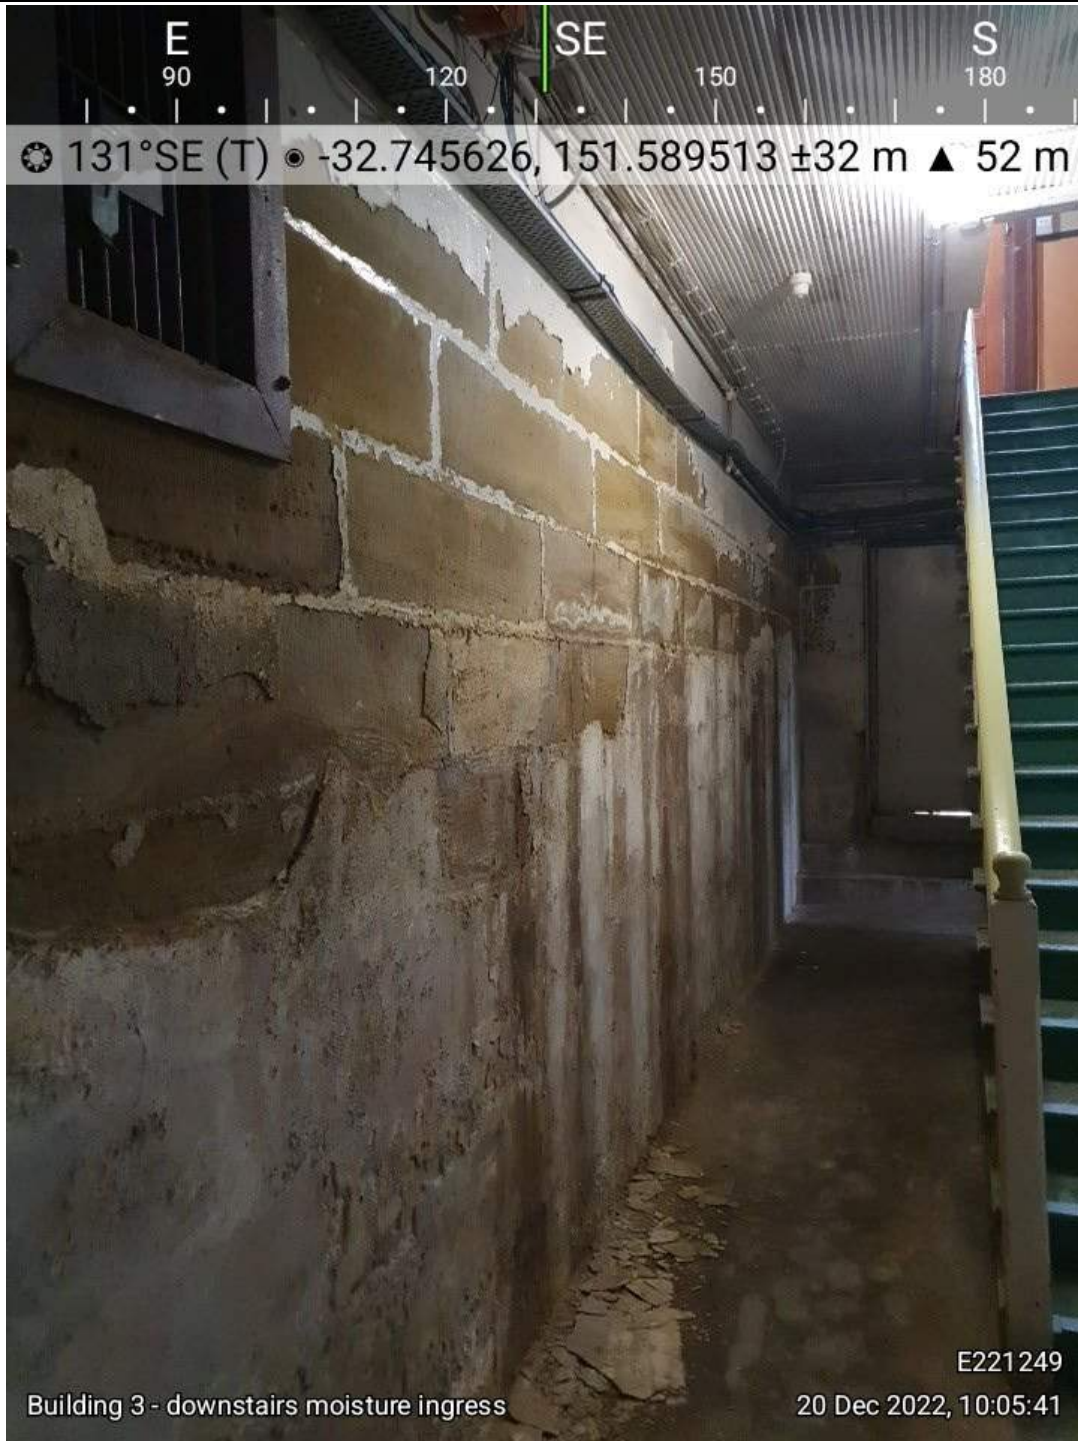
**Photo 6**

Damage to cladding resulting from water ingress

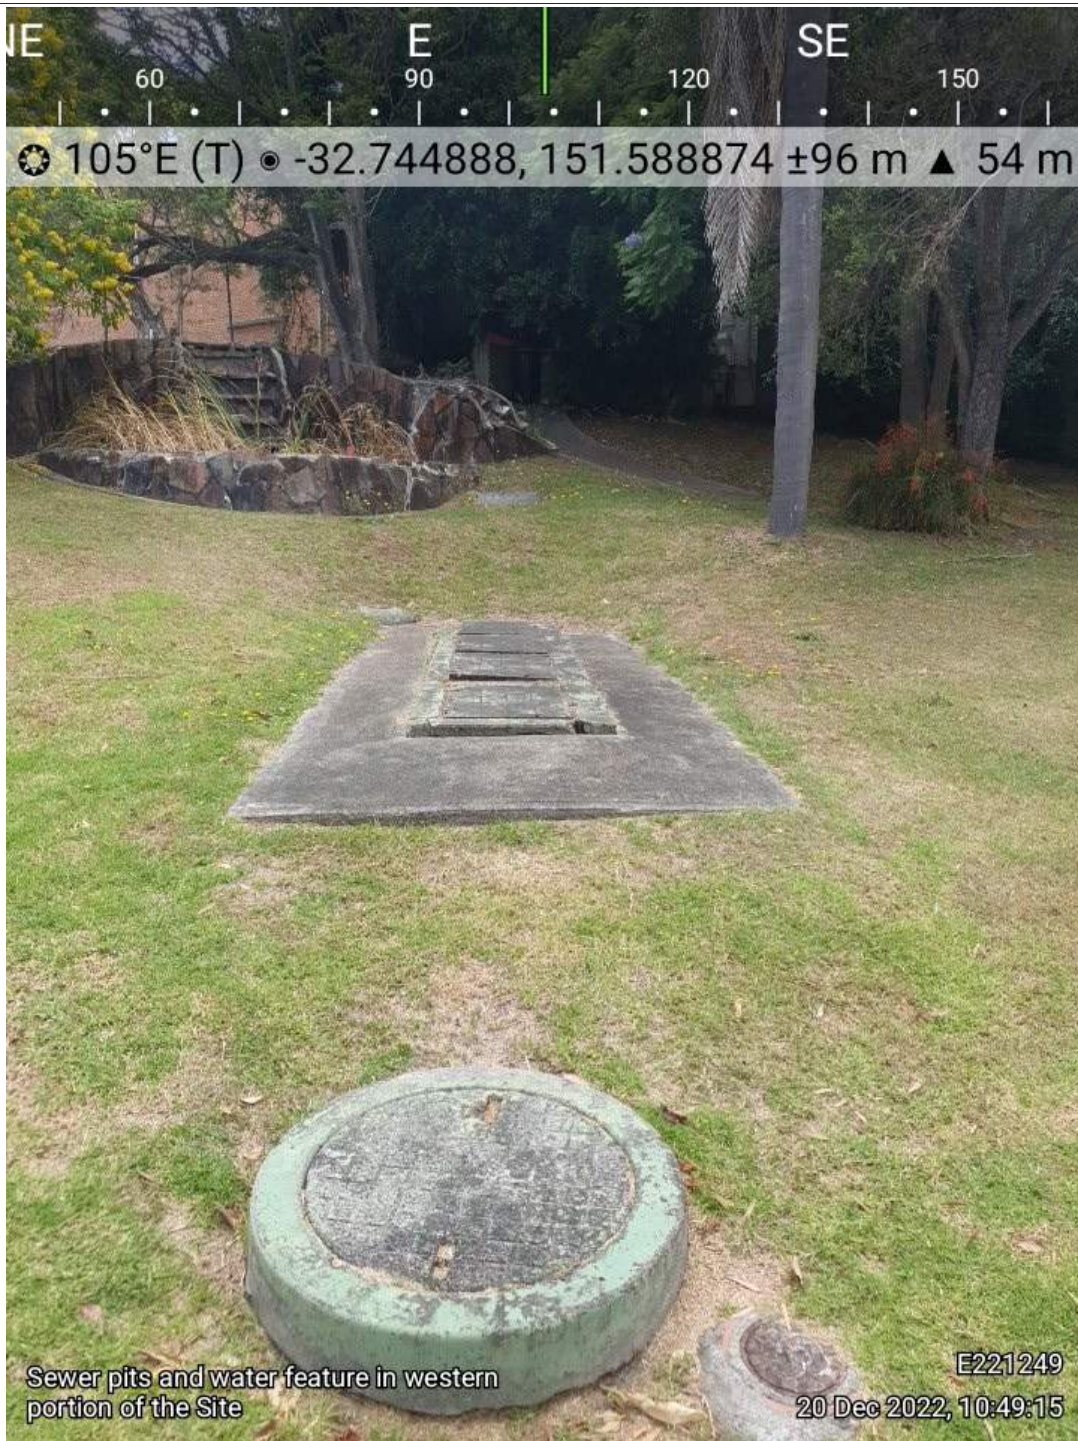
**Photo 15**

Sewer pits looking towards Building 22. Note the disused water feature in the top left of the photo.
