Preliminary Site Investigation

Maitland Gaol Redevelopment

Prepared for Maitland City Council

E221249 RP1

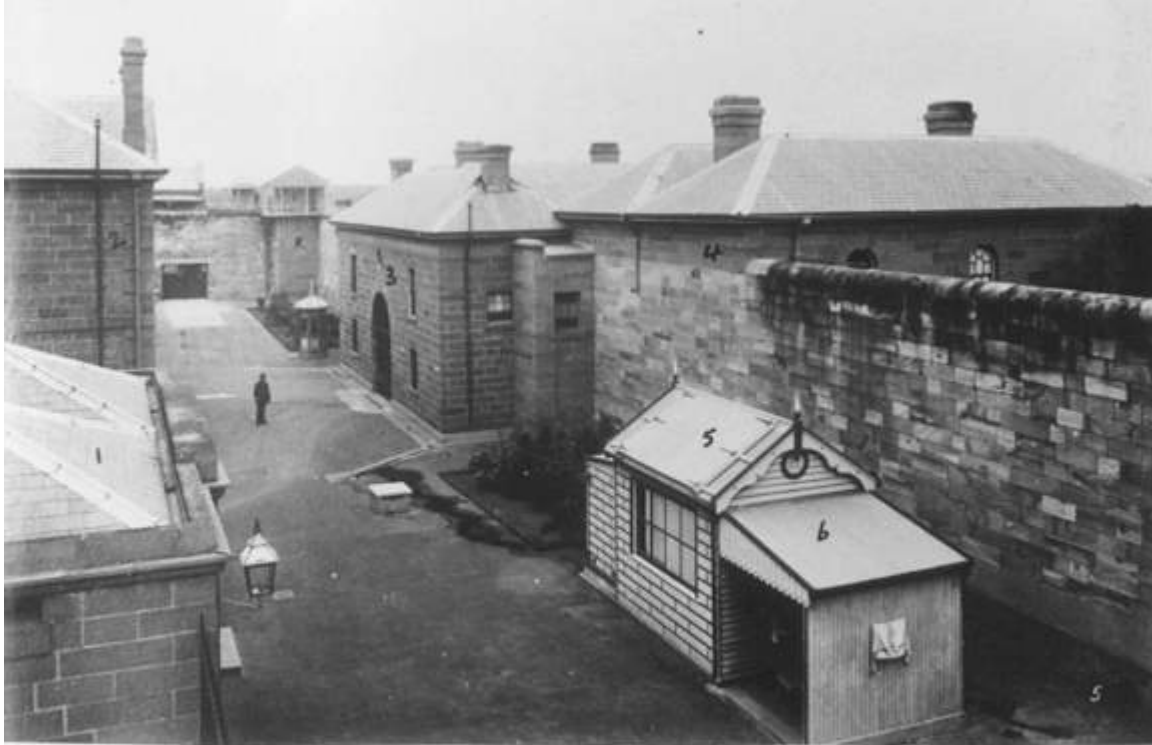
Photo 5

Photograph 5 is taken slightly to the north-east of Photo 4 facing towards the south and shows an alternative view of the Photo Gallery/Messenger's Shed and Building 2. The Gatehouse (Building 1) is also visible within the photograph.

View from No. 10 Tower showing (1) B. Wing (2) Church (3) Gate (4) Back of Deputy Governor's quarters (5) Photo Gallery (6) messengers shed.
