# ***Arborist Report***

**Client: Largs Property Group**

Address: 2 Dunmore Road,

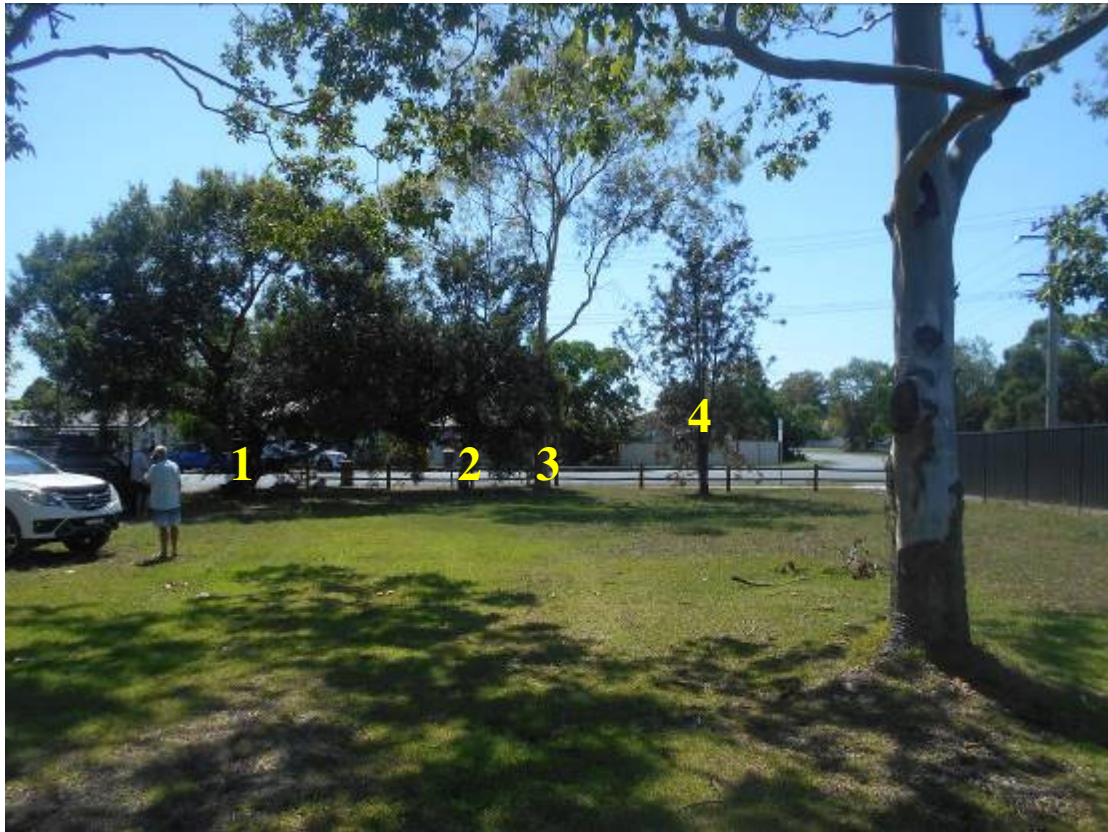
All trees have been tagged for identification purposes that correspond with the tree numbers in Appendix 1. All trees require a S.R.Z and a T.P.Z with Australian Standards 4970- 2009 being used as a guideline. Tree 1 has been given an SRZ and TPZ of 2.88 & 6.84 metres in accordance with Australian Standards 4970 - 2009. Tree 1 is located in the front yard of the subject property. Tree 1 is located inside the proposed porch and the trunk is located on the edge of the development (Unit 1). In order to construct the development will require the removal of Tree 1. Tree 1 is earmarked for removal before commencement of building works on site.

Figure 3 – showing the location of Trees 1 – 4 in the front setback of the front yard inside the subject property.

- It is recommended that Trees 1 - 24 (24 in total) be removed immediately (before commencement of building works) by a qualified arborist (minimum certificate 2 in arboriculture). It is recommended that professional indemnity and public liability insurances be current and sighted before commencement of works begin. The level of cover has to be one in agreement between Largs Property Group and the arborist.

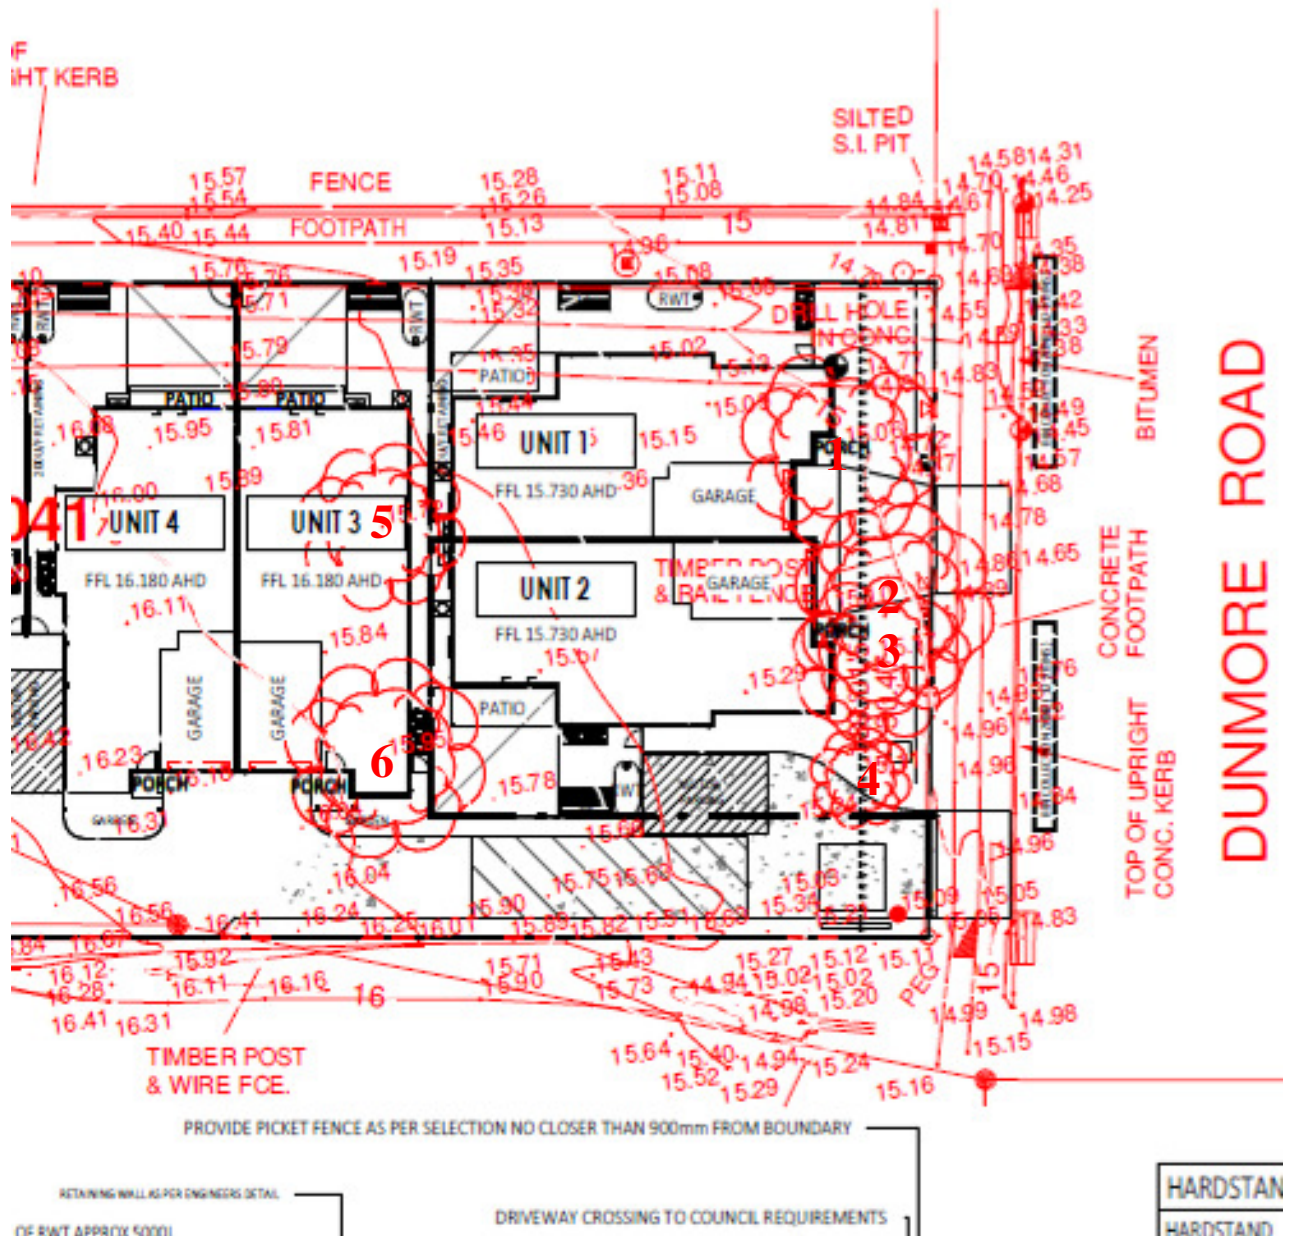
Figure 19 - Close up of the subject property and canopy area of Trees 1 - 6. Not to scale  
 Source: Valley Homes

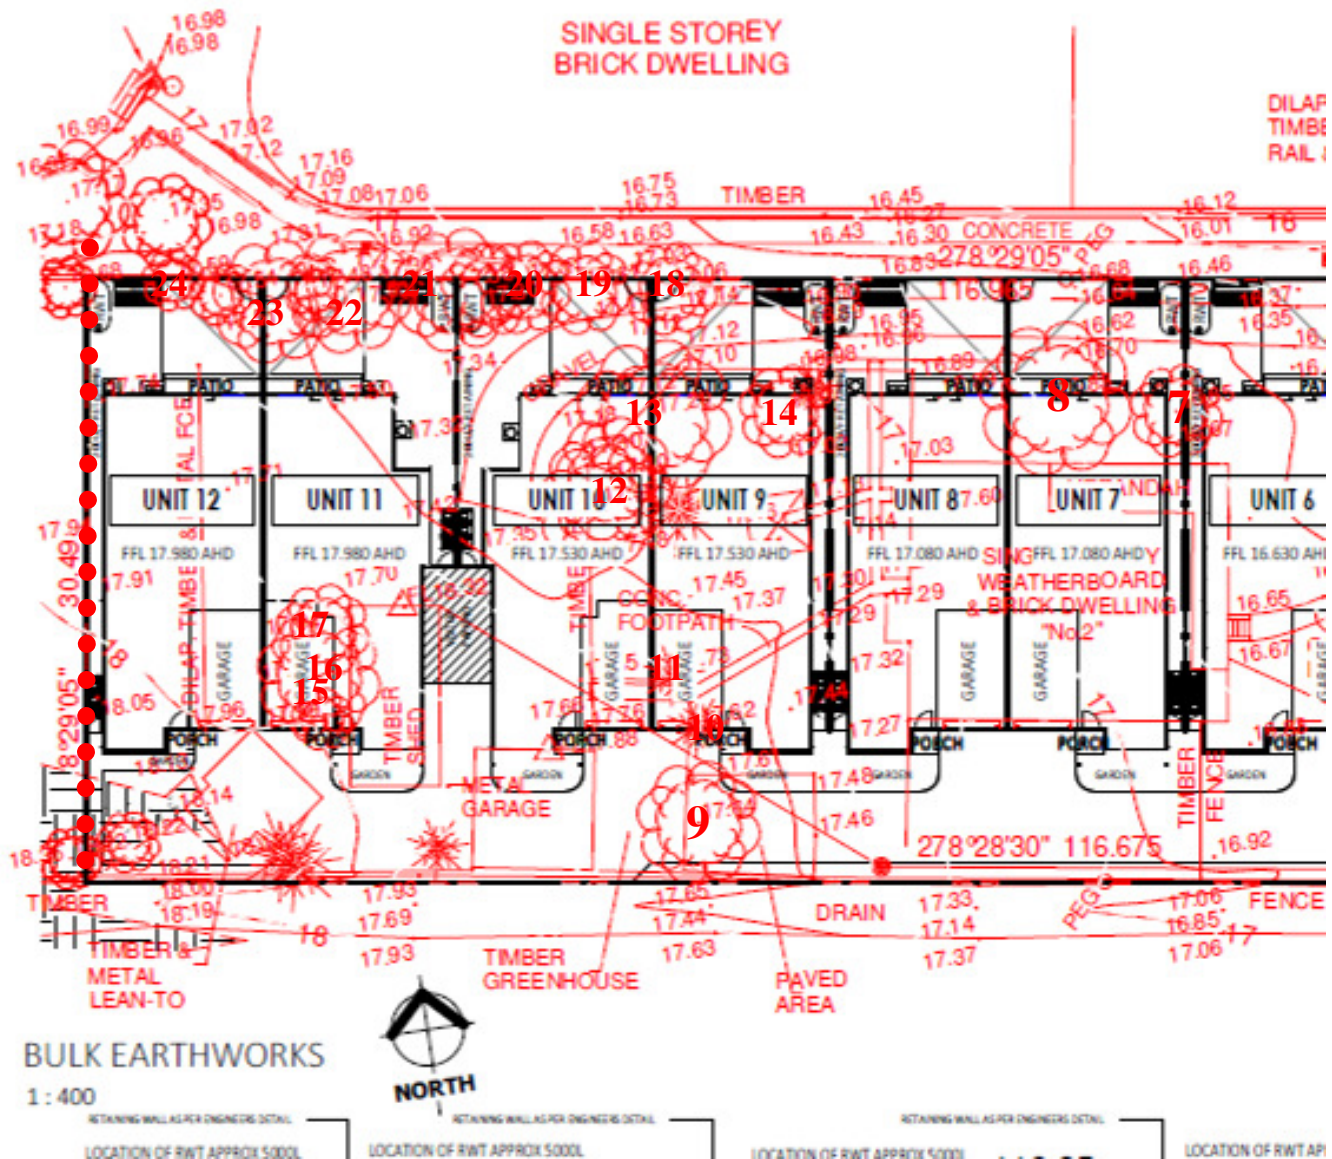
Figure 20 - Close up of the subject property and canopy area of Trees 9 - 24. The fencing as shown is to be erected a minimum of 1.5 metres from Unit 12. This will ensure the protection of trees outside the scope of works. Not to scale  
Source: Valley Homes

- Figure 17 – showing the proposed fencing that is to be put in place before the commencement of building works on site. This is to include perimeter fencing to the back boundary as shown in Figure 20. This will ensure no access to the nature strip trees.
