arboricultural impact assessment report

AIA-01

Revision A, Issued for Development Application 11 June, 2020

PROJECT Residential Aged Care Facility at 7 Martin Close and 42 Stronach Ave

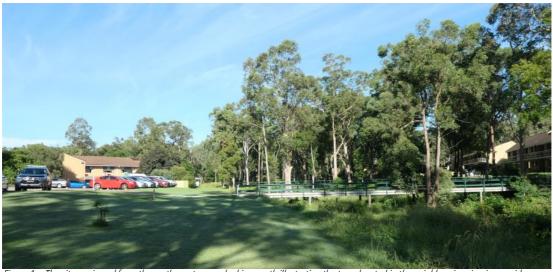
Figure 1 – The site as viewed from the north-west corner looking south illustrating the trees located in the neighbouring riparian corridor area. Those that are close to the site form part of this assessment. (Photo: Arterra 15/4/2020)

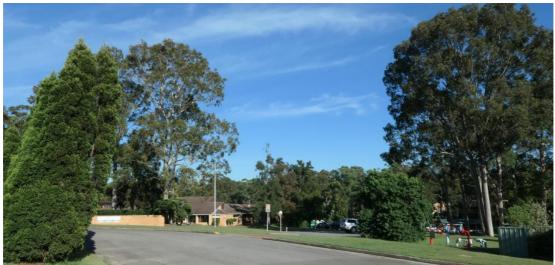
Figure 2 – The site as viewed from the Martin Close looking west illustrating some of the significant endemic trees located in site that have been the focus of tree retention on the project. (Photo: Arterra 15/4/2020)

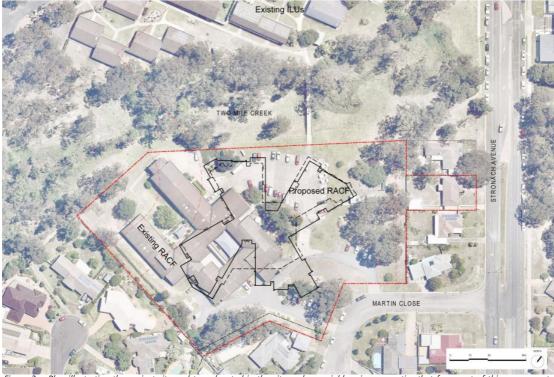
Figure 3 – Plan illustrating the project site and trees located in the site and on neighbouring properties that form part of this assessment. (Source : Aerial – NearMap dated October 2019)
