Arborist Report

Client: Quicksilver Developments

Address: 258 High Street, MAITLAND N.S.W 2320

Project: 258 High Street, Maitland Client: Quicksilver Developments

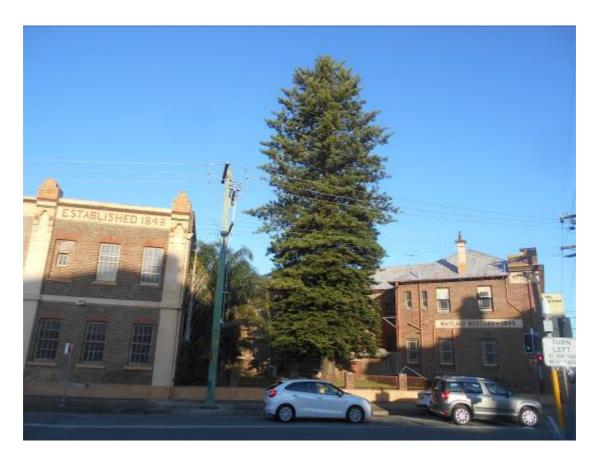
Figure 2 – Location of subject property identified as 258 High Street, Maitland

The site is set on a flat block with the immediate area being dominated by a mix of commercial premises. The nearest major arterial road is Hunter Street. Tree 1 is located within the subject property identified as 258 High Street, Maitland. Tree 1 is within close proximity to the subject property & proposed alterations and additions.
