**ARBORICULTURAL IMPACT ASSESSMENT
CARPARK UPGRADE**

WOODBERRY LEARNING CENTER

**WOODBERRY ROAD
WOODBERRY**

28th JUNE 2022

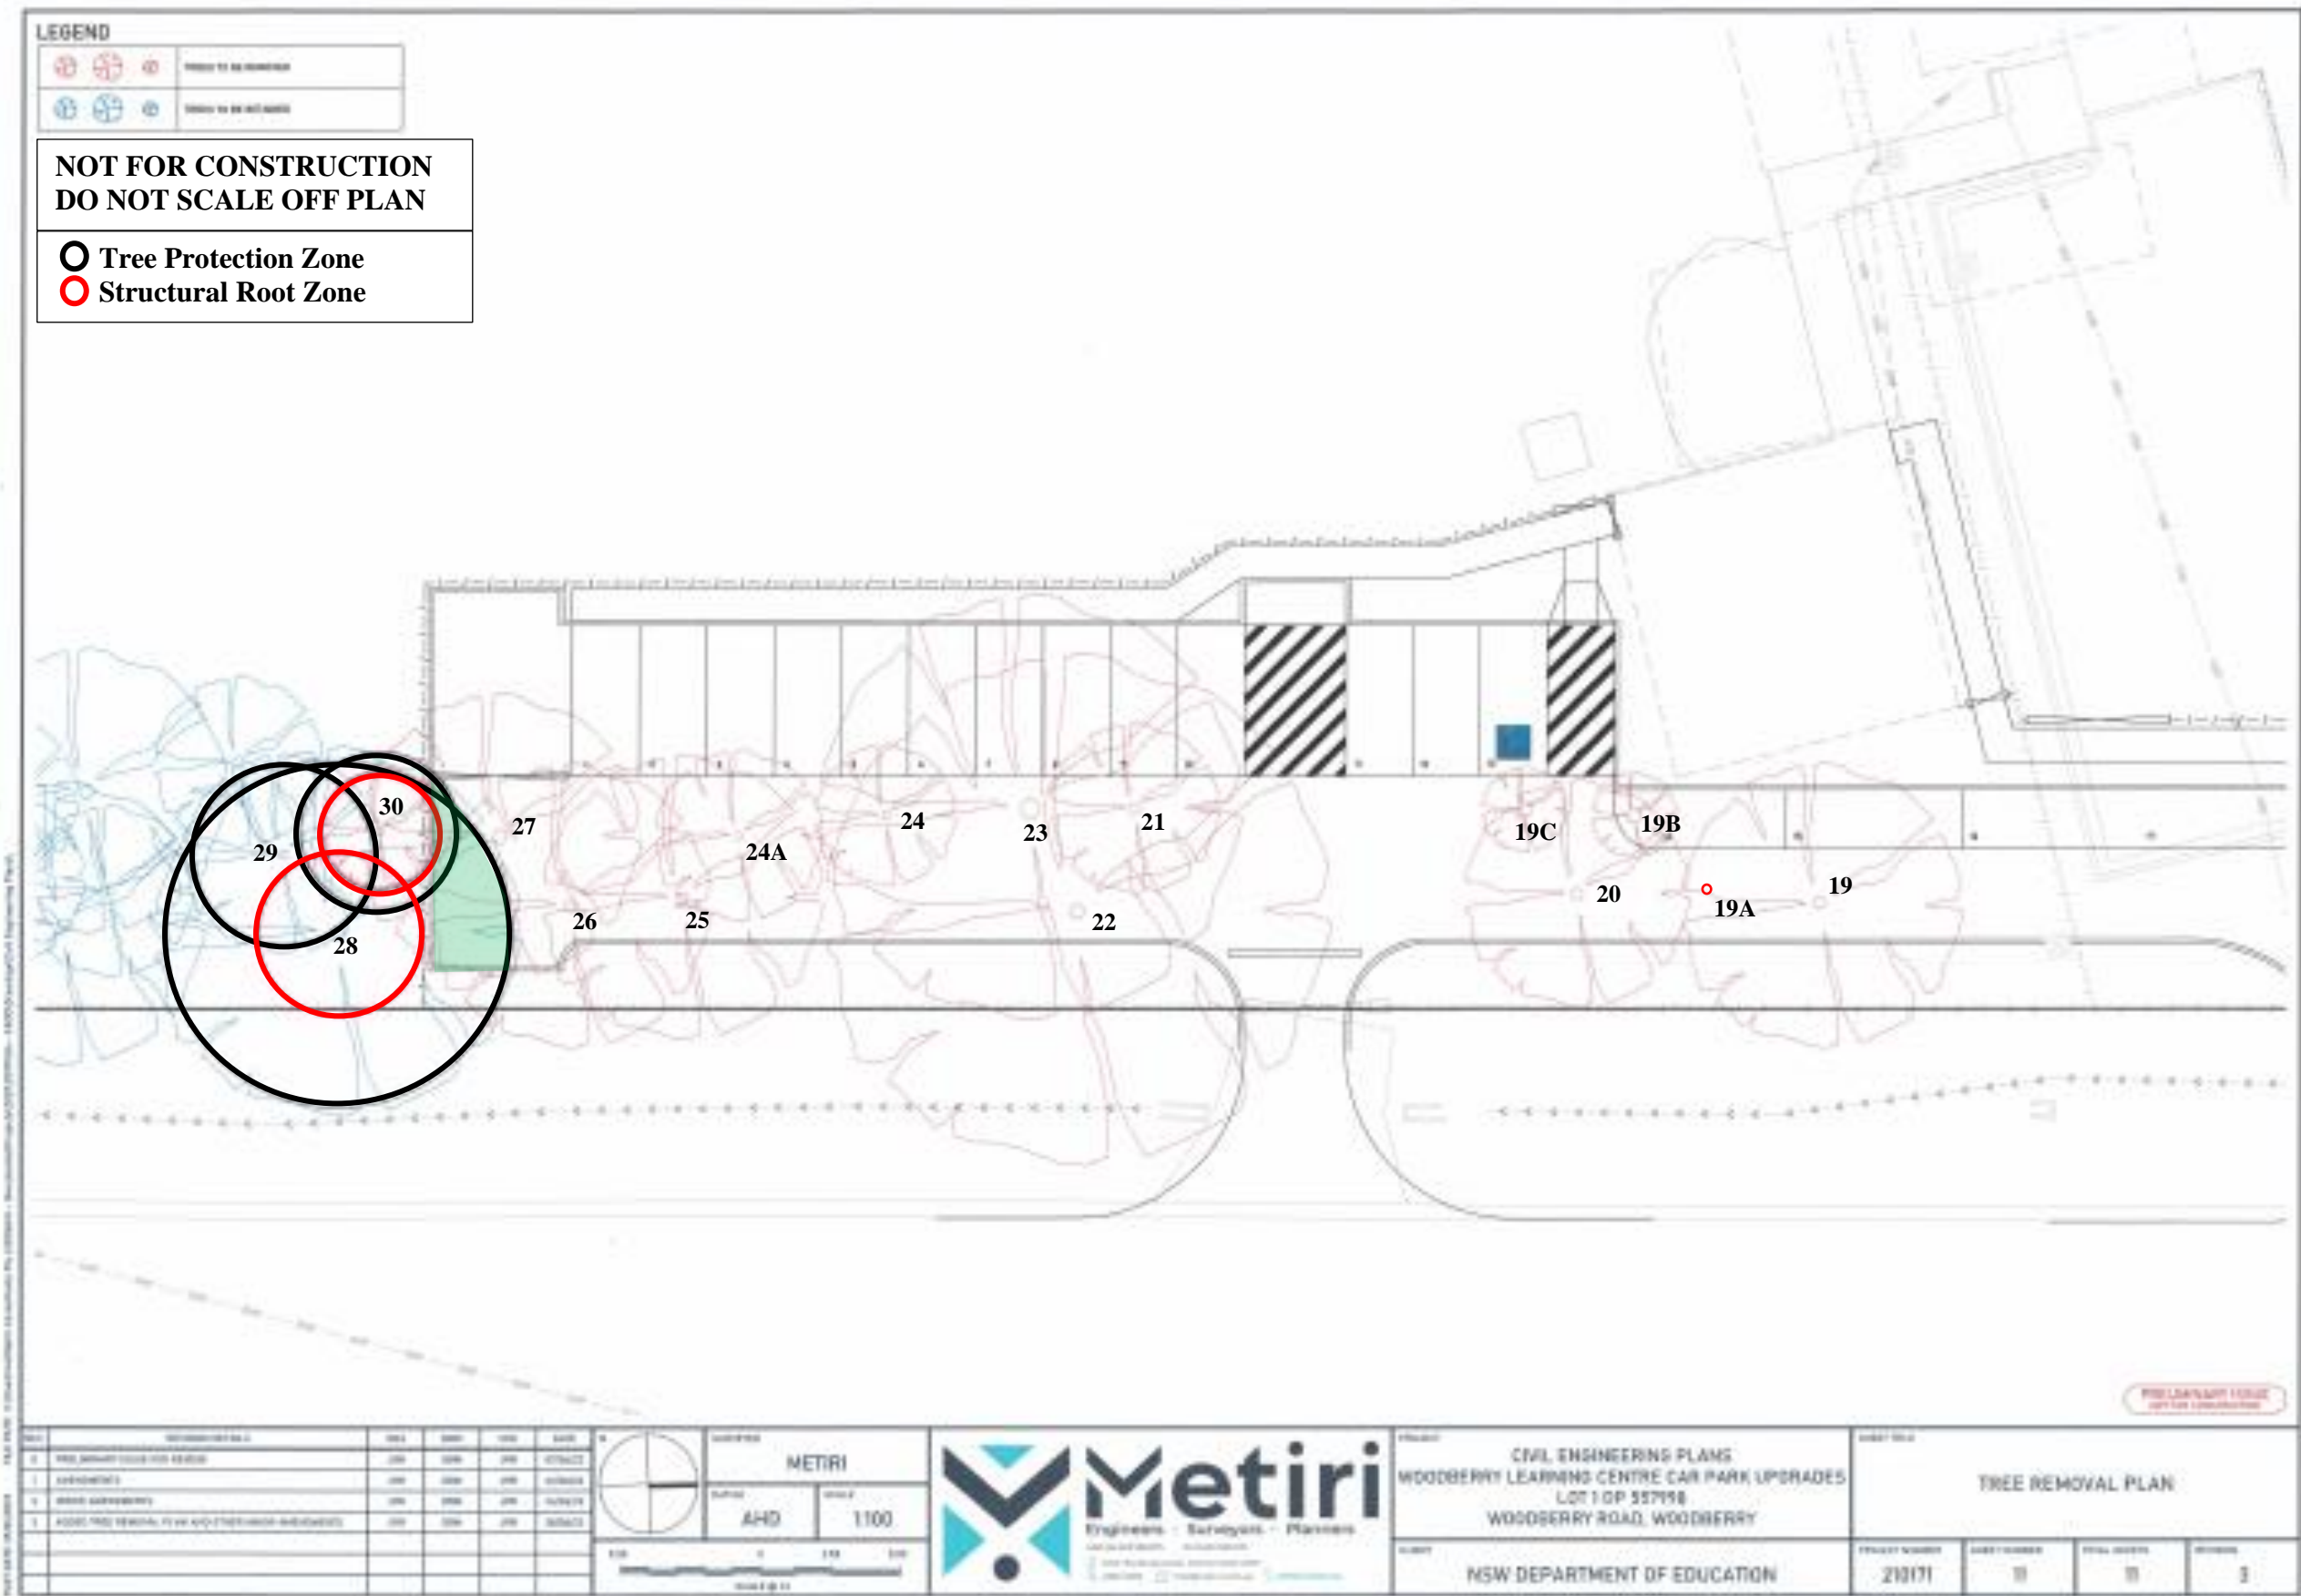
APPENDIX 3 – TREE REMOVAL PLAN

Based on the Site Plan construction will encroach into the calculated TPZ and SRZ of the tree. The main area of concern is damage that may be caused to roots within the SRZ and excessive damage to roots within the TPZ (See Appendix 1 Site Plan).

Due to the close proximity of construction and extent of encroachment into its TPZ and or SRZ its removal would be necessary as it will be adversely impacted upon in a manner that will be detrimental stability and/ or their overall condition
