Arborist Impact Assessment

Proposed Residential Subdivision 69 Kensington Rd, Bolwarra NSW

20 December 2022 AEP Ref: 2526 Revision: 01

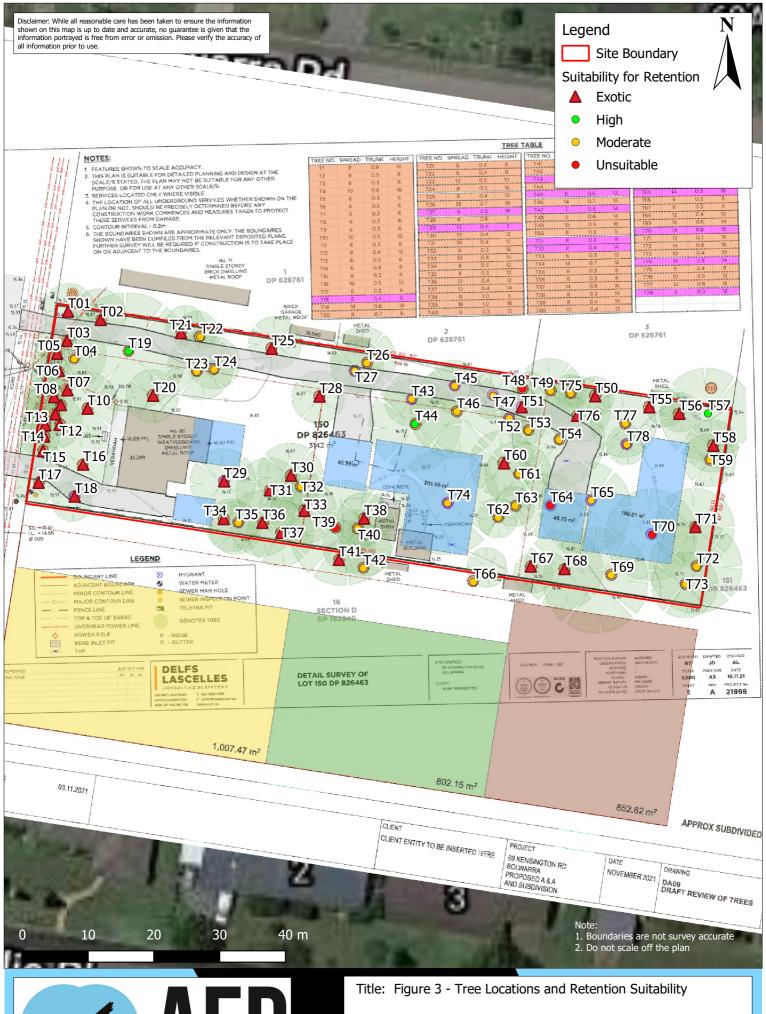
A total of **78** trees within the site were tagged and assessed. Observations were recorded and management recommendations made for each tree (**Table 2**, Full assessment Data in **Appendix B**). Tree locations are shown in **Figure 3**.

- Tree 39, a mature Eucalyptus pilularis (Blackbutt). This tree is exhibiting early subsidence of
 the root-ball, with a lean to the north and soil upheaval on the southern side of the tree.
 Additionally, there is cracking in the stem, decay with fungal fruiting bodies and cracking in
 large canopy branches. Further dieback was noted throughout the higher crown. This tree has
 a poor structural condition.

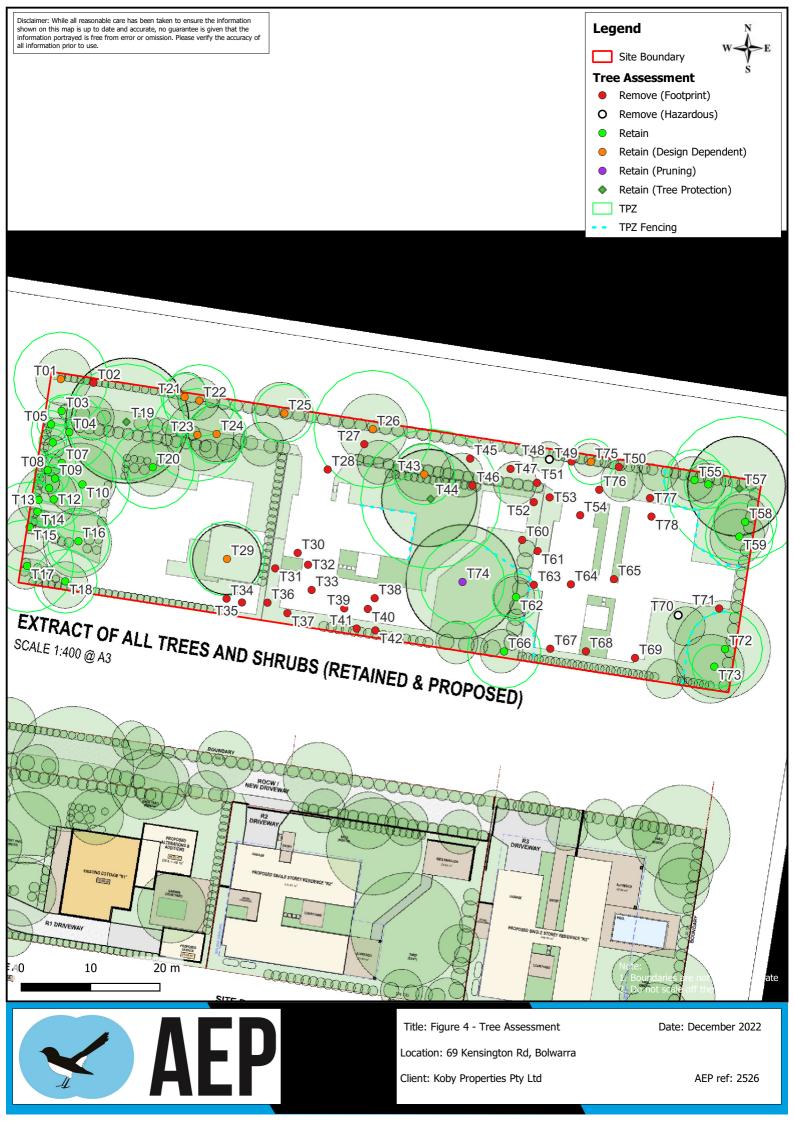
- Tree 44 (Corymbia maculata). This tree has a 13.5 % encroachment into the TPZ by a building footprint. To retain this tree, either TPZ Fencing as displayed in Figure 4. will be required to be established at the boundary of the building footprint closest to this tree, or ground protection measures placed within unimpacted areas of the TPZ (Appendix D). The TPZ of this tree can feasibly offset into unimpacted areas. Tree-sensitive construction techniques should be considered for the building footprint within the TPZ of this tree.

- Tree 55, 56, 58 & 59 will require a continuous TPZ fence in conjunction with Tree 57 as displayed in **Figure 4**.
- Tree 62, 66 will require a continuous TPZ fence in conjunction with Tree 74 as displayed in Figure 4.

- Trees 72 and 73 will require a continuous TPZ fence as displayed in Figure 4.
- Trees 3- 18, & 20, are either of small size, or are unlikely to be impacted by this proposal and can be retained without fencing.
