CONSERVATION MANAGEMENT PLAN

MAITLAND MERCURY

2 Hunter Street and 258 High Street, Maitland

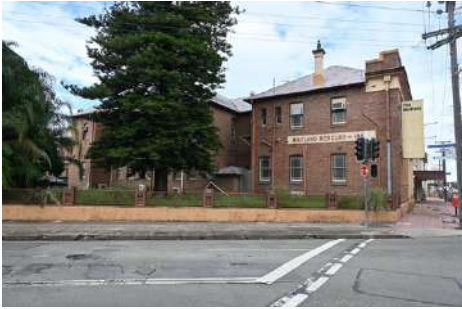
<p>North-western elevation of Building 01 which is in very good condition.</p>	<p>The exterior of this building demonstrates a high level of integrity and intactness.</p>

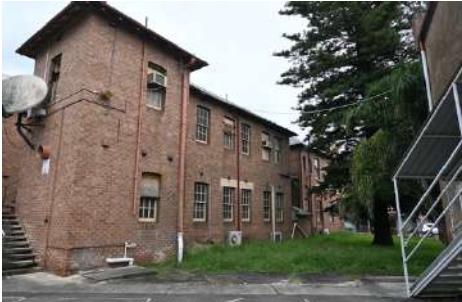
<p>Northern corner of rear of the original portion of Building 01 which is in good condition.</p>	<p>The exterior of this building demonstrates a high level of integrity and intactness. Some later interventions including the satellite dish and staircase are readily removable.</p>

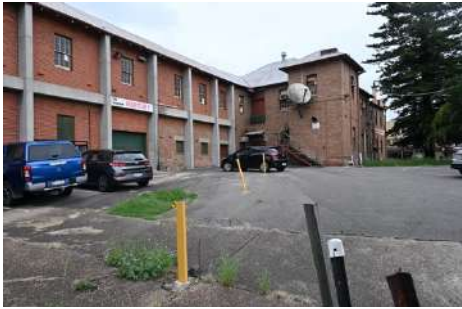
<p>General view from Odd Street towards the rear of Building 01 and showing the rear addition. A change of colour in brickwork identifies an earlier rear addition that was built over. Good condition.</p>	<p>This element is of little significance, not forming part of the original Pender designed building but otherwise demonstrating the growth of the Maitland Mercury. The integrity of the original building is only minimally affected.</p>

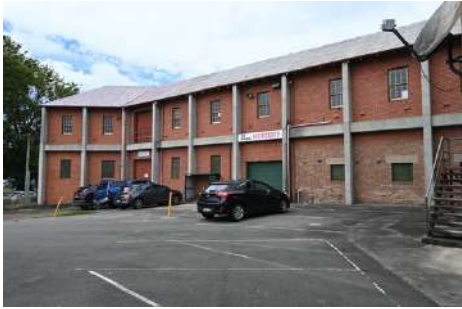
<p>General view from within the site towards the rear addition to Building 01. A change of colour in brickwork identifies an earlier rear addition that was built over. Good condition.</p>	<p>Remaining visible evidence of an earlier rear addition contributes to the storey of development of the site over time.</p>

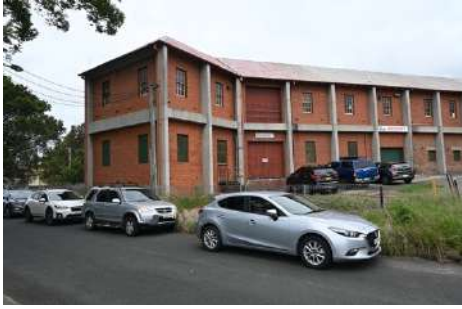
<p>General view from Odd Street towards the rear of Building 01 showing the rear addition. Expressed concrete frame with infill brickwork is clearly visible. Windows match those within the original building. Good condition.</p>

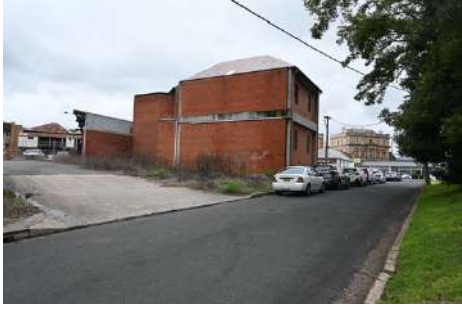
<p>General view from Odd Street towards the rear addition to Building 01. Good condition.</p>

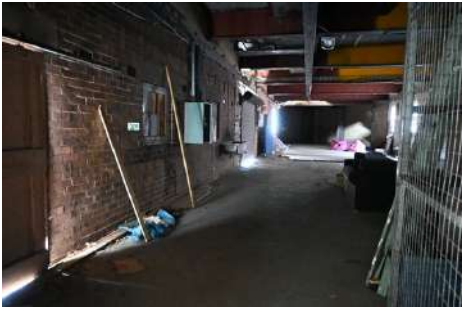
<p>The newspaper press room looking north, is not of high significance and is a very utilitarian, undecorated and unfinished space. This space is within the 1970's rear addition to Building 01. Condition is fair.</p>	<p>Though significance is not particularly high, this element remains intact and has not lost integrity.</p>

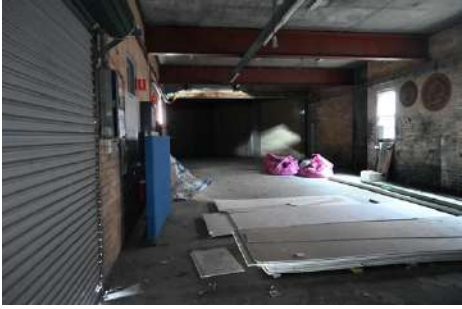
<p>Newspaper Press Room looking north. The aperture between floors is visible to the centre of the image. Fair condition</p>	<p>Though significance is not particularly high, this element remains intact and has not lost integrity.</p>

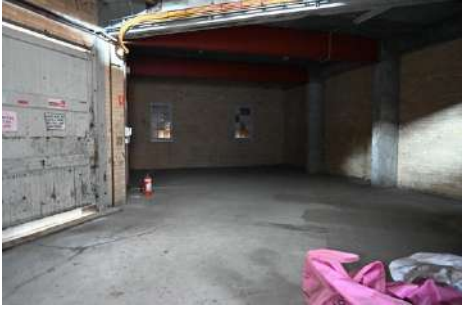
<p>Newspaper Press Room looking north. The aperture between floors is visible at the top of the image. Fair condition</p>	<p>Though significance is not particularly high, this element remains intact and has not lost integrity.</p>

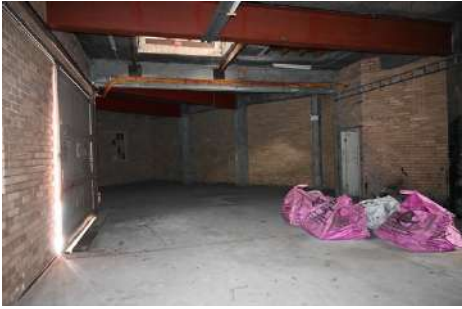
<p>Newspaper Press Room looking north. The aperture between floors is visible to the centre of the image. Fair condition</p>	<p>Though significance is not particularly high, this element remains intact and has not lost integrity.</p>

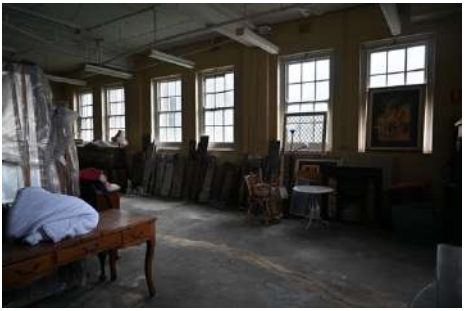
<p>General view within the Administration Room looking west. Good overall condition.</p>	<p>The space is relatively well intact with little loss of integrity. Later partition walls are intrusive and could be removed and original features made good.</p>

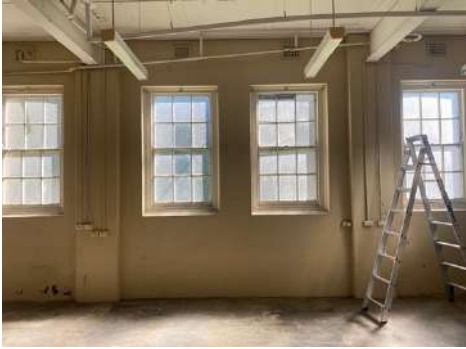
<p>Windows within north-western elevation are in good condition.</p>	<p>Good degree of intactness and integrity.</p>

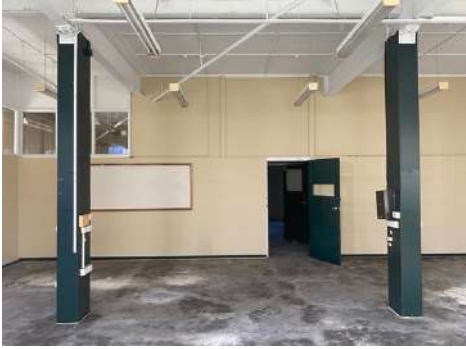
<p>Looking south-east towards a later partition wall within the space that could be removed.</p>	<p>The space is relatively well intact with little loss of integrity. Later partition walls are intrusive and could be removed and original features made good.</p>

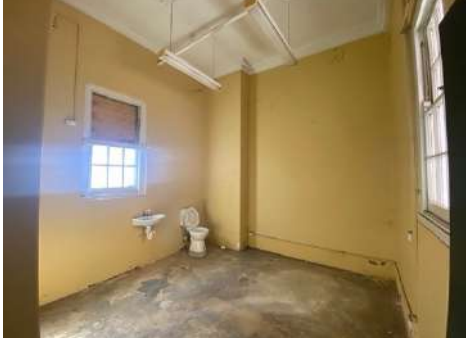
<p>Administration Office accessed off the northern corner of the main Administration Room. Fair Condition.</p>	<p>This room appears to have had a number of uses including modifications to include a toilet. Window in north-western wall has been altered to allow air conditioning in the past but south-eastern window remains intact.</p>

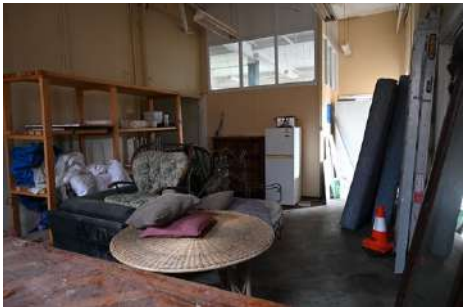
<p>Lunch Room looking back towards the Administration Room and later partition wall between. Overall good condition.</p>	<p>The space is relatively well intact with little loss of integrity. Later partition walls are intrusive and could be removed and original features made good.</p>

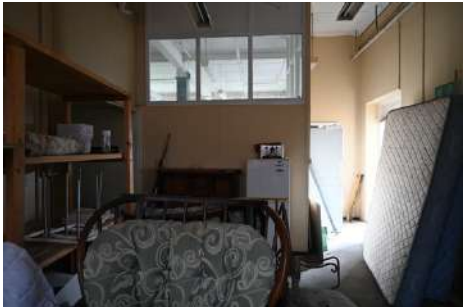
<p>Lunch Room looking back towards the Administration Room and later partition wall between. Overall good condition.</p>	<p>The space is relatively well intact with little loss of integrity. Later partition walls are intrusive and could be removed and original features made good.</p>

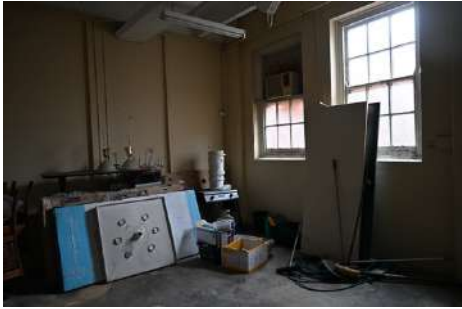
<p>Windows within south-eastern wall are generally well intact however later air conditioning installation has removed the upper portion of one window.</p>	<p>Generally intact with some loss of integrity due to the installation of later partition walls and window alterations which could be made good.</p>

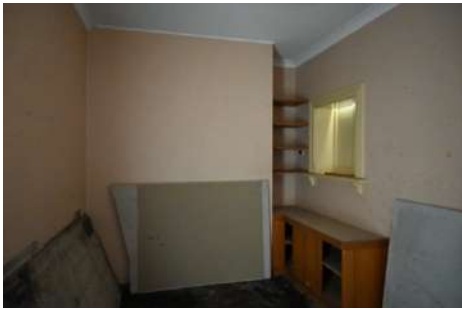
<p>View within general office looking south-east. Later partition wall blocks access to external door. Window on right of image is a hatch through to the adjacent Boardroom.</p>	<p>Low level of integrity. Later partition walls and ceilings obscure original fabric, this room could be removed.</p>
Hallway Ground Floor

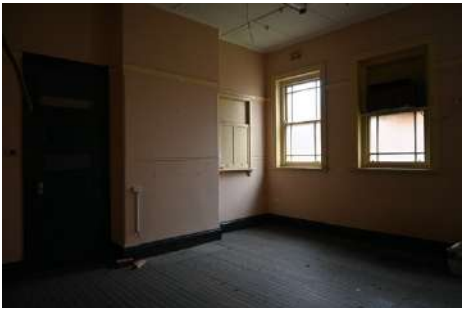
<p>View to south-eastern windows and north-western wall into General Office 1. Good overall condition.</p>	<p>Good level of intactness and integrity. As has occurred elsewhere, the upper portion of a window has been removed in order to install an air conditioning unit.</p>

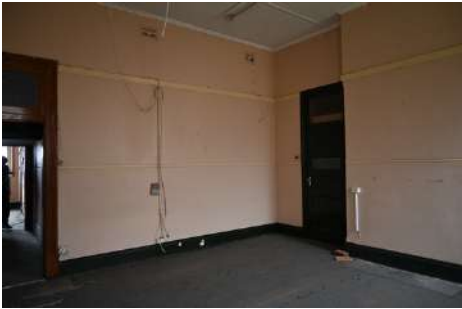
<p>Looking towards the door through into General Office 1. The door to image left provides access from the central hallway. Good overall condition.</p>	<p>Good level of intactness and integrity.</p>

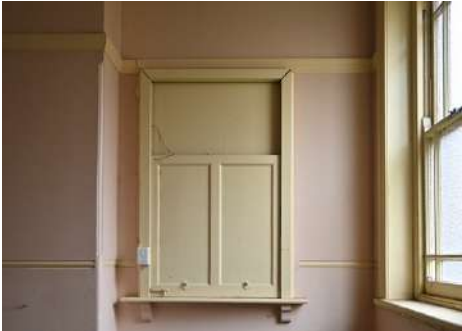
<p>Window hatch between Boardroom and General Office 1. Good condition.</p>	<p>Good level of intactness and integrity.</p>

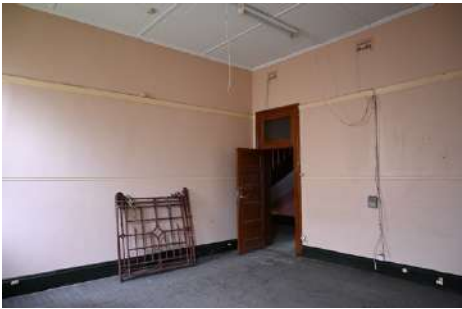
<p>View to hallway door and showing original ceilings. Good overall condition.</p>	<p>Good level of intactness and integrity.</p>

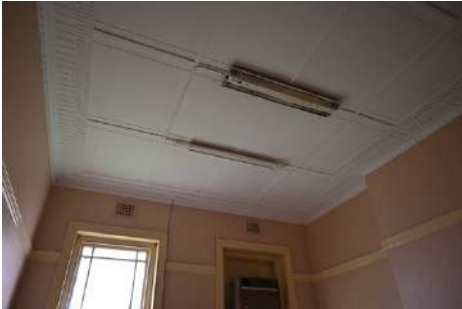
<p>View to ceiling in good condition.</p>	<p>Good level of intactness and integrity.</p>

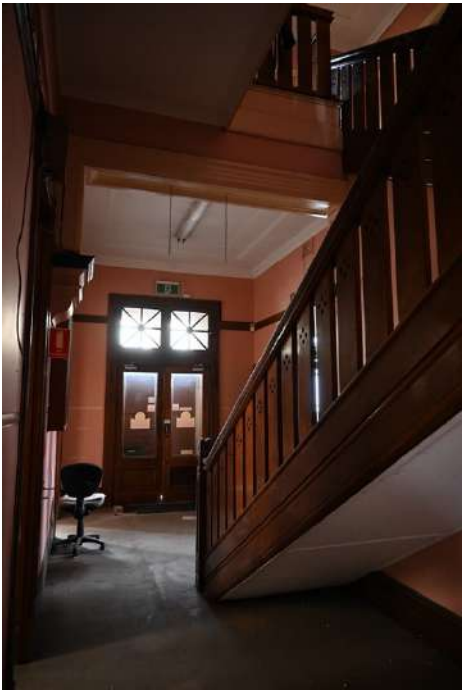
Entry stairwell in very good condition overall.	Good level of intactness and integrity.

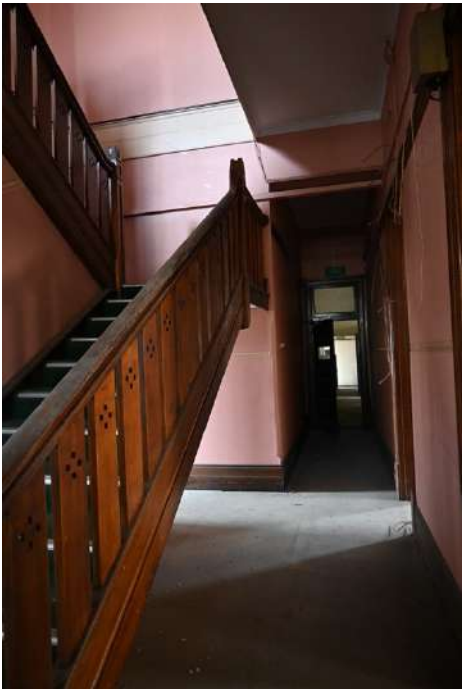
<p>Entry stairwell in very good condition overall.</p>	<p>Good level of intactness and integrity.</p>

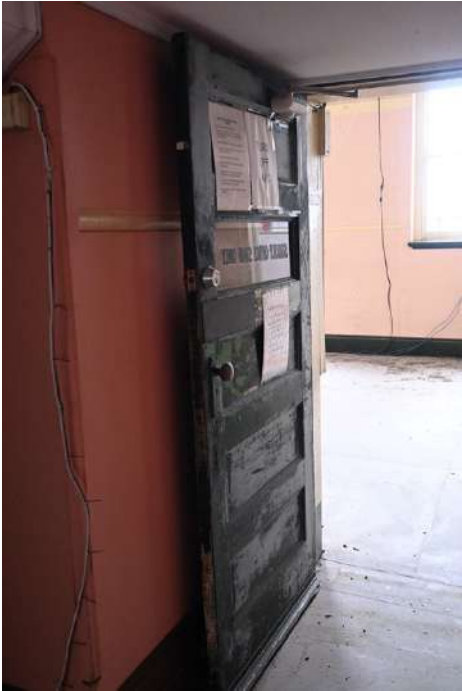
<p>Secondary door into Front Office accessed below stairs all in good condition.</p>	<p>Good level of intactness and integrity.</p>

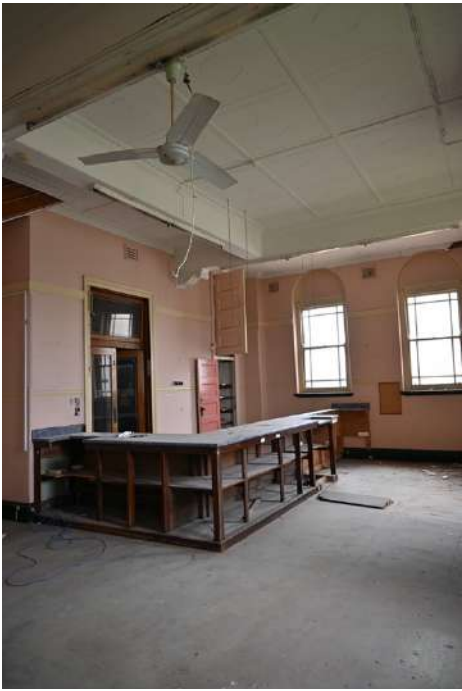
<p>View from northern corner looking south towards the front elevation showing arched windows and the back of the reception desk and original ceilings all generally in good condition.</p>	<p>Good level of intactness and integrity.</p>

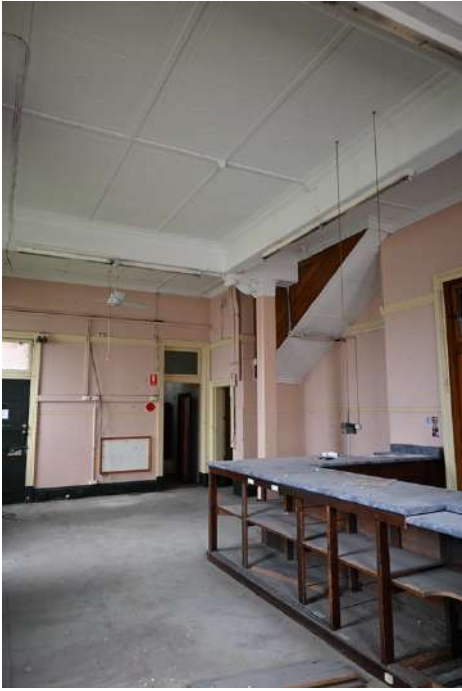
<p>View from front elevation looking northerly and showing the underside of the stairs ascending above. All generally in good condition.</p>	<p>Good level of intactness and integrity.</p>

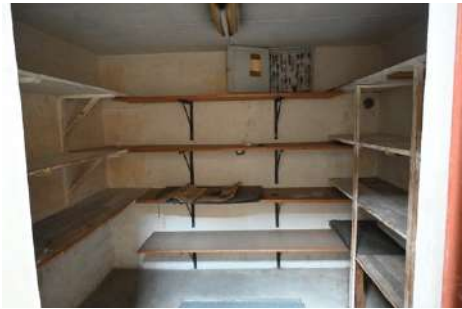
<p>Interior of the safe which is of simple masonry construction and is in good condition but not of high significance.</p>

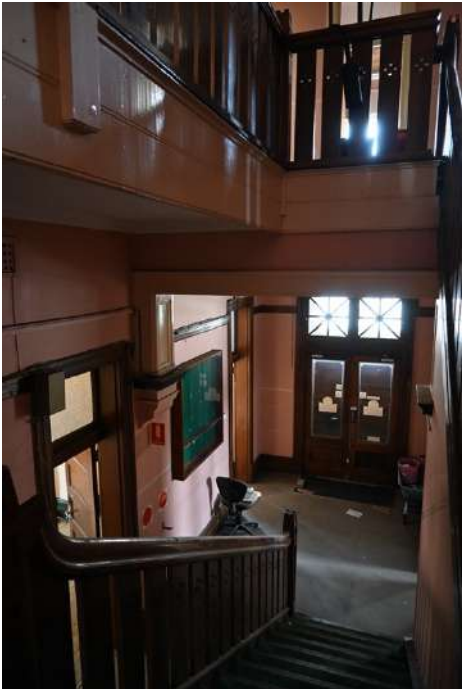
<p>Entry stairwell in very good condition overall.</p>	<p>Good level of intactness and integrity.</p>

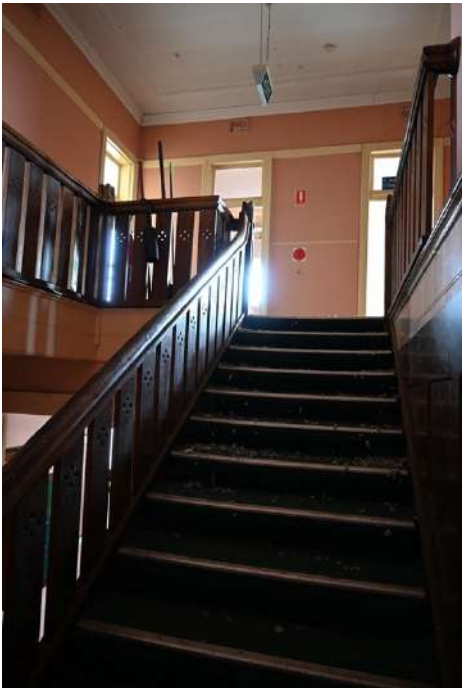
<p>Entry stairwell in very good condition overall.</p>	<p>Good level of intactness and integrity.</p>

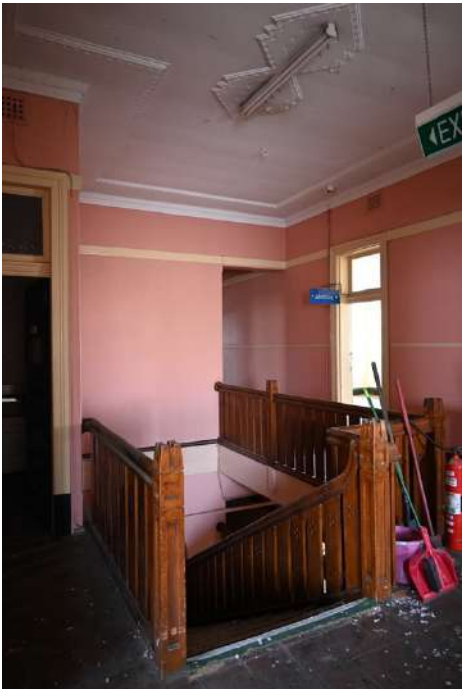
<p>Entry stairwell showing ceilings and architraves in very good condition overall.</p>	<p>Good level of intactness and integrity.</p>

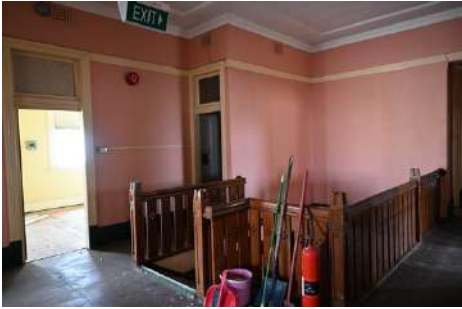
<p>Entry stairwell showing ceilings and architraves in very good condition overall.</p>	<p>Good level of intactness and integrity.</p>

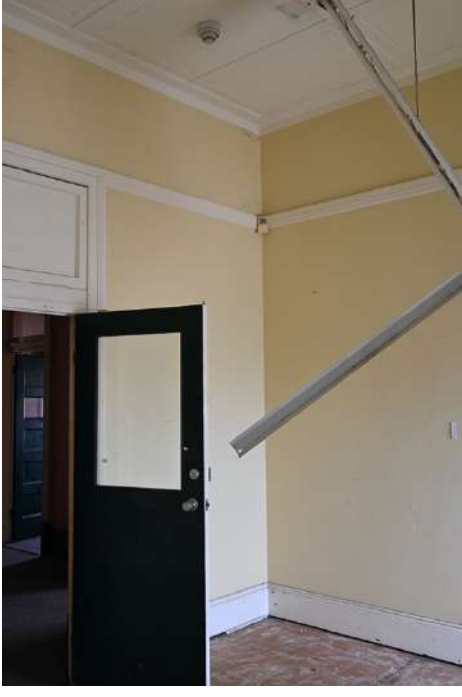
<p>View to southerly corner and showing doorway into central hallway. Good overall condition.</p>	<p>Reasonable level of intactness and integrity.</p>

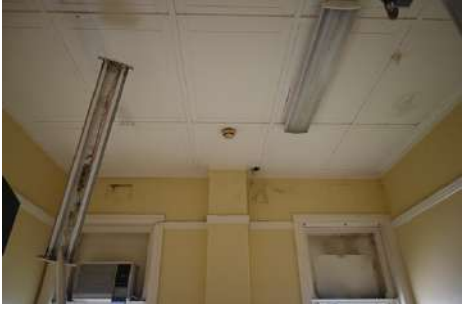
<p>Both external windows have been altered to allow air conditioning units to be installed. Original ceilings, floors and architraves remain. All is generally in good condition.</p>	<p>Reasonable level of intactness and integrity.</p>

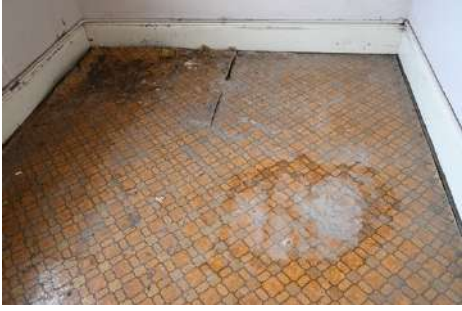
<p>Floor coverings are not significant but expected to be in reasonable condition other than western corner to top-left of the image.</p>	<p>Damage is local to western corner and original ceilings are otherwise intact and in reasonable condition.</p>

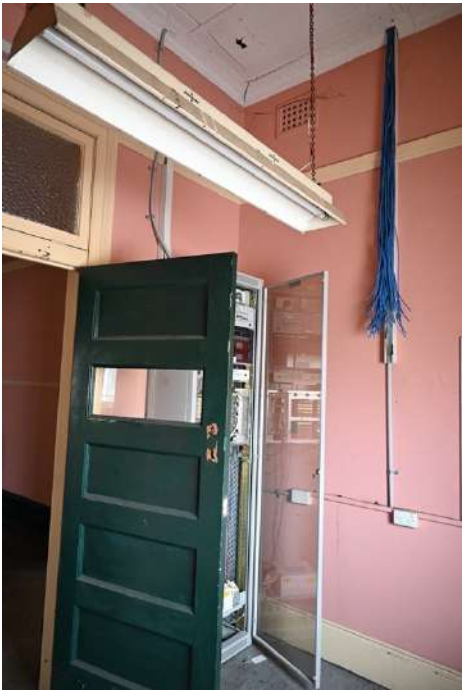
<p>View showing internal door. Room and features are in good condition.</p>	<p>Reasonable level of intactness and integrity, later installations appear readily removable in order to improve the condition of this room.</p>

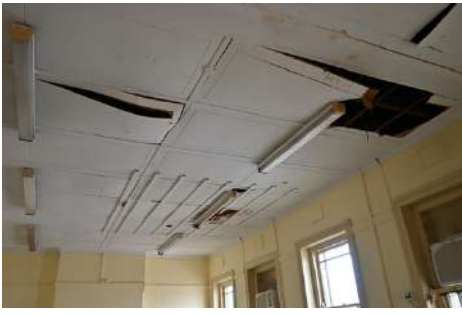
<p>Detail view to masonite ceilings and showing damage to be repaired.</p>	<p>Good level of intactness though integrity is diminished as a result of water damage.</p>

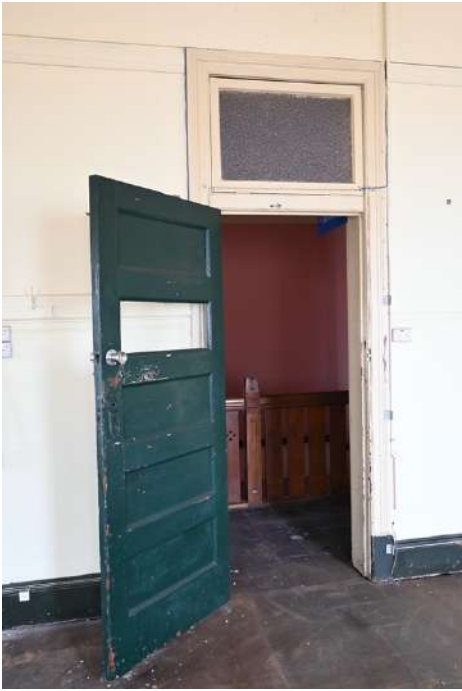
<p>Doorway through to adjacent hallway in reasonable condition.</p>	<p>Good level of intactness and integrity.</p>

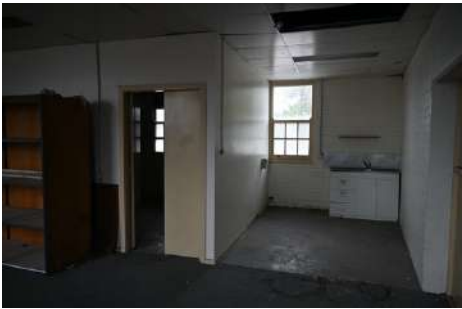
Plate Room is of low significance and is in poor condition generally.	Though significance is not particularly high, this area remains intact but is of reduced integrity.

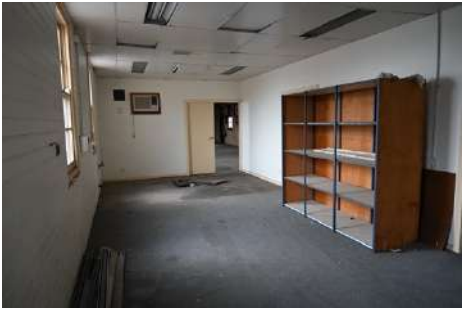
Plate Room is of low significance and is in poor condition generally.	Though significance is not particularly high, this area remains intact but is of reduced integrity.
Store Room

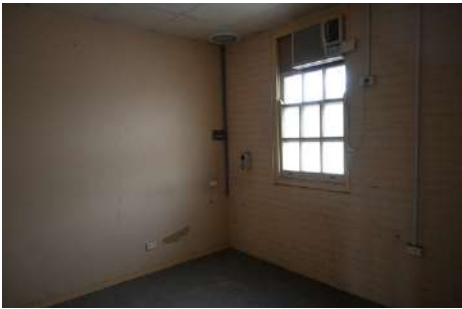
Store Room is of low significance and is in poor condition generally.	Though significance is not particularly high, this area remains intact but is of reduced integrity.
Print Room

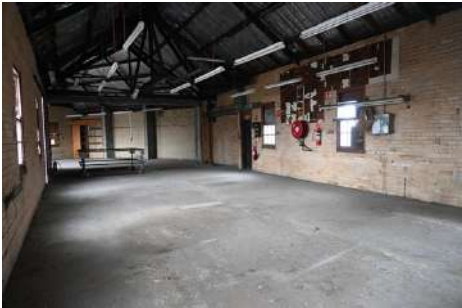
Print Room is of low significance and is in reasonable condition generally.	Though significance is not particularly high, this area remains intact and with some degree of integrity.

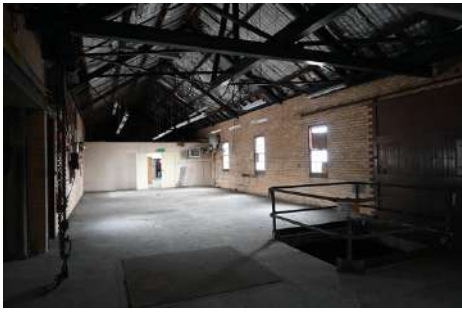
<p>Print Room is of low significance and is in reasonable condition generally. There are two floor apertures, one of which remains open with a hoist frame suspended above.</p>	<p>Though significance is not particularly high, this area remains intact and with some degree of integrity.</p>

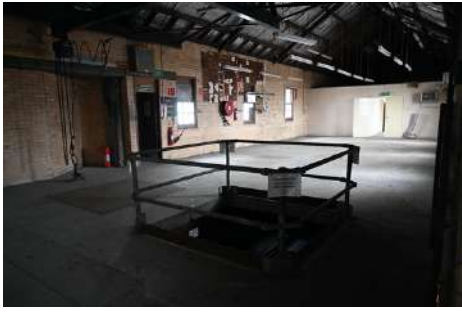
<p>Print Room is of low significance and is in reasonable condition generally. There are two floor apertures, one of which remains open with a hoist frame suspended above.</p>	<p>Though significance is not particularly high, this area remains intact and with some degree of integrity.</p>

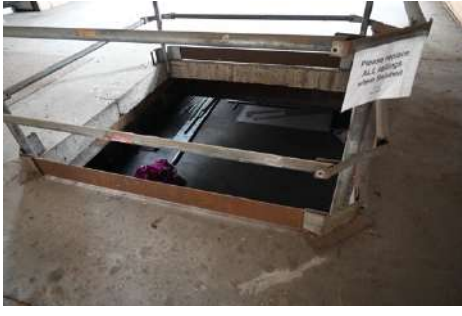
<p>Print Room is of low significance and is in reasonable condition generally. There are two floor apertures, one of which remains open with a hoist frame suspended above.</p>	<p>Though significance is not particularly high, this area remains intact and with some degree of integrity.</p>

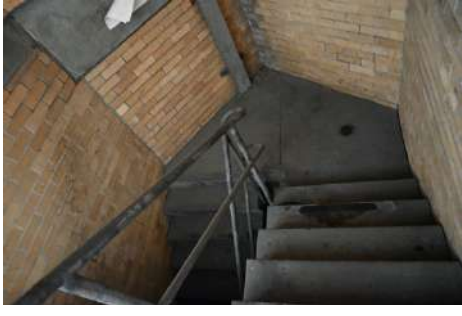
<p>Rear stairs between levels of the Print Room in reasonable condition.</p>	<p>Though significance is not high, this area remains intact and with some degree of integrity.</p>

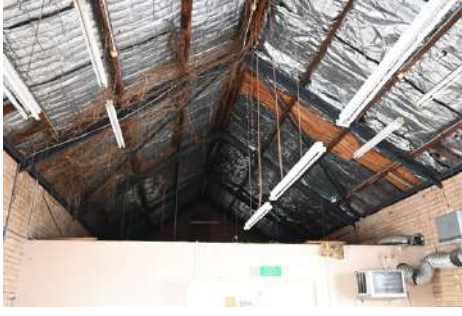
<p>Rear extending towards the rear of the original building. Lack of use has allowed vegetation to grow.</p>	<p>Though significance is not high, this area remains generally intact but is of low integrity.</p>

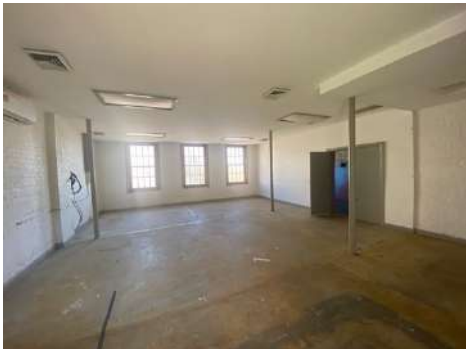
<p>Ground floor within original 1882 section of the building and showing original windows. Wall to image right is an original external wall whilst the wall to image left is a later wall constructed following demolition of the remainder of the building.</p>	<p>Reasonable level of intactness and integrity though ceilings have been replaced.</p>

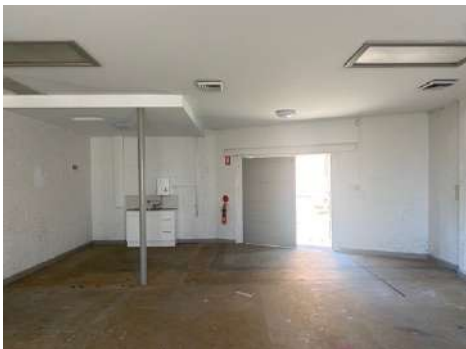
<p>Ground floor within original 1882 section of the building and showing original windows. Wall to image left is an original external wall whilst the wall to image right is a later wall constructed following demolition of the remainder of the building.</p>	<p>Reasonable level of intactness and integrity though ceilings have been replaced.</p>

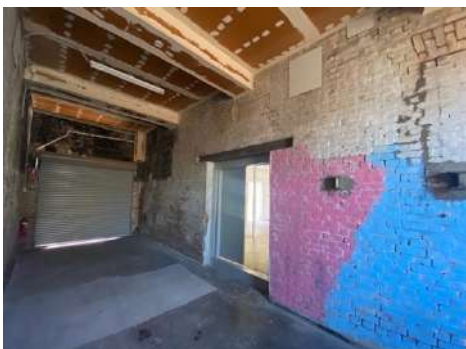
<p>View within the ground floor of the latter two storey addition to the building. Earlier windows are evident within the wall to image right.</p>	<p>Reasonable level of intactness and integrity though ceilings have been replaced and windows have been reused elsewhere.</p>

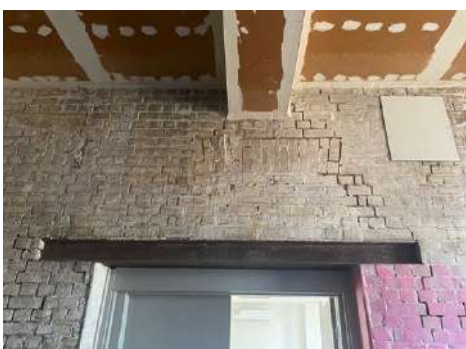
<p>View within the ground floor of the latter two storey addition to the building. Earlier windows are evident within the wall to image centre.</p>	<p>Reasonable level of intactness and integrity though ceilings have been replaced and windows have been reused elsewhere.</p>
