Report on  
Hazardous Material Survey - Buildings 10, 11, 12, 13  
and 14

Existing Buildings, Closebourne Retirement Living  
Morpeth Road, Morpeth

Prepared for  
Lend Lease (Retirement Living)

Project 81251.13  
September 2016

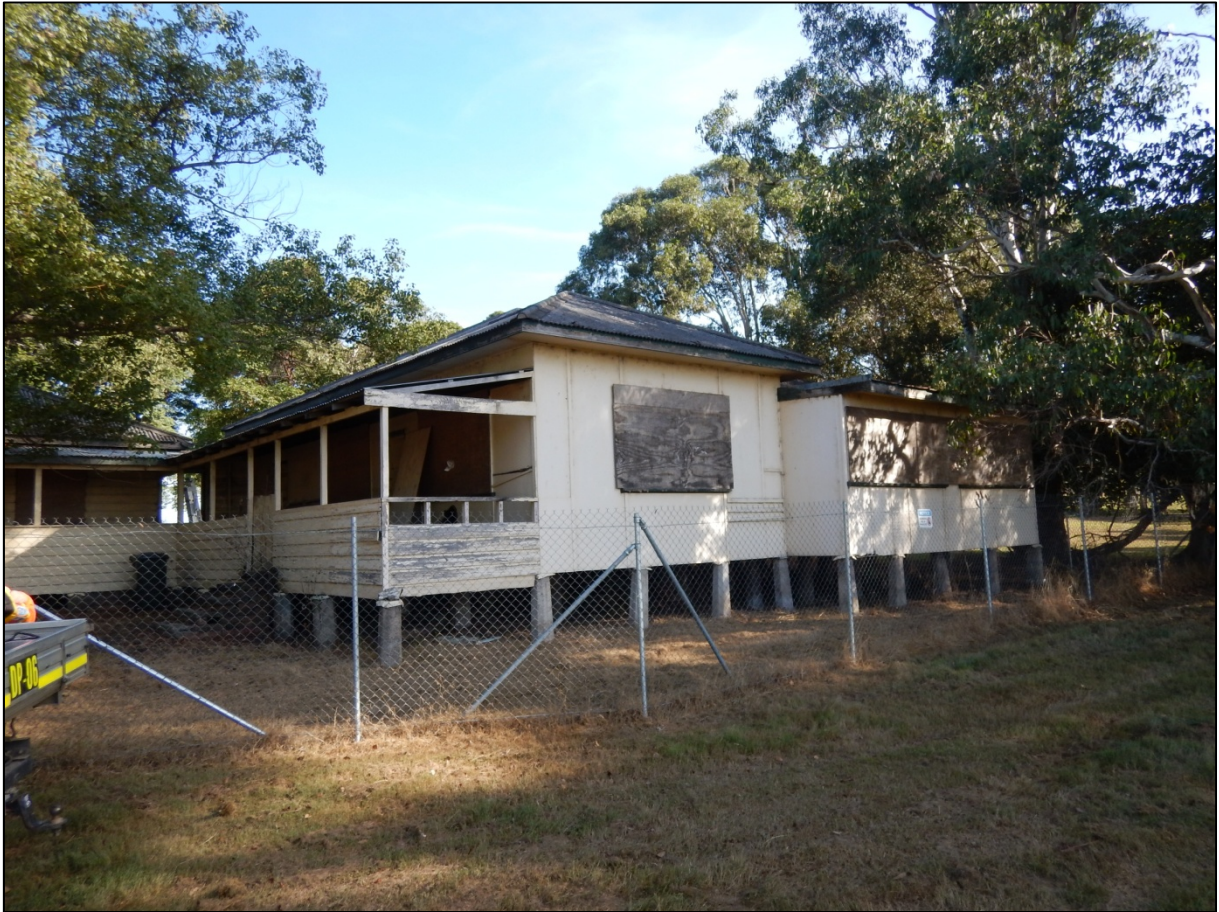
**Figure 3: View of Buildings 10 and 11**

Buildings 10 and 11 are known as the “Tank Street Cottages” and are two single storage buildings connected by a verandah (refer Figure 3). It is understood to have been constructed in 1829.

- Timber external walls;
- Corrugated asbestos roof sheeting;
- Timber floors;
- Masonite and cement sheeting interior walls;
- Metal guttering;
- Vinyl sheet flooring in kitchen; and
- Fluorescent lighting.

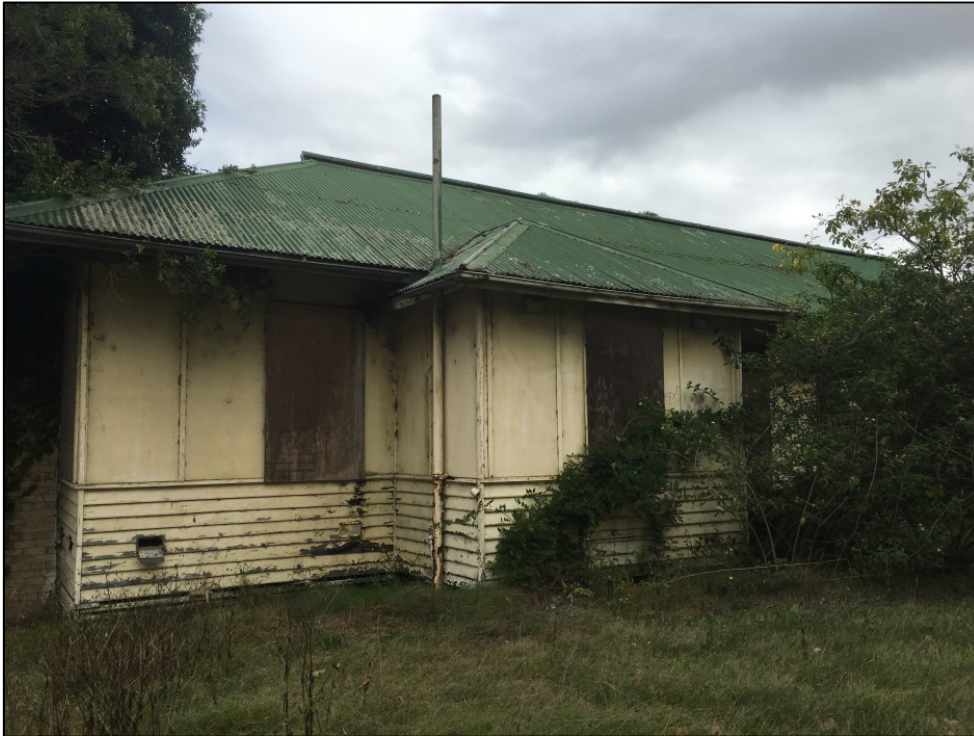
**Figure 6: View of eastern frontage of Building 14**

Building 14 is a single storey building which has a common wall with part of Building 13 (refer Figure 6).
