DETAILED MINE SUBSIDENCE ASSESSMENT

Regrowth Kurri Kurri, Precinct 1

Prepared for Loxford Project Management Pty Ltd

RCA ref 15924-203/1

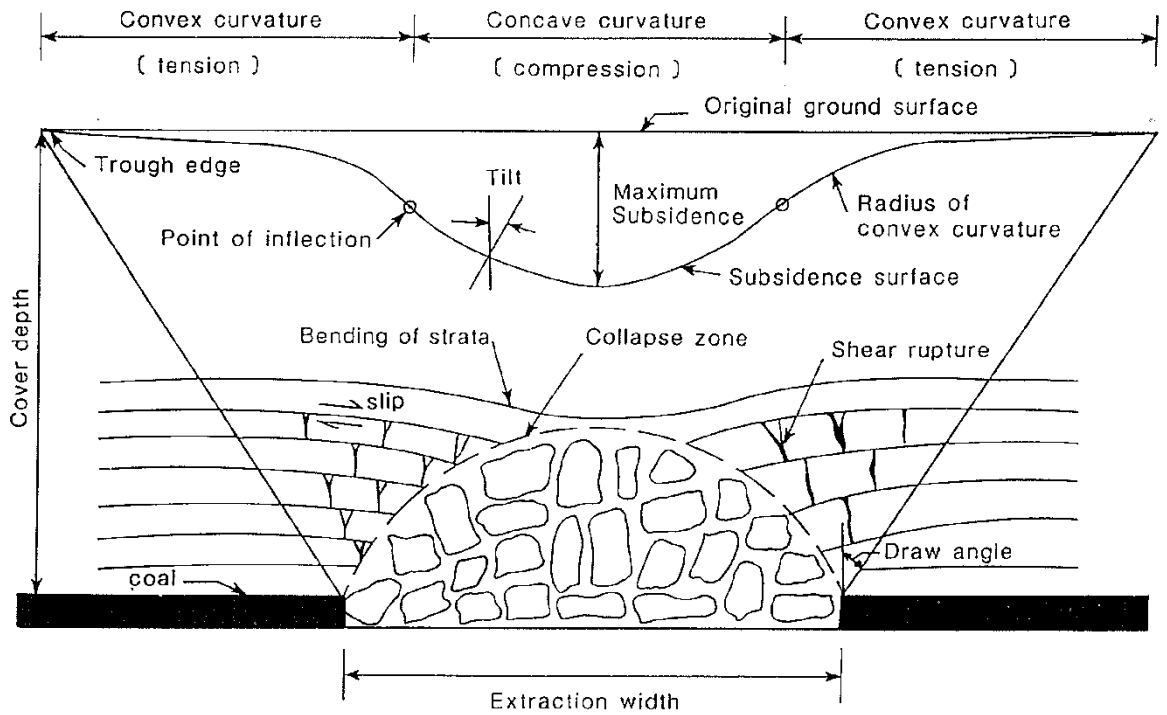
Figure 1 Components of Trough Subsidence (Holla, 1987)

Indicative estimates of trough subsidence have been made using the empirical subsidence model for the Newcastle Coalfield presented by Holla (1987) (Ref [2]). The components of ground movement that are of significance include subsidence, tilt and strain. These components are illustrated in **Figure 1** and the variation of the ground movement components is illustrated in **Figure 2**. The key element of the model is a relationship between maximum subsidence (S_{max}) and the panel width/cover depth ratio (W/H). This relationship is shown in **Figure 3**. It is noted that the empirical model makes no account of geological discontinuities such as faults and dykes. It is also noted that the empirical data is unlikely to include data from steeply dipping strata as is present at this site. Nonetheless it is considered that subsidence data assessed by this method will be conservative for the site geometry and site conditions.

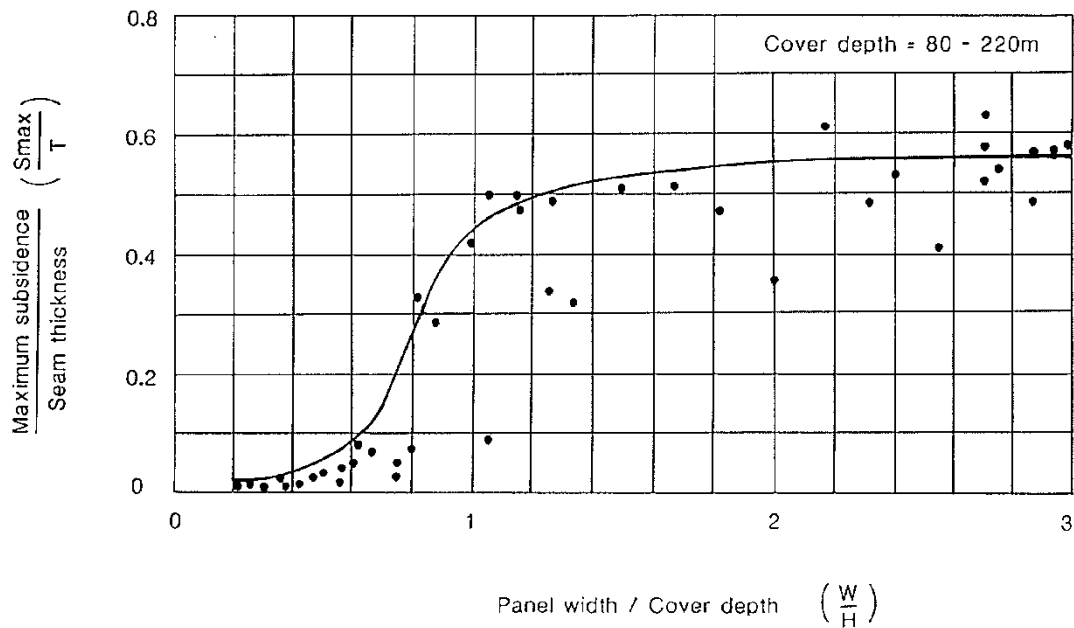
Figure 3 Relationship between Maximum Subsidence and W/H (Holla, 1987)

The model shown in **Figure 3** indicates that:

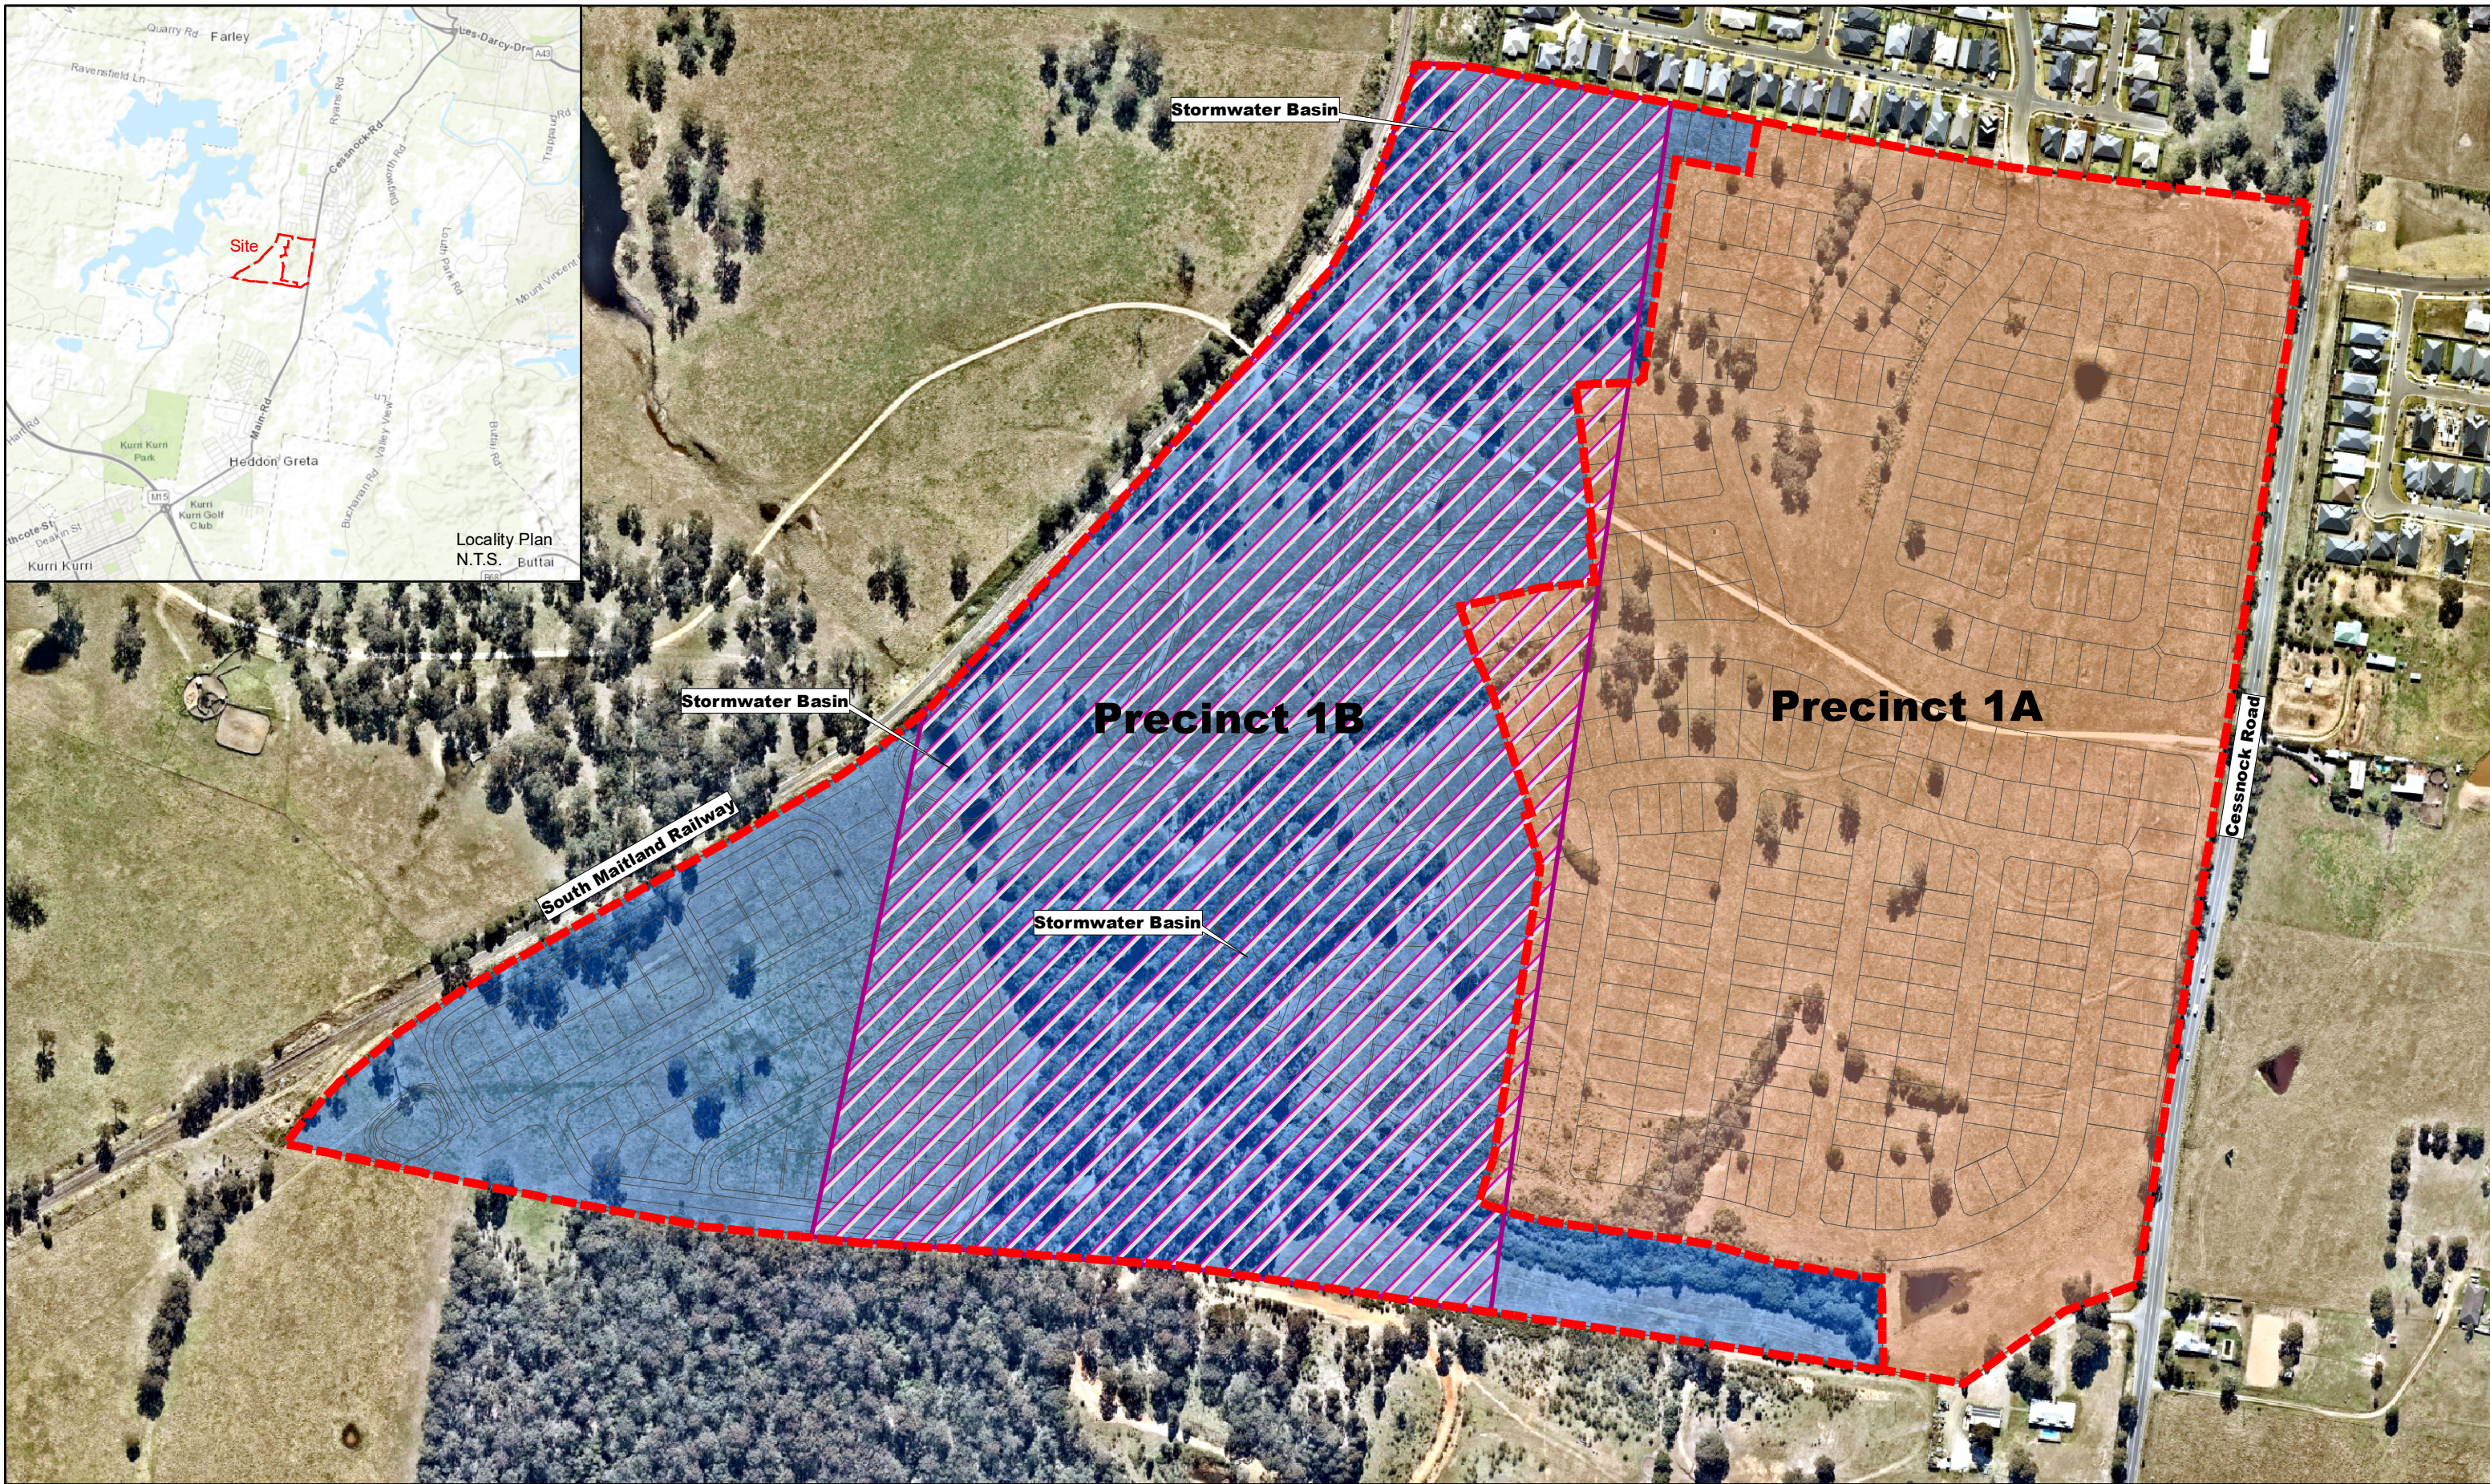
GEOTECHNICAL • ENVIRONMENTAL		REGROWTH KURRI KURRI PRECINCT 1 SITE PLAN					
		CLIENT	Loxford Project Management Pty Ltd	RCA Ref	15924-203/1		
DRAWN BY	MA	SCALE	1:4,000 (A3)	DRAWING No	1	REV	1
APPROVED BY	MA	DATE	21/12/2021	OFFICE	NEWCASTLE

With reference to **Drawing 1** it is noted that bore locations were selected to lie within the shallow depth to seam zone just east of the seam subcrop (ie. less than about 100m cover). Bores were undertaken at four different locations across the site with dual bores at two of these locations.
