# Long Term Environmental Management Plan

## Walka Water Works

Maitland City Council

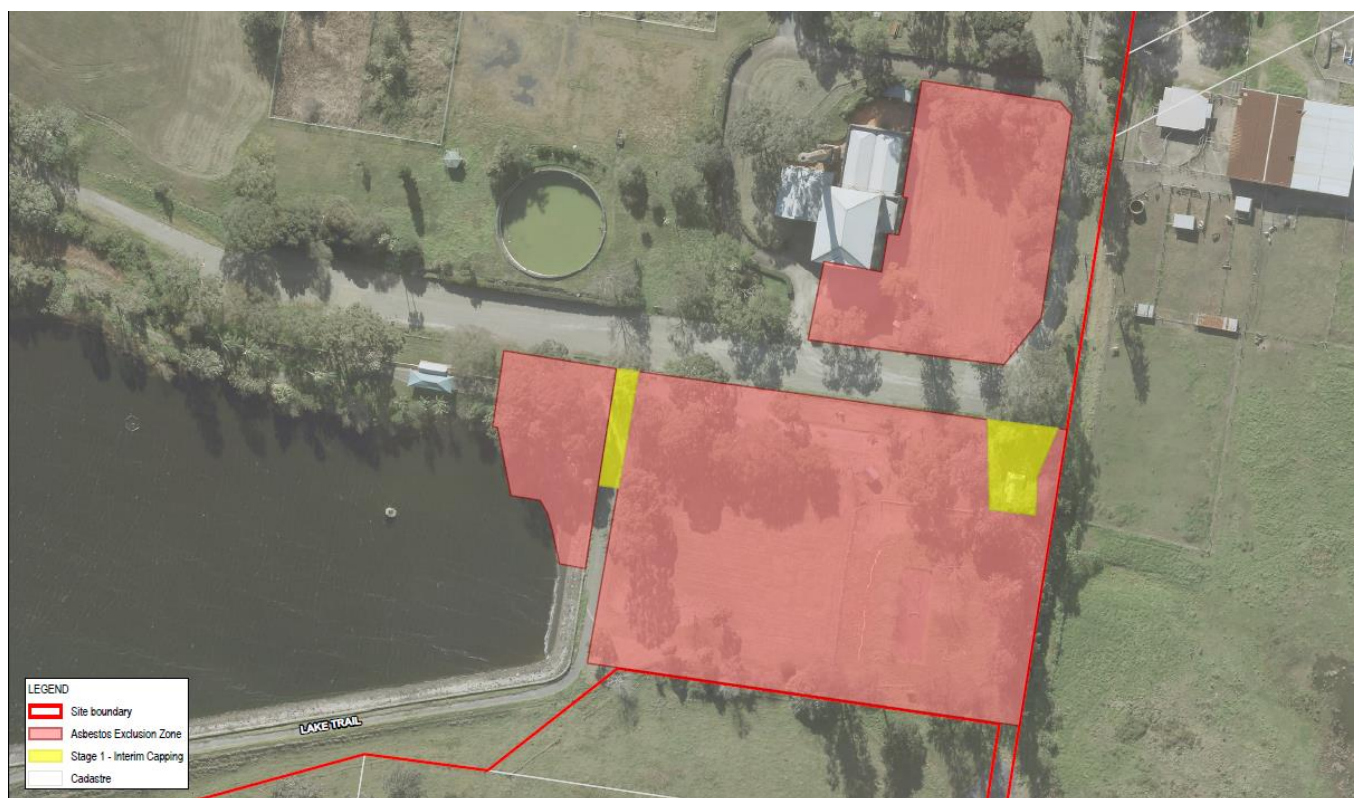
Figure E.1 Stage 1 access restrictions

This LTEMP is intended for use with the Stage 1 re-opening of Walka Water Works, as described in Sections 1.3 and 6.3 of this LTEMP and illustrated in Figure E.1 below. Access to asbestos exclusion zones (as shown below) is prohibited except for workers who have been fully inducted in this LTEMP, and subject to appropriate safe work procedures and personal protective equipment (PPE).

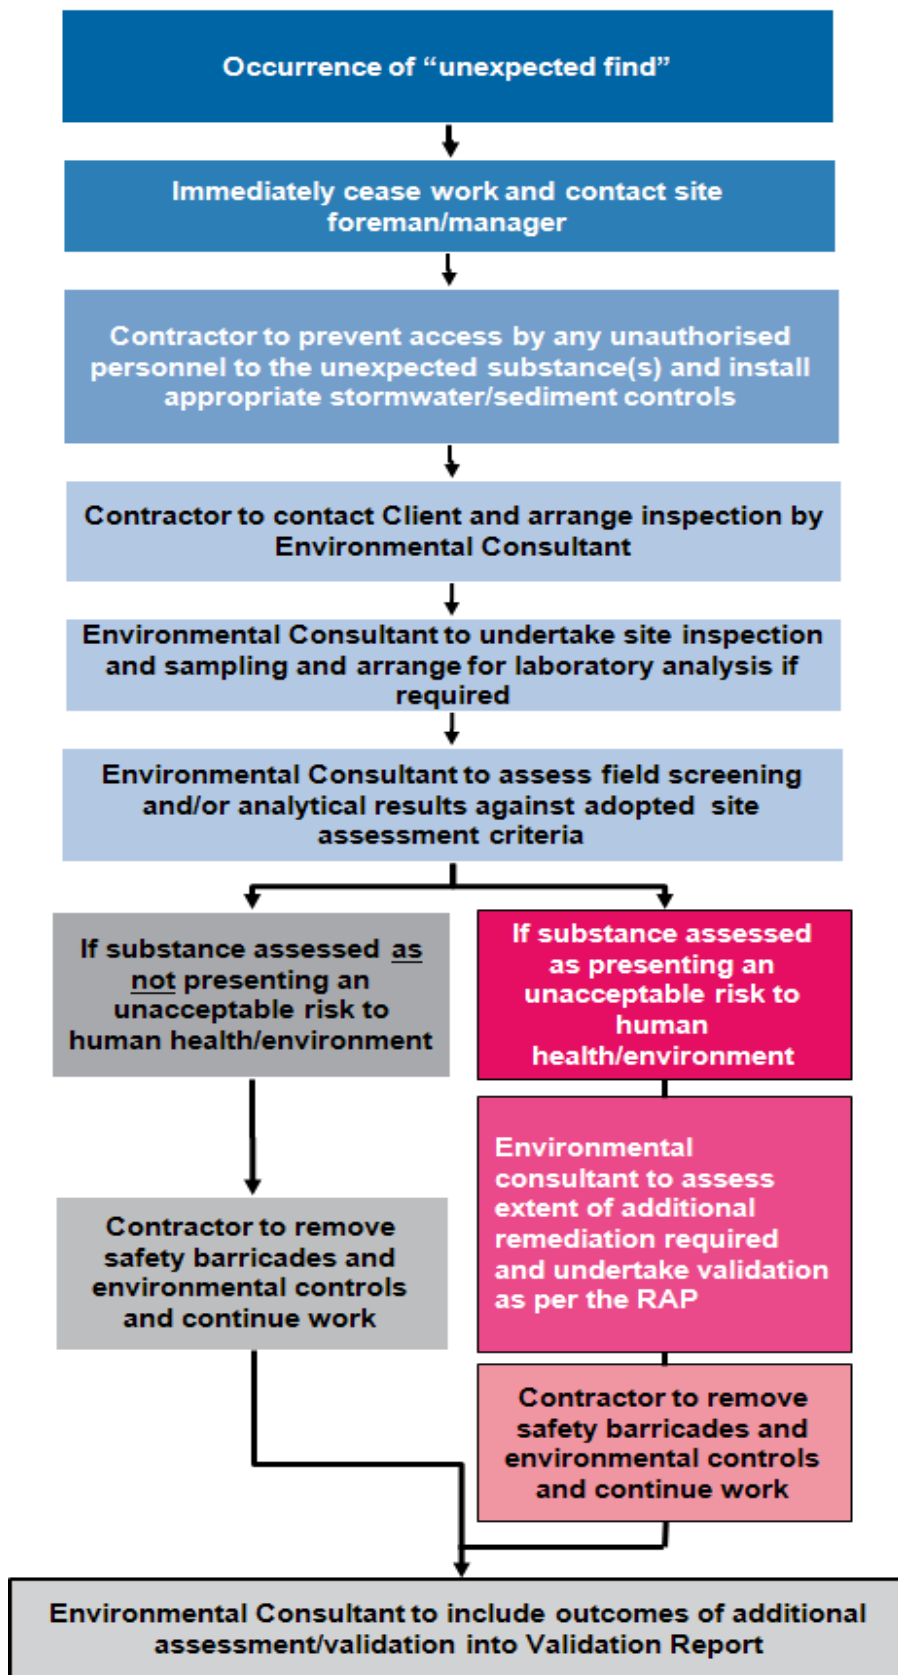
Figure E.2 Unexpected finds decision process

A competent person must be engaged to undertake appropriate assessment of unexpected contamination that may be encountered, and to recommend necessary management requirements (if any) prior to the continuation of works in the affected area. A preliminary unexpected finds protocol (UFP) has been developed for the site and is included as Figure E.2 below.

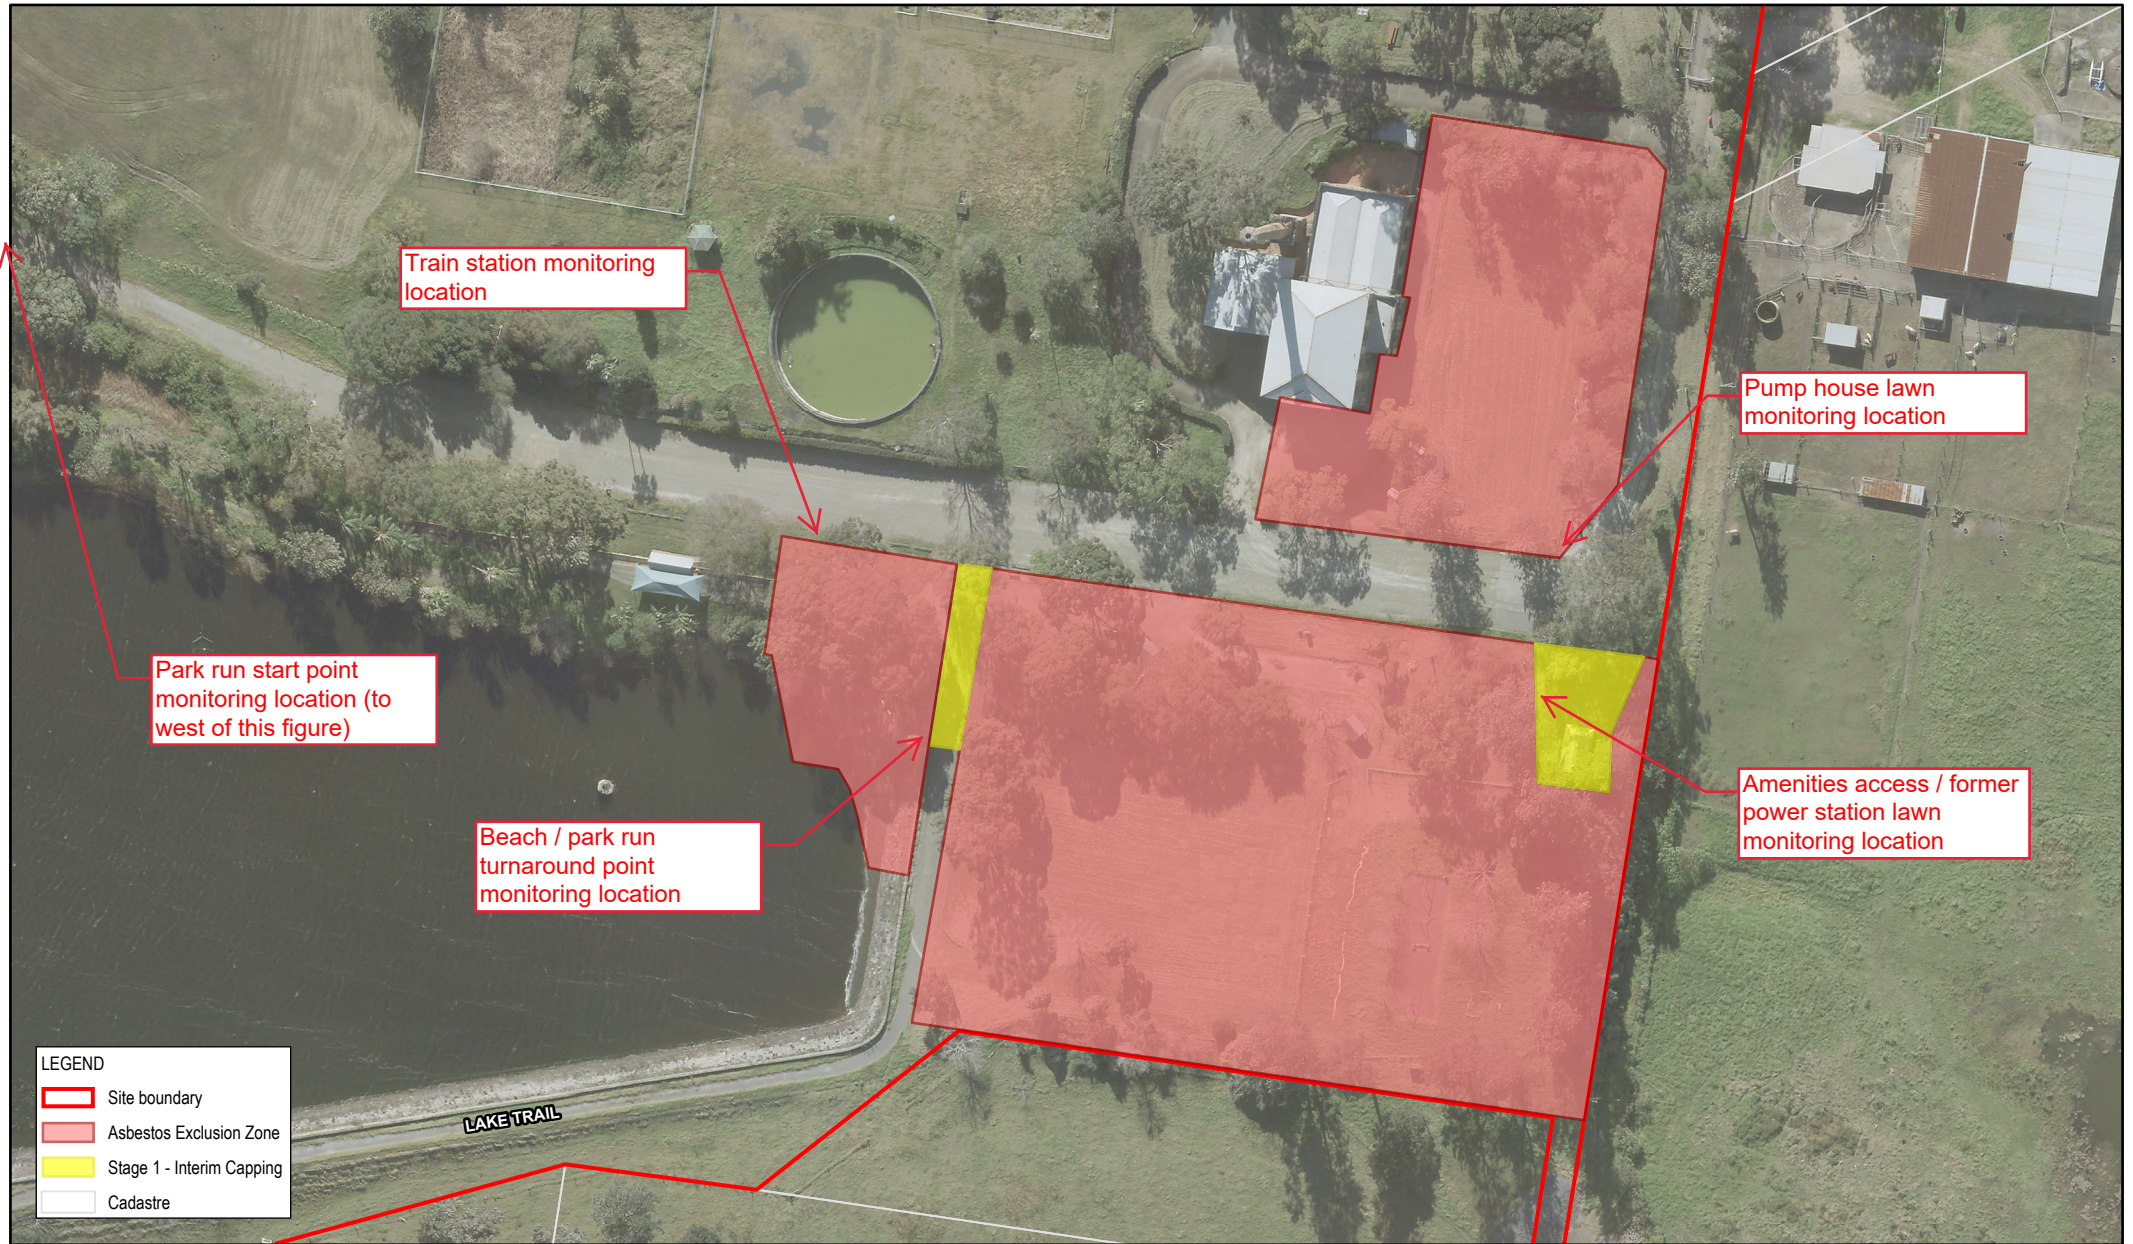
**FIGURE 6**

Site boundary
	Asbestos Exclusion Zone
	Stage 1 - Interim Capping
	Cadastre

Areas where asbestos in soils (comprising bonded and/or friable asbestos containing materials) has been identified at concentrations exceeding HSLs for recreational land use, either on or beneath the site surface, and where no capping is in place, are to remain fenced and excluded from unauthorised access. Current exclusion zones are shown on Figure 6 in Appendix A.

Stage 1 areas, which are to be capped prior to reopening of the site to the public, are shown on Figure 6 in Appendix A. Areas which will be capped in subsequent stages of remediation (indicative areas are shown in Figure 7 in Appendix A) will be identified by survey and referenced in updated versions of the LTEMP.

As noted in Section 1.2, the site has been closed to public access. Council's intent is to open selected areas of the site to the public under interim management measures, in line with "Stage 1" as indicated on Figure 6 provided within Appendix A, prior to the commencement of remediation works described in Section 6.3.1. Interim management requirements for this stage of access will comprise the following:

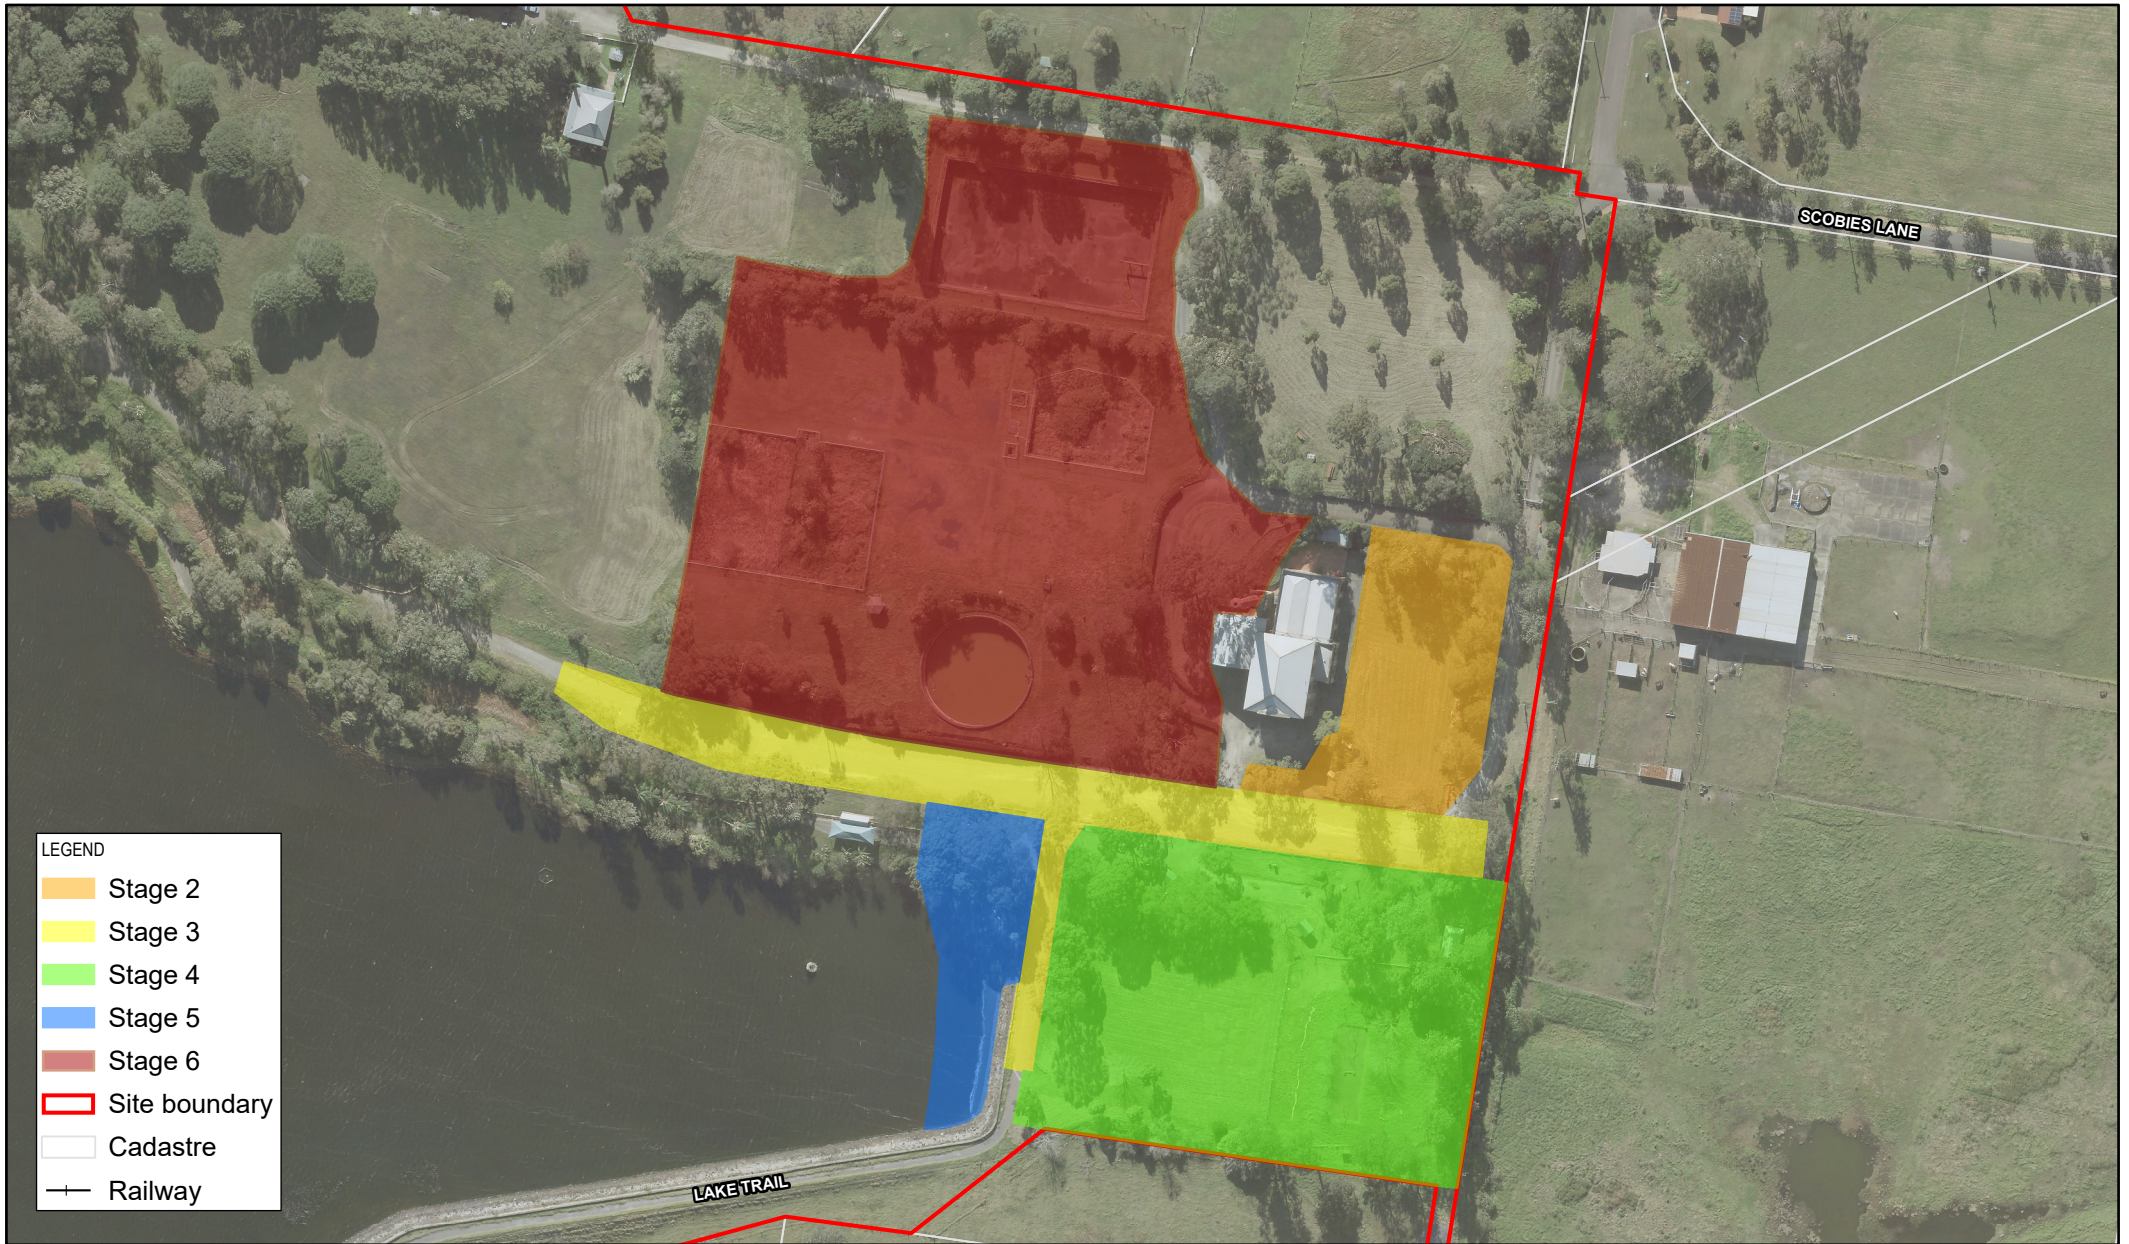
- Stage 2
- Stage 3
- Stage 4
- Stage 5
- Stage 6
- Site boundary
- Cadastre
- Railway

Council's preferred remediation staging approach is shown on Figures 6 and 7 provided within Appendix A.

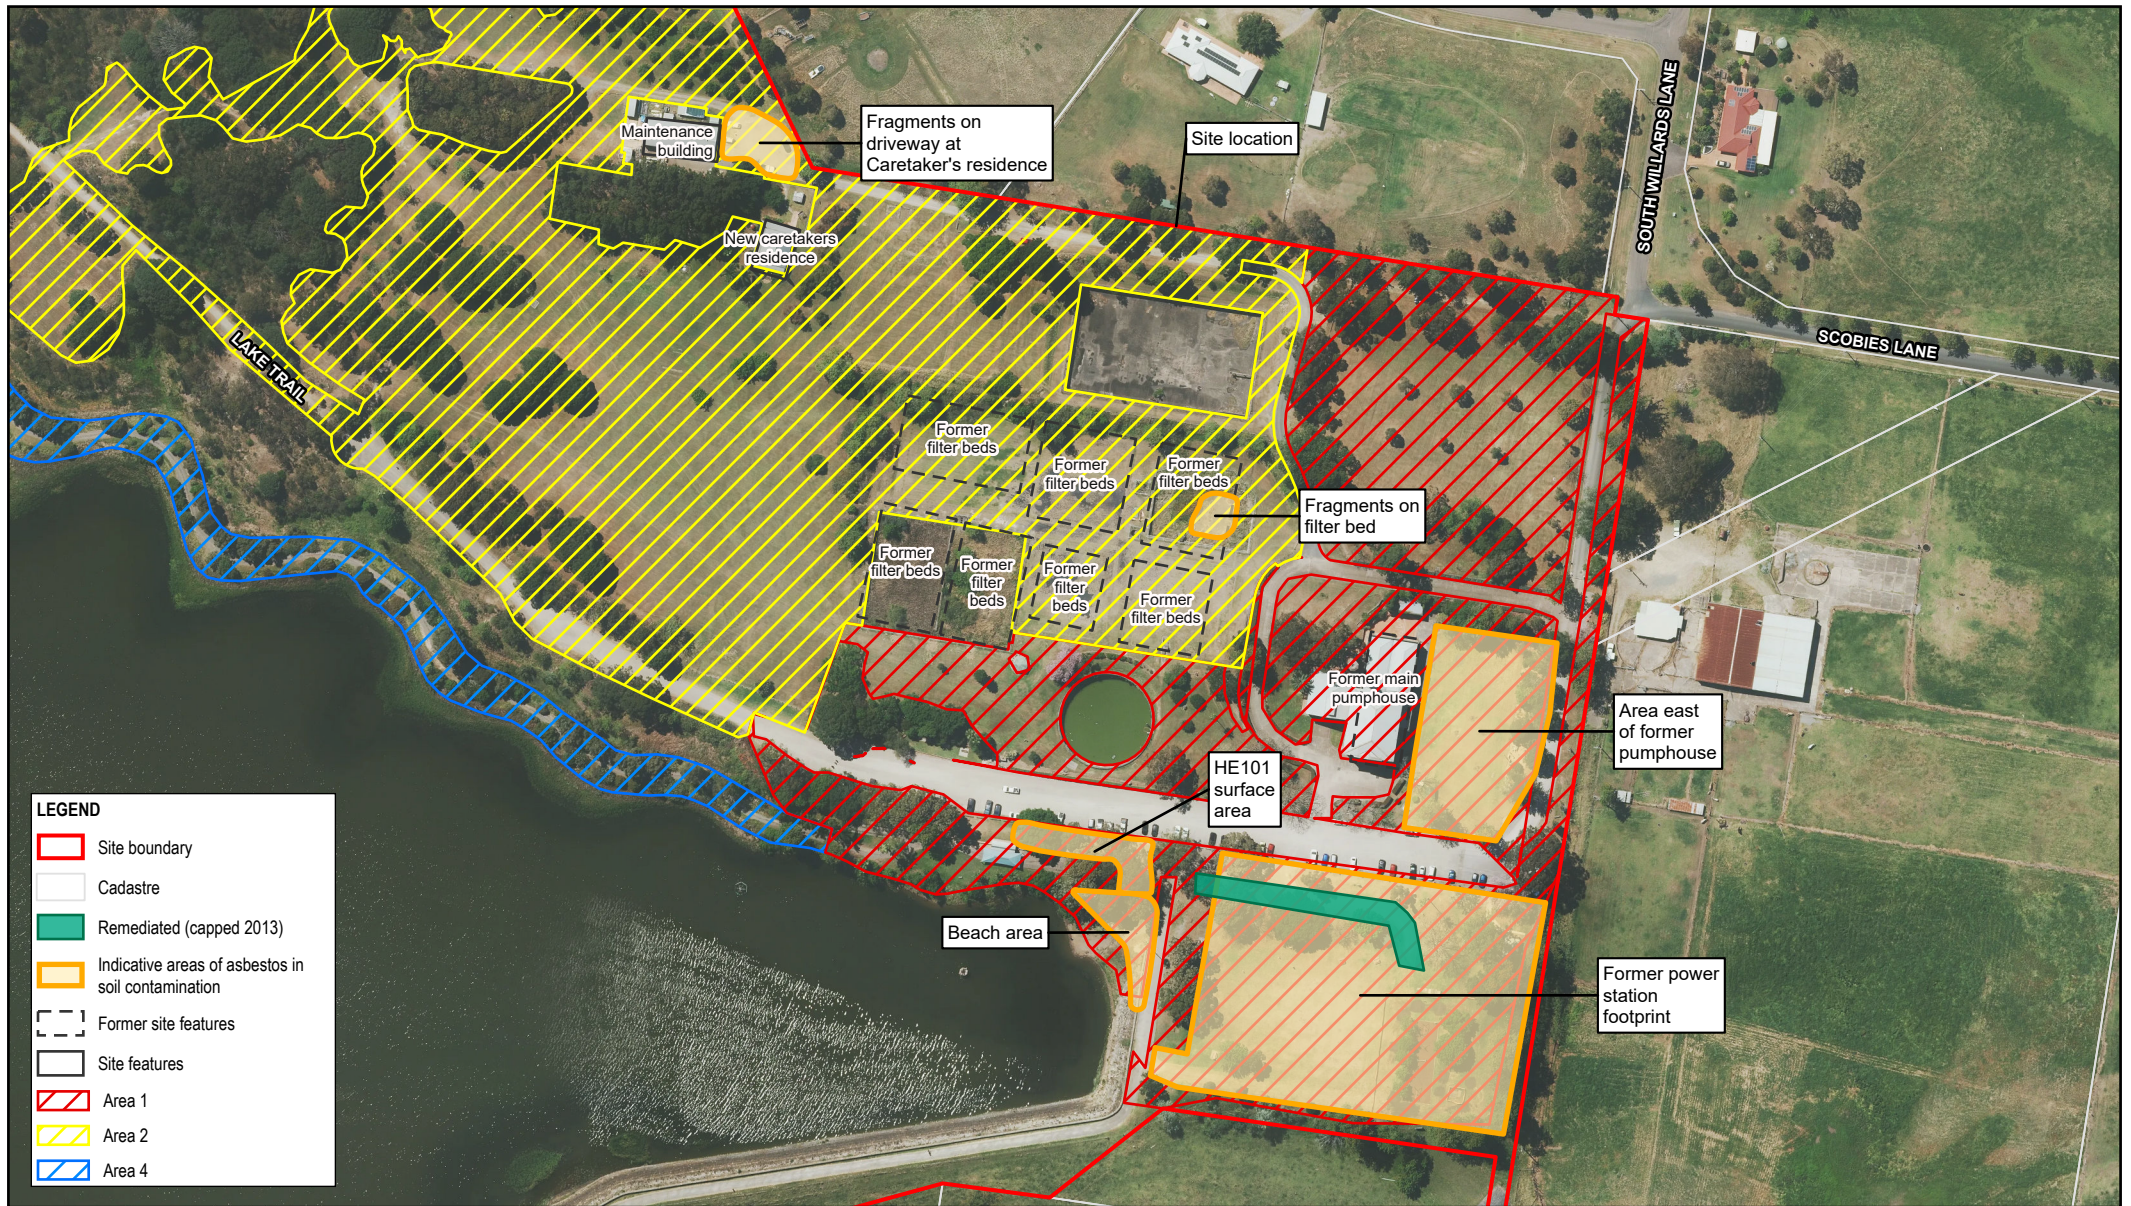
**FIGURE 1**

- Site boundary
- Cadastre
- Remediated (capped 2013)
- Indicative areas of asbestos in soil contamination
- Former site features
- Site features
- Area 1
- Area 2
- Area 4

A location plan of the site showing structures and areas of known asbestos in soil contamination is provided as Figure 1, Appendix A.

Various areas of the site contain asbestos in soil concentrations above applicable criteria at the site surface, near surface and at depth including findings of ACM, asbestos fines (AF) and fibrous asbestos (FA). A location plan of the site showing structures and areas of known asbestos in soil contamination is provided as Figure 1, Appendix A.

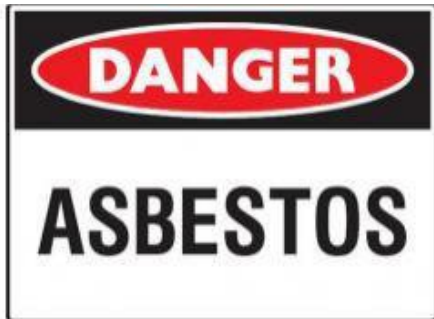
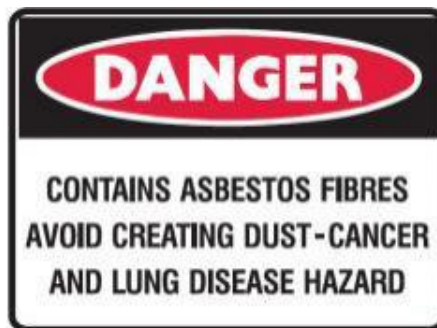
**Procedure:** *How to manage and control asbestos in the workplace* recommends signs and labels should comply with Australian Standard 1319 Safety Signs for the Occupational Environment. Areas where asbestos related work is undertaken will be signposted with appropriate signs as per the examples below.
