# Preliminary Geotechnical Investigation

523 Raymond Terrace Road, Chisholm NSW

Prepared for: ACG Clovelly Road Ltd C/- ADW Johnson Pty Ltd  
EP3045.001 18 April 2023

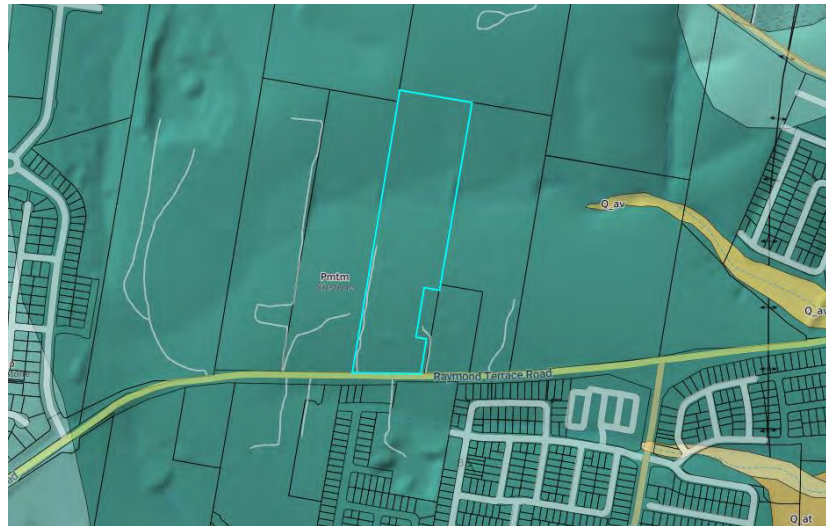
Figure 2. Geological Map Excerpt (Pmtm-Mulbring Siltstone-green)

Based on the geological data sourced from the NSW Department of Industry, Resources and Energy ([www.minview.geoscience.nsw.gov.au](http://www.minview.geoscience.nsw.gov.au)) the Site is underlain by Guadalupian aged Mulbring siltstone (**Pmtm**). The dominant siltstone lithology consists of medium to dark grey siltstone, minor claystone, sporadic thin cherty beds, rare thin sandstone and limestone beds and sporadic marine fossils. An excerpt of the geological map with the geological units is shown in Figure 2.

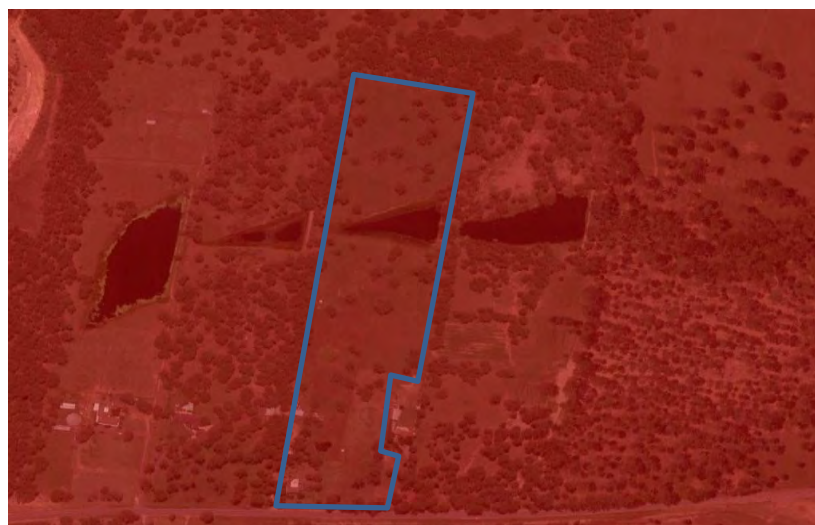
Figure 3. Soil Landscape Map Excerpt (red 9232be-Beresfield)

The soil landscape is the Beresfield Soil Landscape comprising undulating low hills and rises on Permian sediments in the East Maitland region. The soils are described as moderately well drained, yellow and brown podzolic soils as well as brown and yellow soloths on side slopes. The limitations of the Beresfield soil landscape are high foundation hazard, water erosion hazard, seasonal waterlogging and high run-on localised lower slopes, highly acid soils and low fertility. An extract of the soil landscape map is shown in Figure 3.

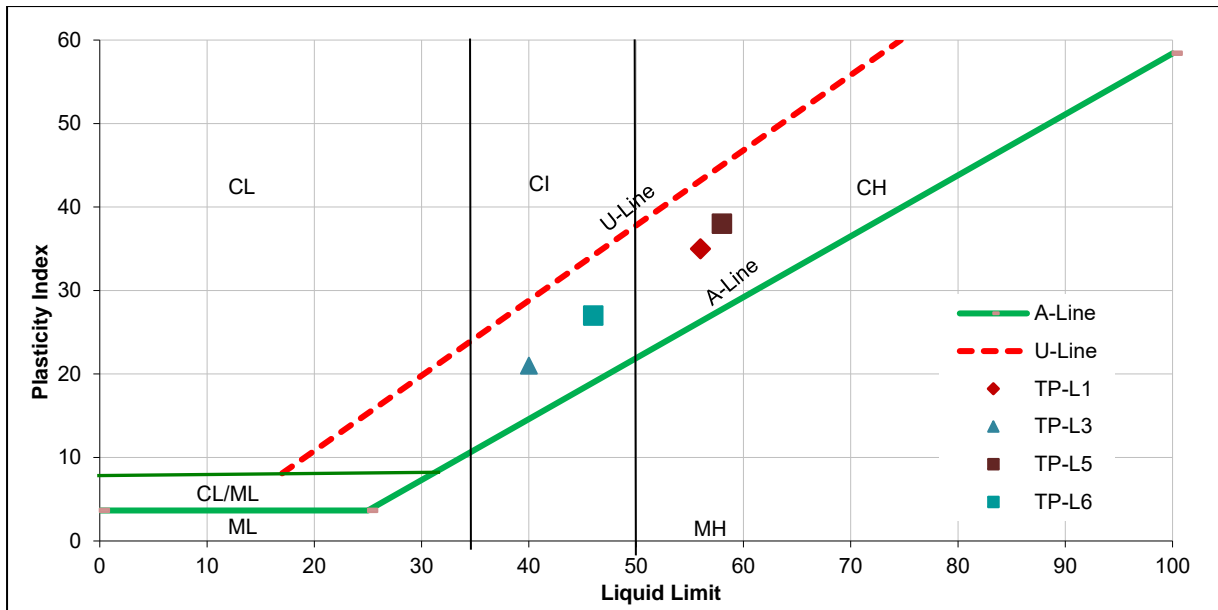
Figure 5. Atterberg Limit Plot

A summary of Atterberg Limits and Linear Shrinkage test results are presented in Table 3 and are plotted graphically in Figure 5. Testing indicates that most clayey materials are from medium to high plasticity.

Test Pit ID	Soil	Classification	Depth (m BGL)	Atterberg Limits			Linear Shrinkage (%)
				LL (%)	PL (%)	PI (%)	
TP-L1	Silty CLAY	CI-CH	0.5-1.0	56	21	35	15.0
TP-L3	Sandy SILT	ML	1.0-1.5	40	19	21	10.0
TP-L5	Silty CLAY	CI-CH	0.5-1.0	58	20	38	12.0
TP-L6	Clayey SILT	ML	0.8-1.5	46	19	27	11.5

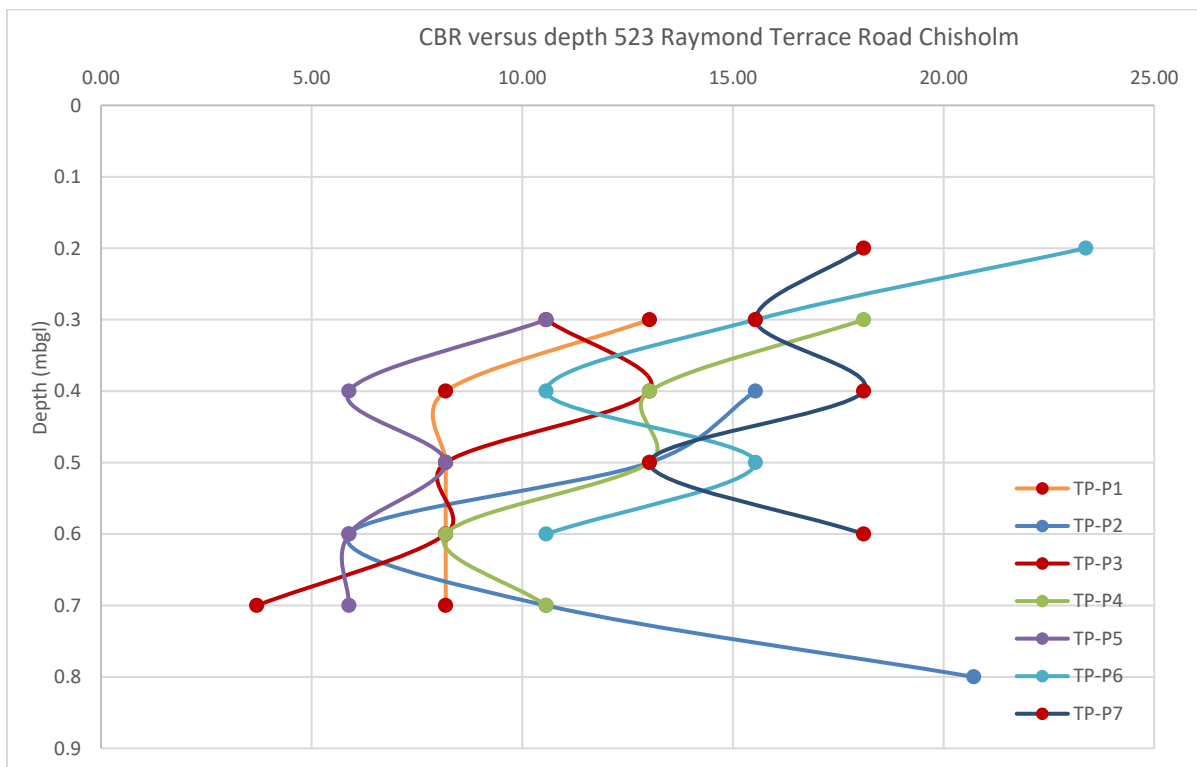
**Figure 6. In-Situ CBR values**

The DCP test can be used to provide a correlation with in-situ (field) CBR in accordance with Austroads Guidelines. The in-situ CBR values for substrata for the pavement test pits are presented in Figure 6 and the correspondent field CBR versus laboratory CBR values are presented in Table 9.

The CBR values at estimated subgrade level (0.2-0.7m) shown in Figure 6 are ranging between 3% to >20%. Overall, there is no clear correlation between the in situ CBR values with the soaked laboratory test results with all the field test results overestimating the CBR value. This can be attributed to the dry in-situ moisture condition of the soils, with samples tested for CBR approximately 2% to 4.3% dryer than the SOMC and to the ferruginous cementations contained within the soil matrix.

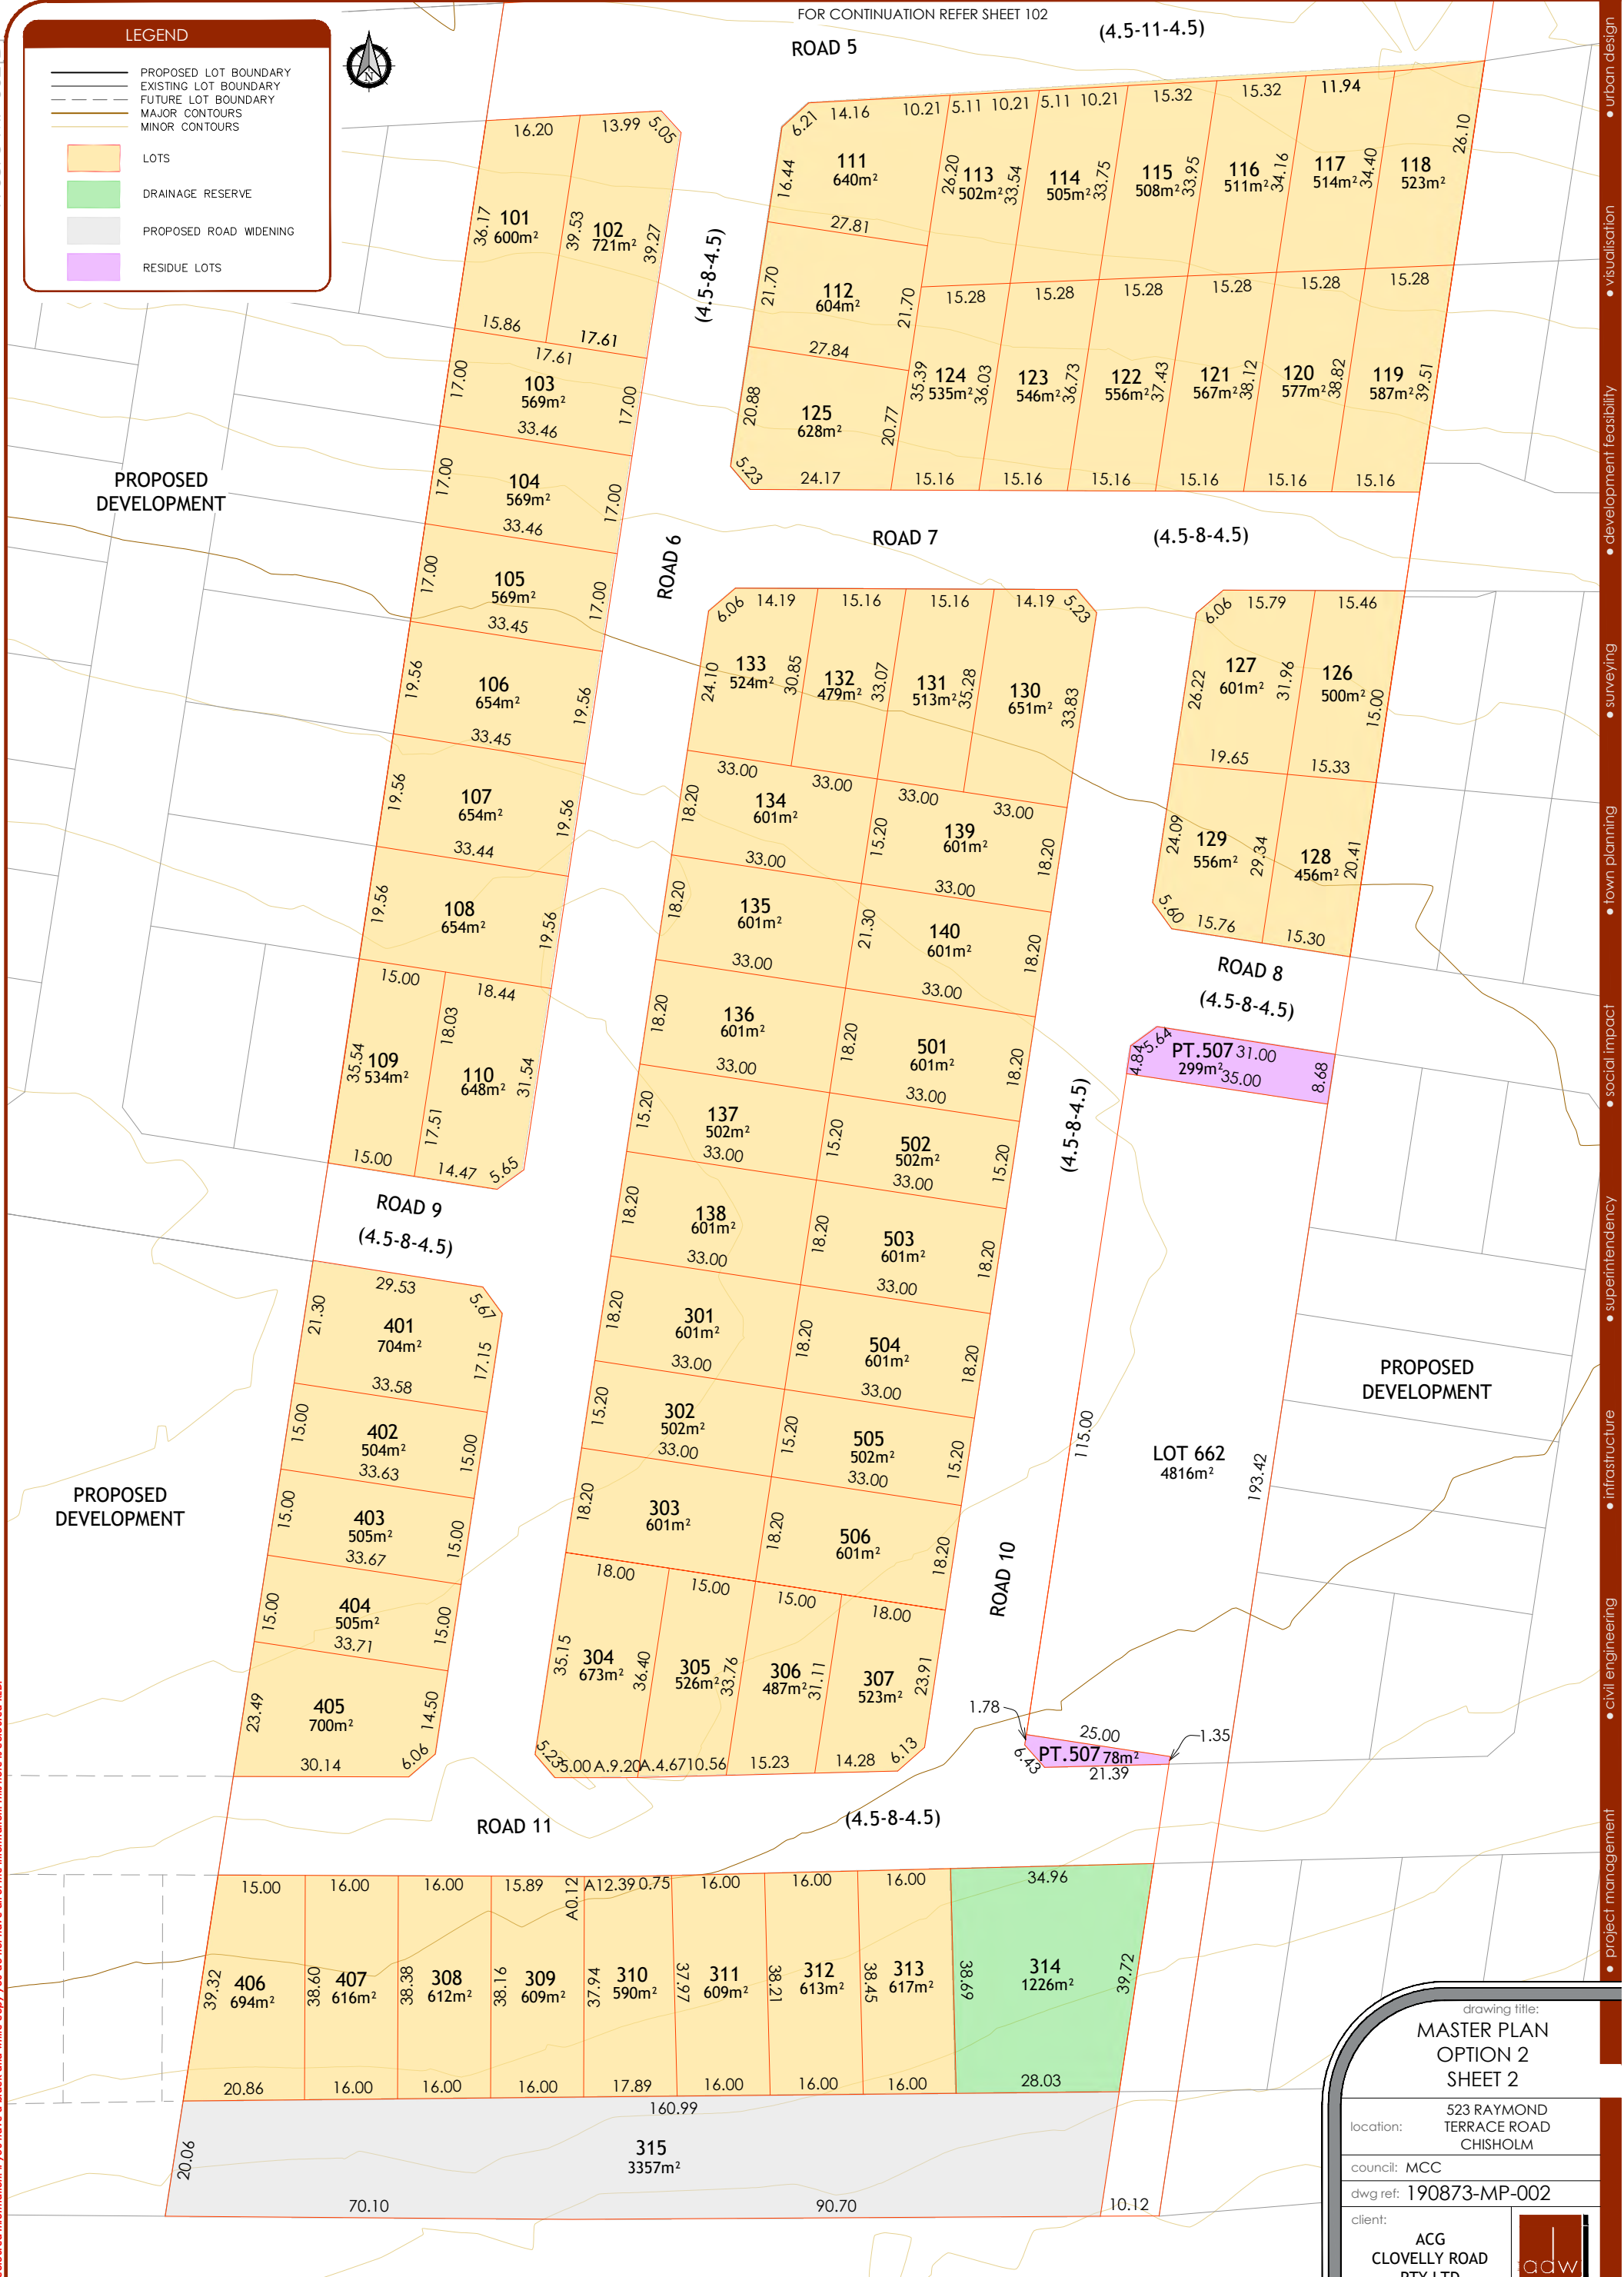
drawing title:  
**MASTER PLAN  
OPTION 2  
SHEET 2**

- PROPOSED LOT BOUNDARY
- EXISTING LOT BOUNDARY
- FUTURE LOT BOUNDARY
- MAJOR CONTOURS
- MINOR CONTOURS
- LOTS
- DRAINAGE RESERVE
- PROPOSED ROAD WIDENING
- RESIDUE LOTS

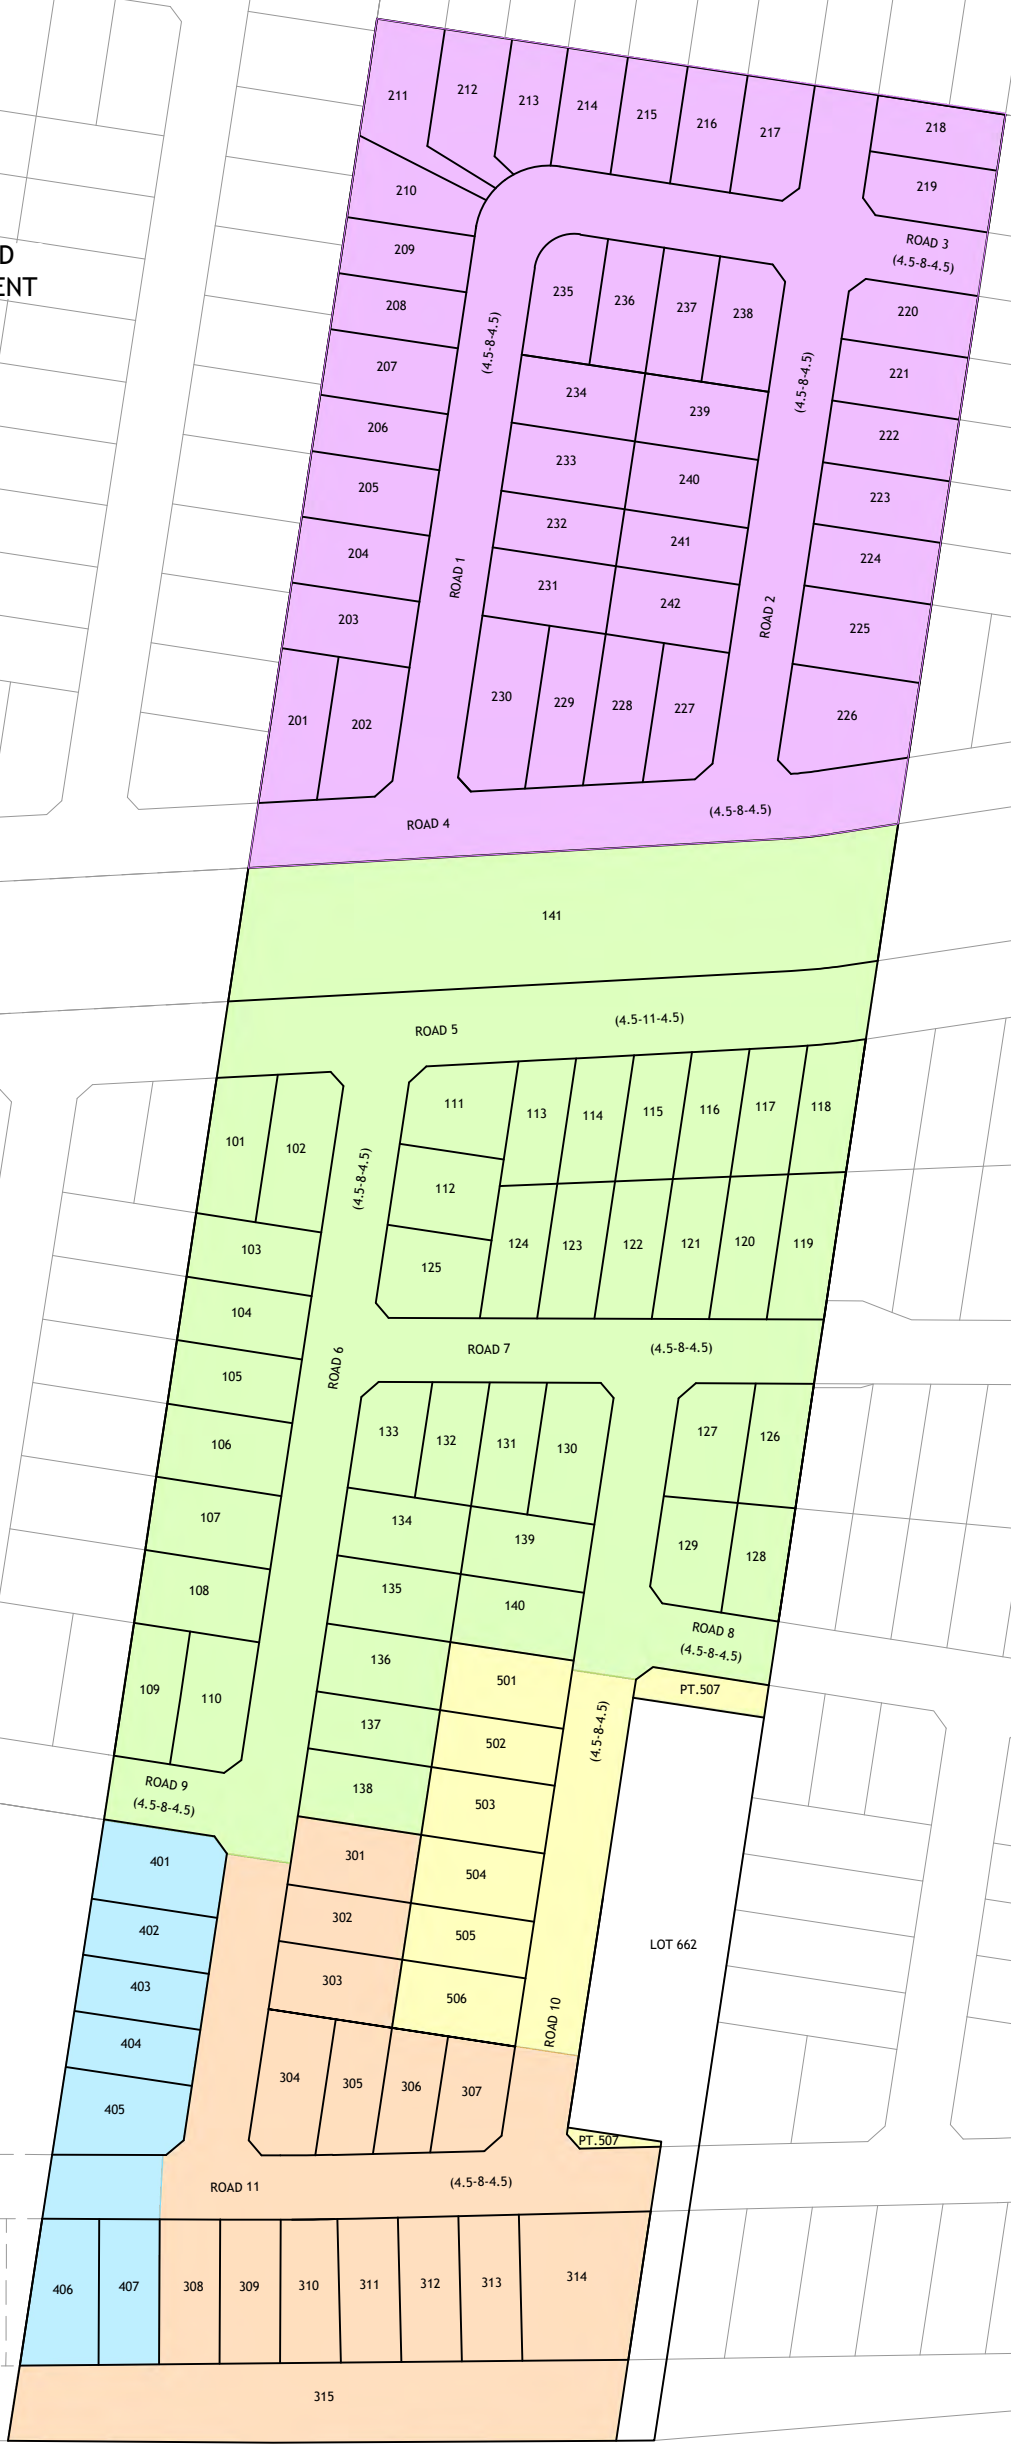
drawing title:  
**STAGING PLAN**

location: 523 RAYMOND TERRACE ROAD CHISHOLM  
council: MCC  
dwg ref: 190873-MP-003  
client: ACG CLOVELLY ROAD PTY LTD

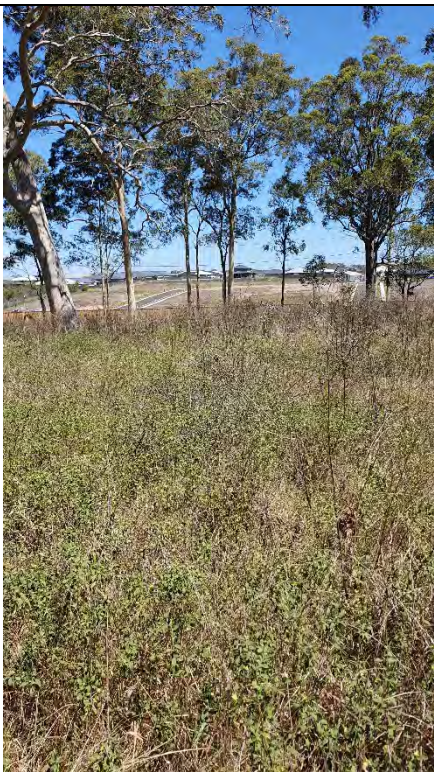
<p><b>Plate 1</b></p> <p><b>Description:</b> Looking towards Raymond Terrace Road</p> <p><b>Date:</b>16.02.2023</p>
	 	<p><b>Plate 2</b></p> <p><b>Description:</b> Looking NW from the southern part of the site</p> <p><b>Date:</b> 16.02.2023</p>

The locations of the test pits were based on the proposed development layout and are presented in **Appendix C – Geotechnical Investigation Locations**. Upon completion of the investigation, the holes at each location were backfilled with excess spoil to pre-existing ground conditions.

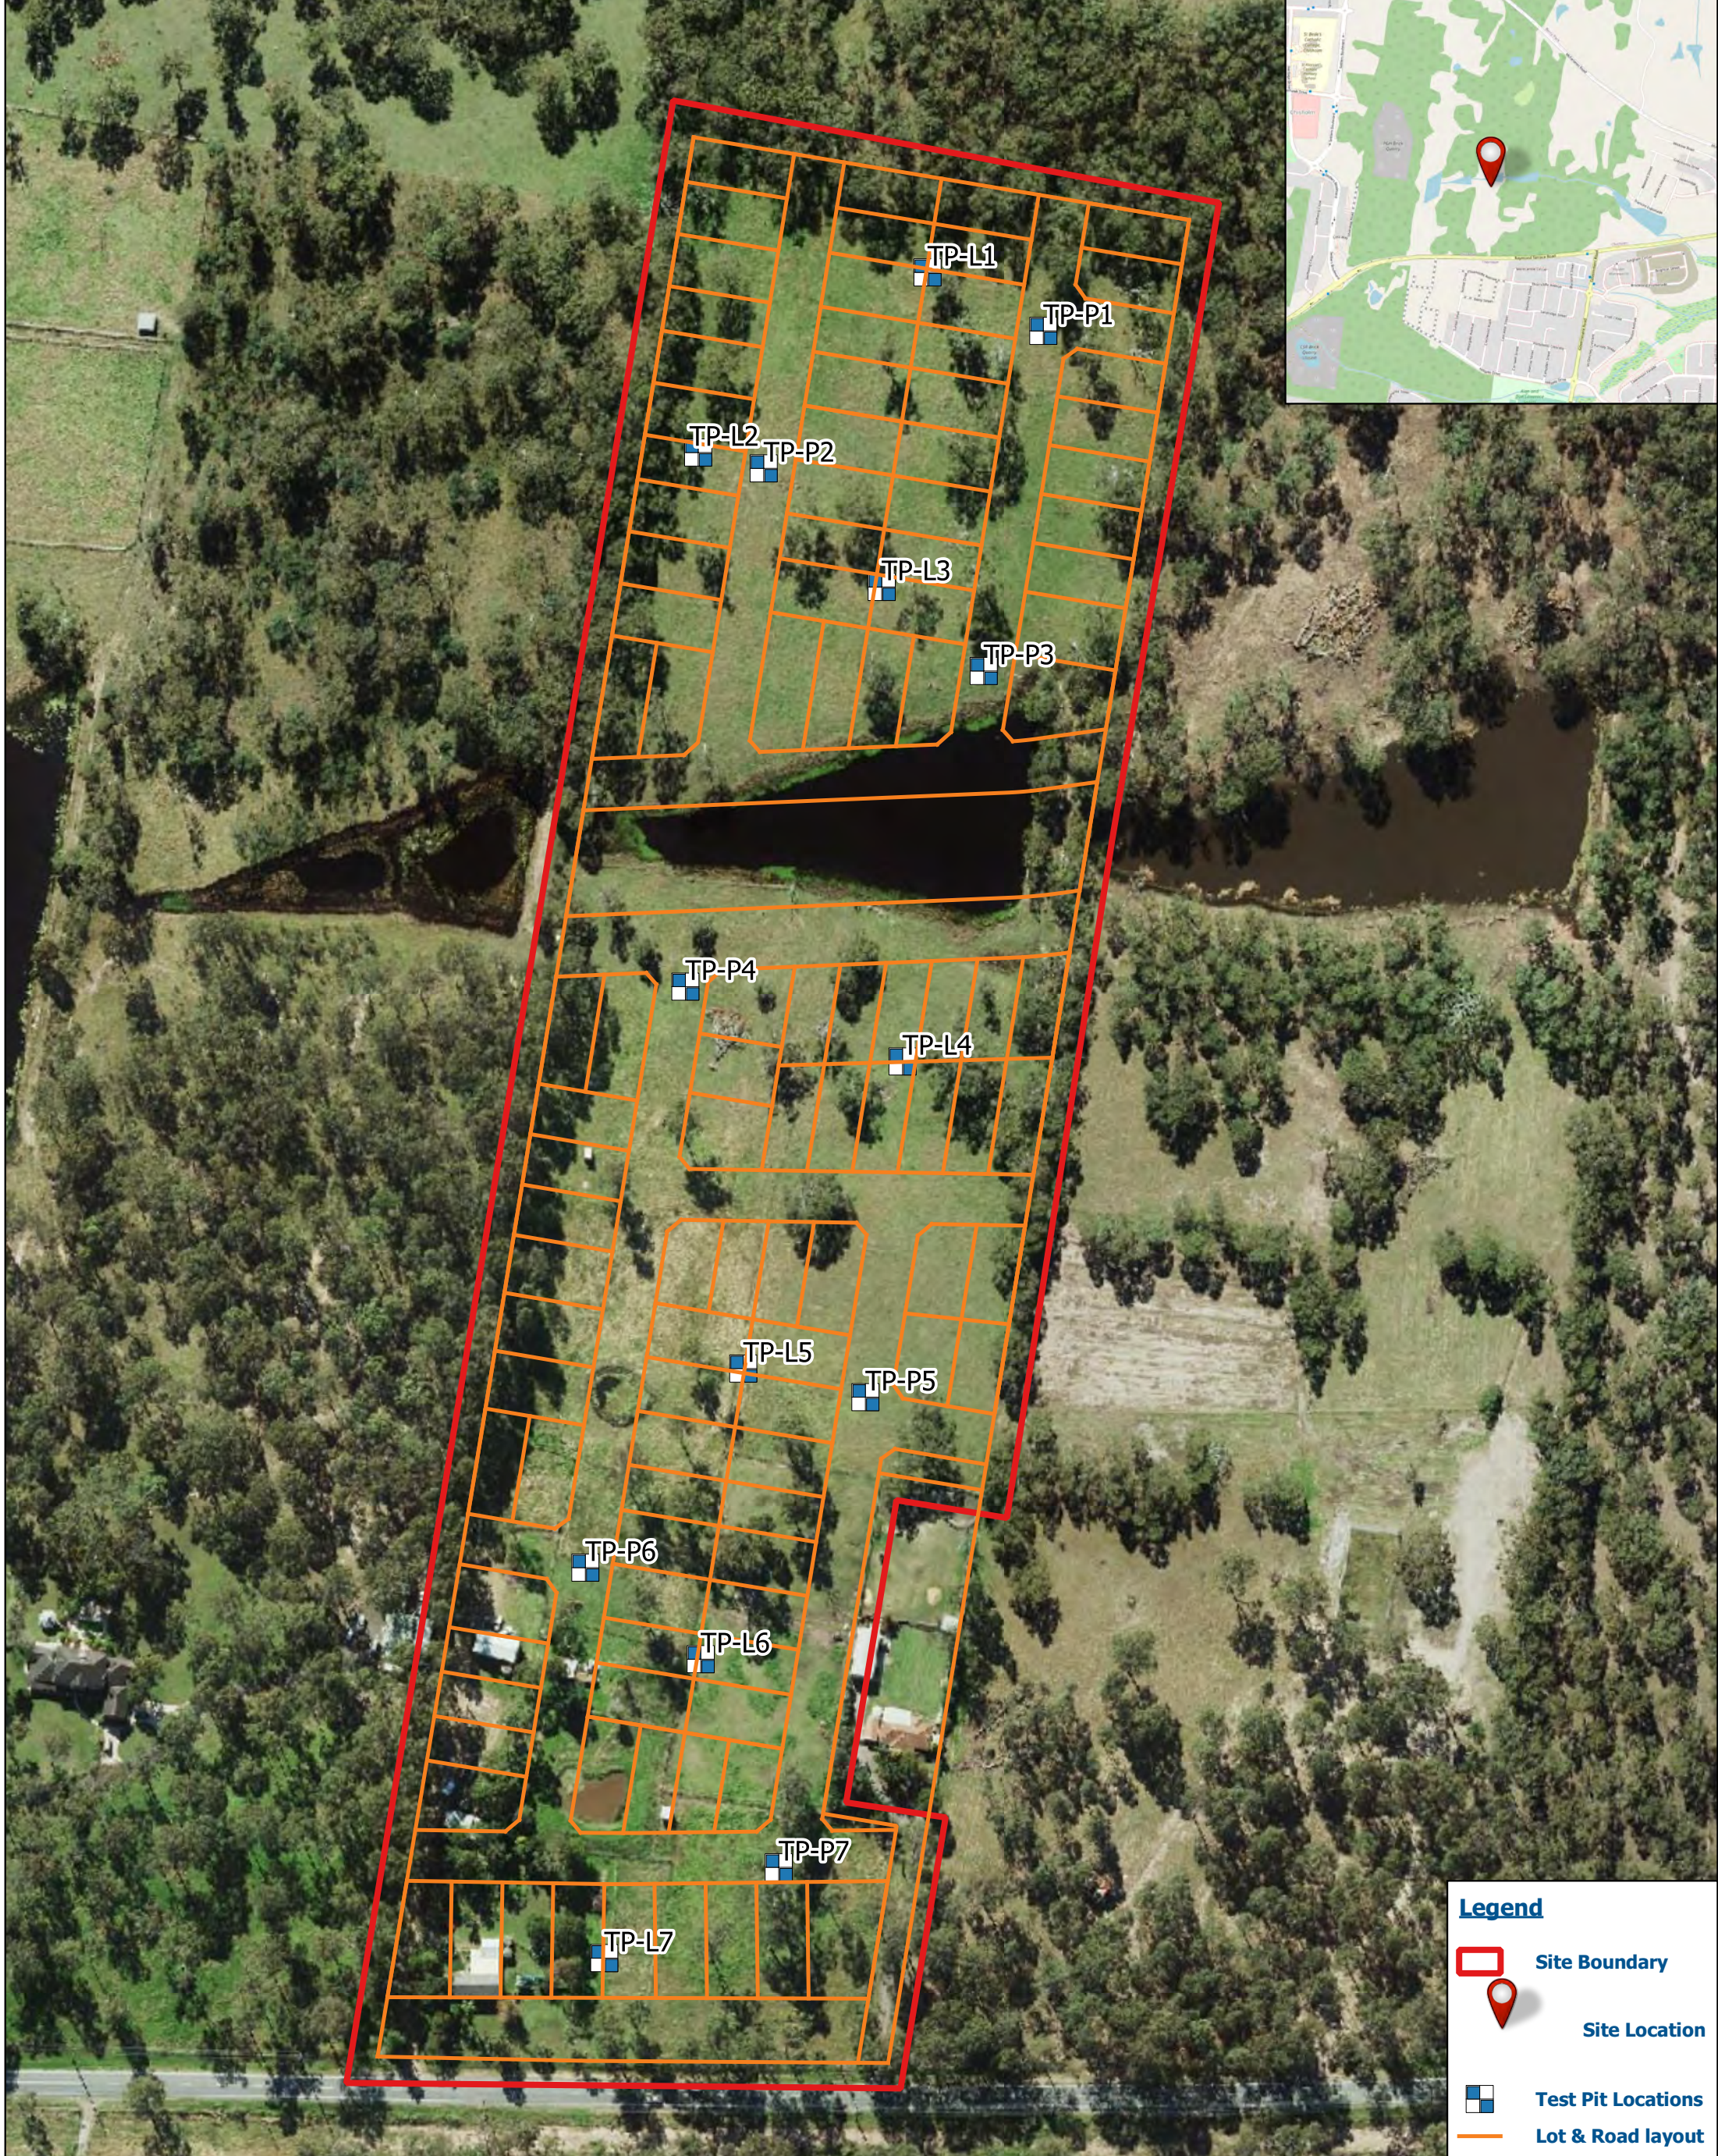
## GEOTECHNICAL INVESTIGATION LOCATIONS

Job No: EP3045  
 Date: 22/02/2023  
 Drawing Ref: Fig 1  
 Version No: v1

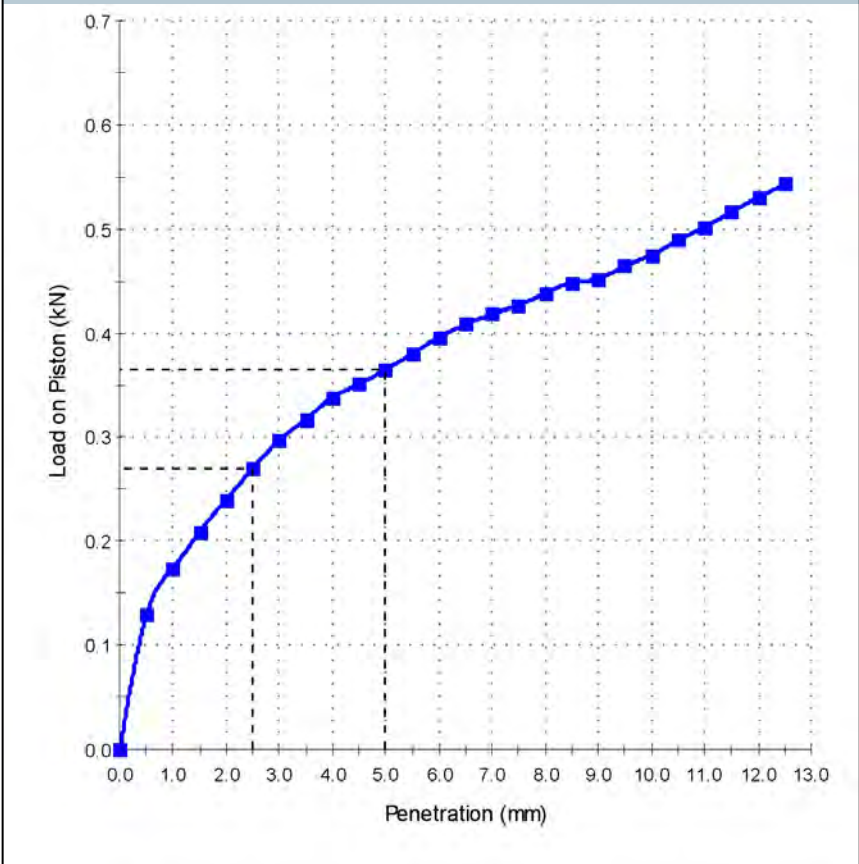
## Load vs Penetration

<b>Sample ID:</b>	NEWC23S-01318	<b>Sampling Method:</b>	Submitted by client*
<b>Client ID:</b>		<b>Material:</b>	Existing Ground
<b>Date Sampled:</b>	16/02/2023	<b>Source:</b>	On-Site
<b>Date Submitted:</b>	21/02/2023	<b>Specification:</b>	No Specification
<b>Date Tested:</b>	3/03/2023		
<b>Project Location:</b>	Chisholm, NSW		
<b>Sample Location:</b>	TP-P4, Depth:0.5 - 1.5m

AS 1289.6.1.1	
<b>CBR at 2.5mm (%):</b>	<b>2.0</b>
Dry Density before Soaking (t/m <sup>3</sup> ):	1.61
Density Ratio before Soaking (%):	101.0
Moisture Content before Soaking (%):	20.9
Moisture Ratio before Soaking (%):	99.0
Dry Density after Soaking (t/m <sup>3</sup> ):	1.57
Density Ratio after Soaking (%):	99.0
Swell (%):	2.5
Moisture Content of Top 30mm (%):	28.4
Moisture Content of Remaining Depth (%):	23.5
Compaction Hammer Used:	Standard
	AS 1289.5.1.1
Surcharge Mass (kg):	4.50
Period of Soaking (Days):	4
Retained on 19 mm Sieve (%):	1
CBR Moisture Content Method:	AS 1289.2.1.1
Sample Curing Time (h):	66
Plasticity Determination Method:	Visual/Tactile

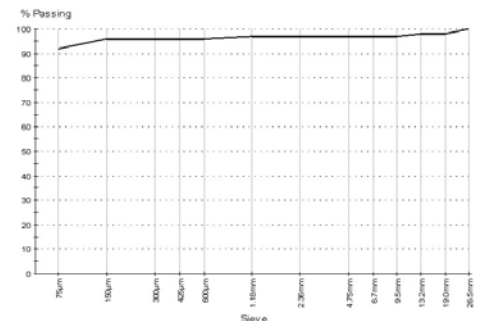
## Chart

Description	Method	Result	Limits
Sample History	AS 1289.1.1	Air-Dried	
Preparation	AS 1289.1.1	Dry-Sieved	
Linear Shrinkage (%)	AS 1289.3.4.1	15.0	
Mould Length (mm)		250	
Crumbling		No	
Curling		No	
Cracking		No	
Liquid Limit (%)	AS 1289.3.1.1	56	
Method		Four Point	
Plastic Limit (%)	AS 1289.3.2.1	21	
Plasticity Index (%)	AS 1289.3.3.1	35	
Date Tested		24/02/2023

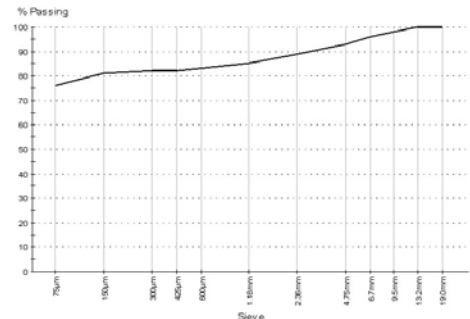
## Chart

Description	Method	Result	Limits
Sample History	AS 1289.1.1	Air-Dried	
Preparation	AS 1289.1.1	Dry-Sieved	
Linear Shrinkage (%)	AS 1289.3.4.1	10.0	
Mould Length (mm)		250	
Crumbling		No	
Curling		No	
Cracking		No	
Liquid Limit (%)	AS 1289.3.1.1	40	
Method		Four Point	
Plastic Limit (%)	AS 1289.3.2.1	19	
Plasticity Index (%)	AS 1289.3.3.1	21	
Date Tested		24/02/2023

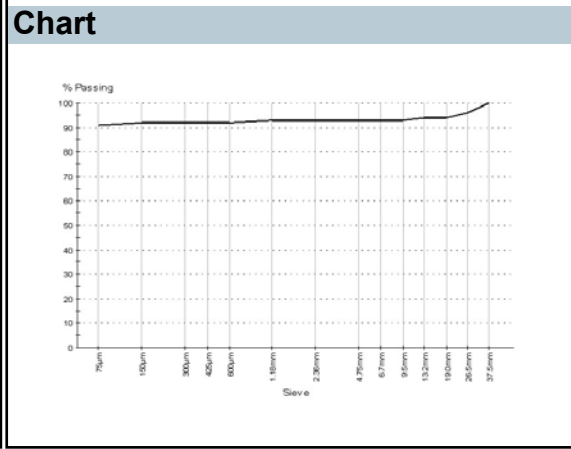
Description	Method	Result	Limits
Sample History	AS 1289.1.1	Air-Dried	
Preparation	AS 1289.1.1	Dry-Sieved	
Linear Shrinkage (%)	AS 1289.3.4.1	12.0	
Mould Length (mm)		254	
Crumbling		No	
Curling		No	
Cracking		No	
Liquid Limit (%)	AS 1289.3.1.1	58	
Method		Four Point	
Plastic Limit (%)	AS 1289.3.2.1	20	
Plasticity Index (%)	AS 1289.3.3.1	38	
Date Tested		24/02/2023

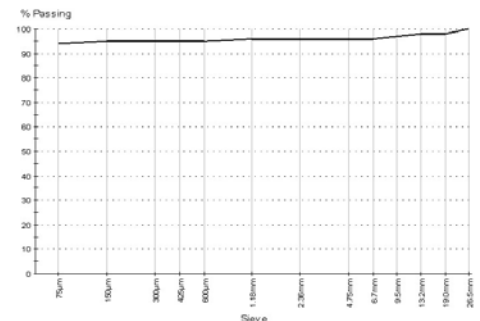
## Chart

Description	Method	Result	Limits
Sample History	AS 1289.1.1	Air-Dried	
Preparation	AS 1289.1.1	Dry-Sieved	
Linear Shrinkage (%)	AS 1289.3.4.1	11.5	
Mould Length (mm)		249.5	
Crumbling		No	
Curling		No	
Cracking		No	
Liquid Limit (%)	AS 1289.3.1.1	46	
Method		Four Point	
Plastic Limit (%)	AS 1289.3.2.1	19	
Plasticity Index (%)	AS 1289.3.3.1	27	
Date Tested		24/02/2023

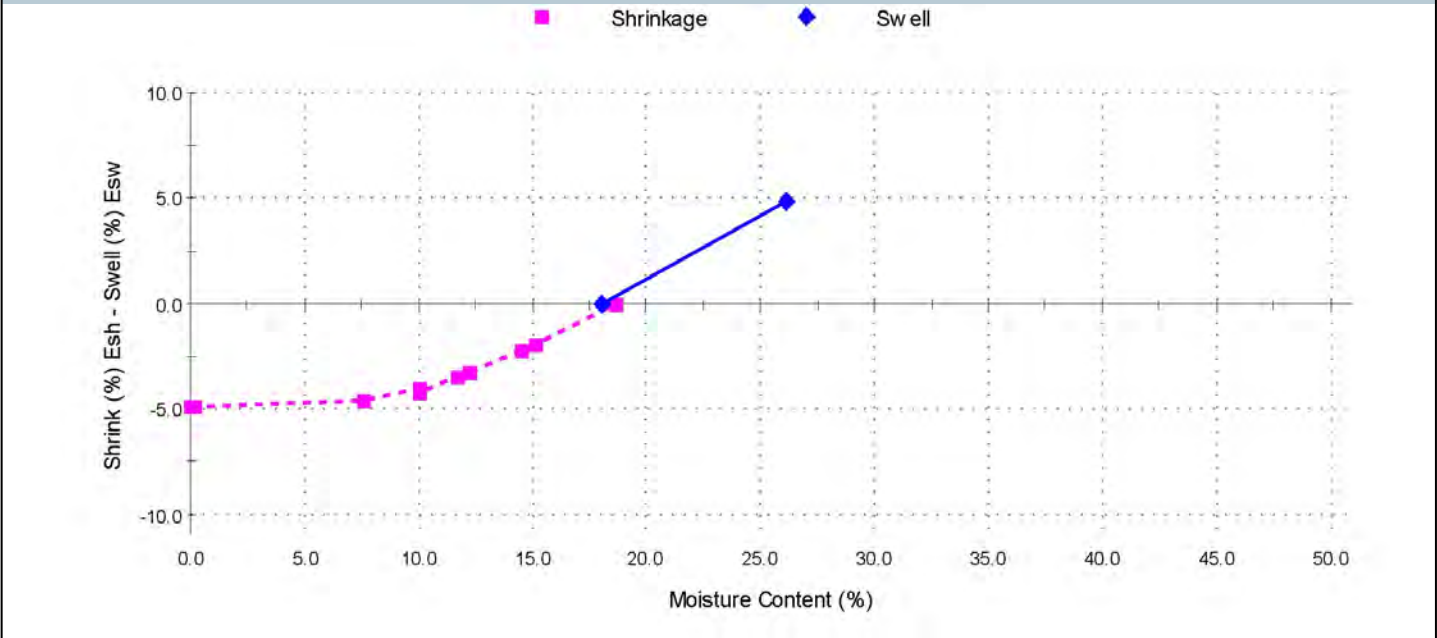
## Shrink Swell

Swell Test		AS 1289.7.1.1	Shrink Test		AS 1289.7.1.1
<b>Swell on Saturation (%):</b>	4.8		<b>Shrink on drying (%):</b>	4.9	
<b>Moisture Content before (%):</b>	18.0		<b>Shrinkage Moisture Content (%):</b>	18.6	
<b>Moisture Content after (%):</b>	26.1		<b>Est. inert material (%):</b>	<5	
<b>Est. Unc. Comp. Strength before (kPa):</b>	+600		<b>Crumbling during shrinkage:</b>	Nil	
<b>Est. Unc. Comp. Strength after (kPa):</b>	150		<b>Cracking during shrinkage:</b>	Nil

**Shrink Swell Index - Iss (%): 4.1**

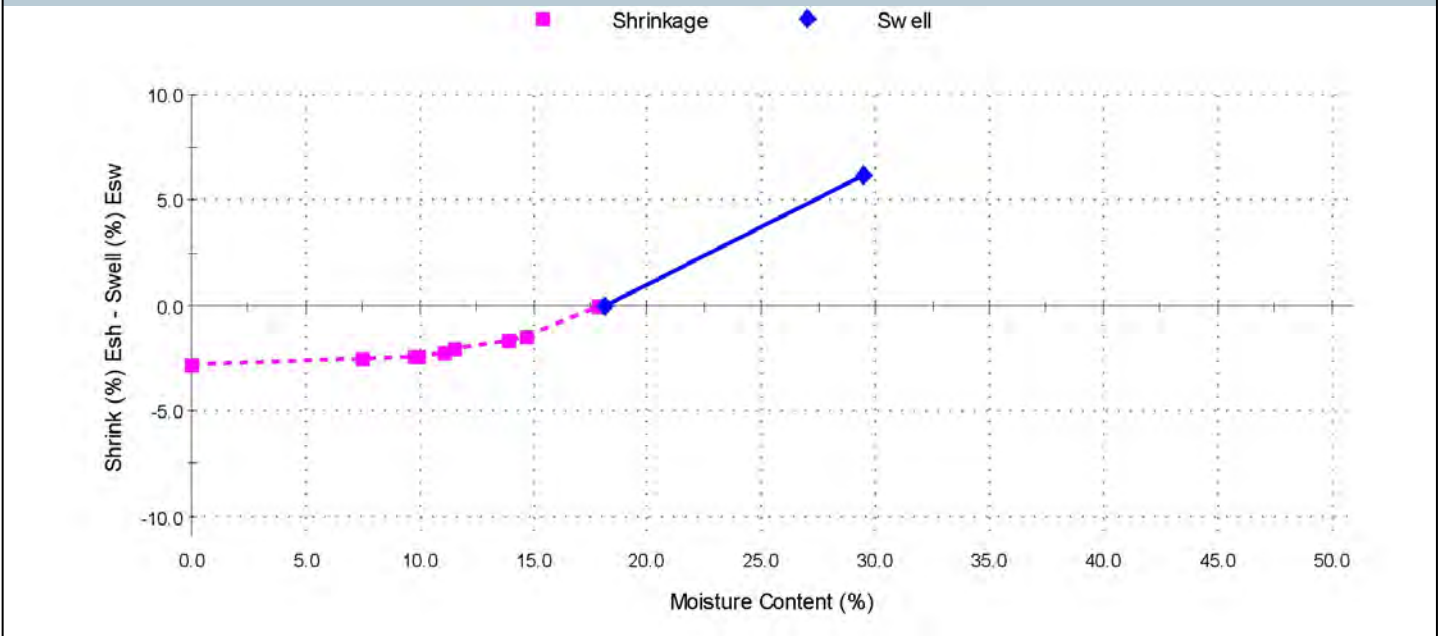
## Shrink Swell

Swell Test		AS 1289.7.1.1	Shrink Test		AS 1289.7.1.1
<b>Swell on Saturation (%):</b>	6.2		<b>Shrink on drying (%):</b>	2.8	
<b>Moisture Content before (%):</b>	18.1		<b>Shrinkage Moisture Content (%):</b>	17.8	
<b>Moisture Content after (%):</b>	29.4		<b>Est. inert material (%):</b>	15-25	
<b>Est. Unc. Comp. Strength before (kPa):</b>	+600		<b>Crumbling during shrinkage:</b>	Nil	
<b>Est. Unc. Comp. Strength after (kPa):</b>	180		<b>Cracking during shrinkage:</b>	Slight

**Shrink Swell Index - Iss (%): 3.3**

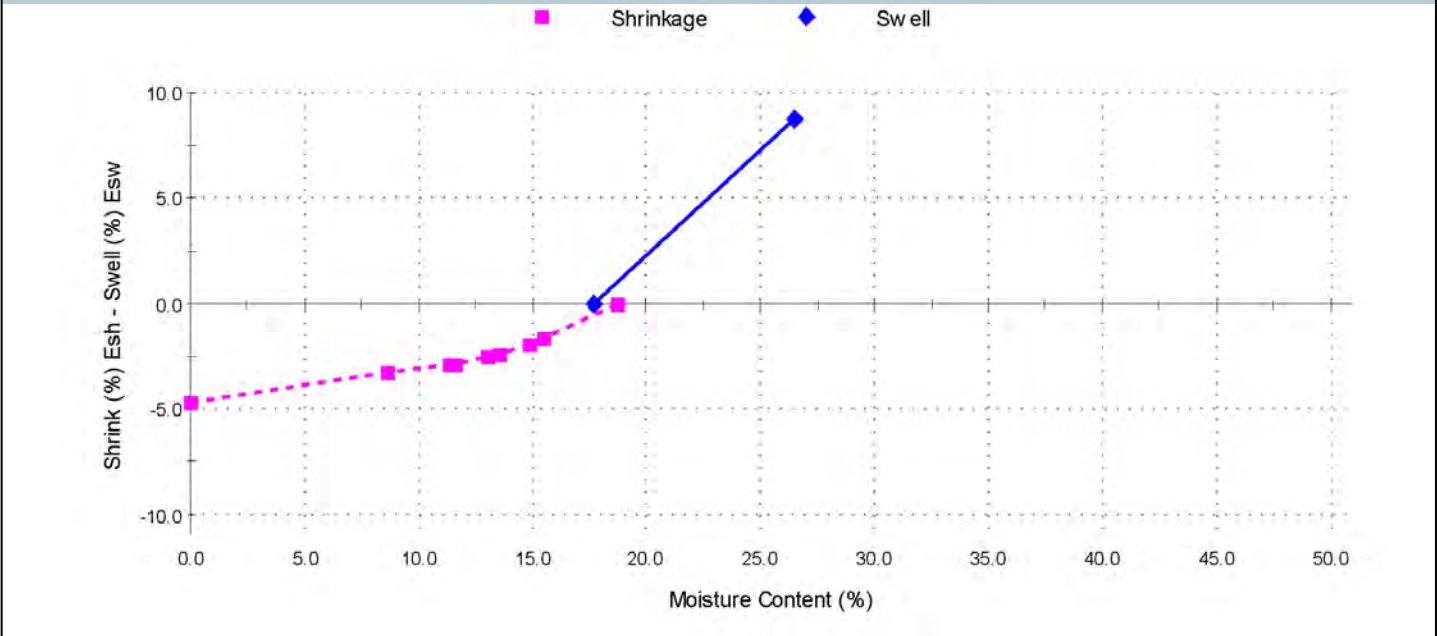
## Shrink Swell

Swell Test		AS 1289.7.1.1	Shrink Test		AS 1289.7.1.1
<b>Swell on Saturation (%):</b>	8.8		<b>Shrink on drying (%):</b>	4.7	
<b>Moisture Content before (%):</b>	17.7		<b>Shrinkage Moisture Content (%):</b>	18.7	
<b>Moisture Content after (%):</b>	26.4		<b>Est. inert material (%):</b>	<5	
<b>Est. Unc. Comp. Strength before (kPa):</b>	510		<b>Crumbling during shrinkage:</b>	Nil	
<b>Est. Unc. Comp. Strength after (kPa):</b>	240		<b>Cracking during shrinkage:</b>	Nil

**Shrink Swell Index - Iss (%): 5.0**

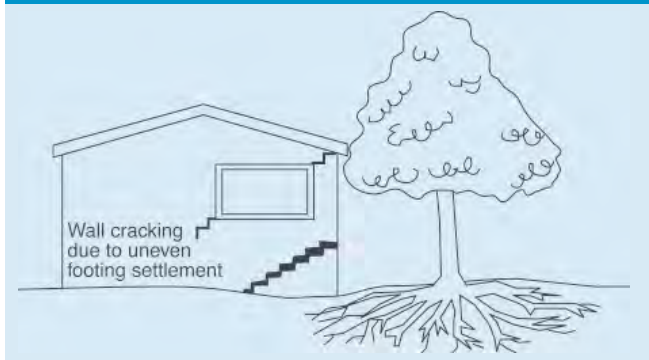
### Trees can cause shrinkage and damage

As the weather pattern changes and the soil begins to dry out, the external footings will be first affected, beginning with the locations where the sun's effect is strongest. This has the effect of lowering the external footings. The doming is accentuated and cracking reduces or disappears where it occurred because of dishing, but other cracks open up. The roof lines may become convex.
