Preliminary Geotechnical Assessment

24 Duckenfield Road, Chisholm, NSW

Prepared for: AVID Property Group C/- ADW Johnson Pty Ltd
EP2681.003 28 February 2023

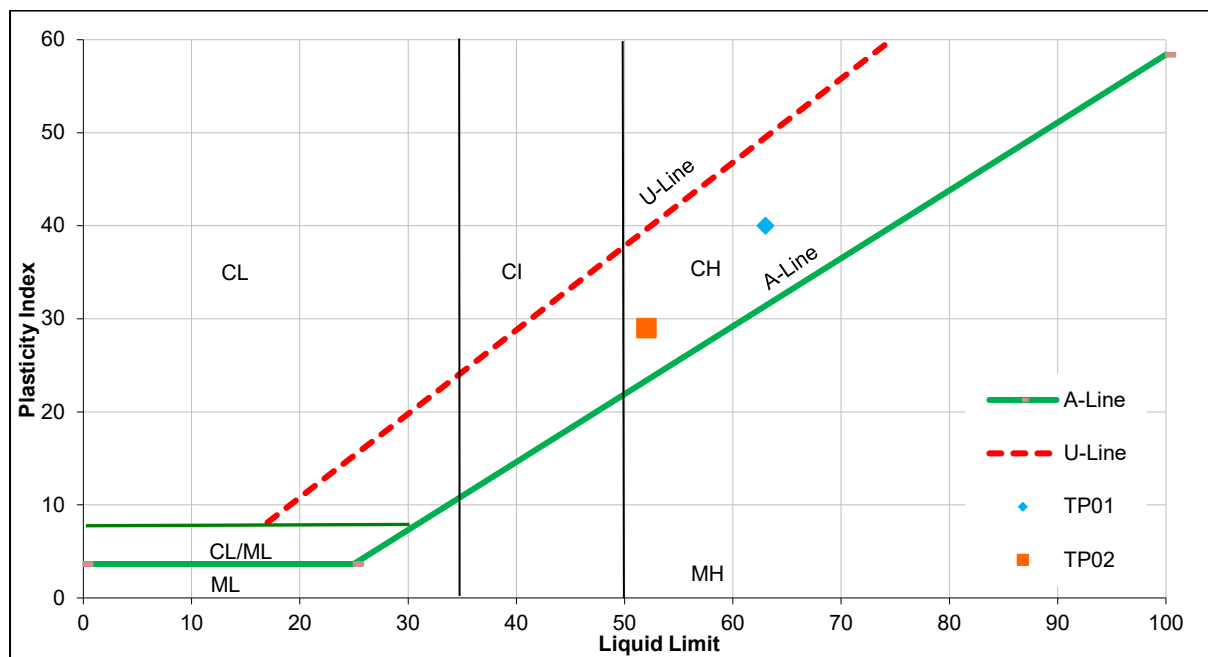
Figure 3. Atterberg Limits Graphical Plot

A summary of Atterberg Limits and Linear Shrinkage test results are presented in Table 4 and are plotted graphically in Figure 3. Testing indicates that the clayey materials range from medium to high plasticity.

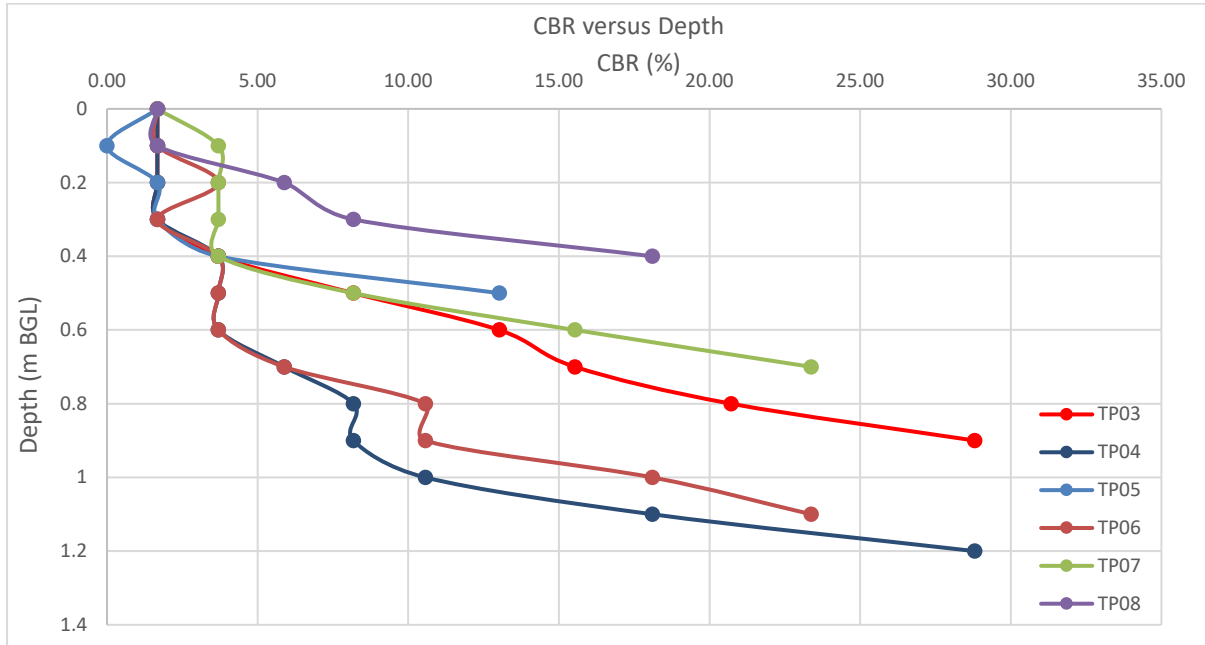
Figure 4. In-Situ CBR values

It should be noted that the correlation is valid up to 10 DCP blows / 100 mm (i.e., CBR < 20%). The in-situ CBR values for substrata for the pavement test pits are presented in Figure 4 and the correspondent field CBR versus laboratory CBR values are presented in Table 7.

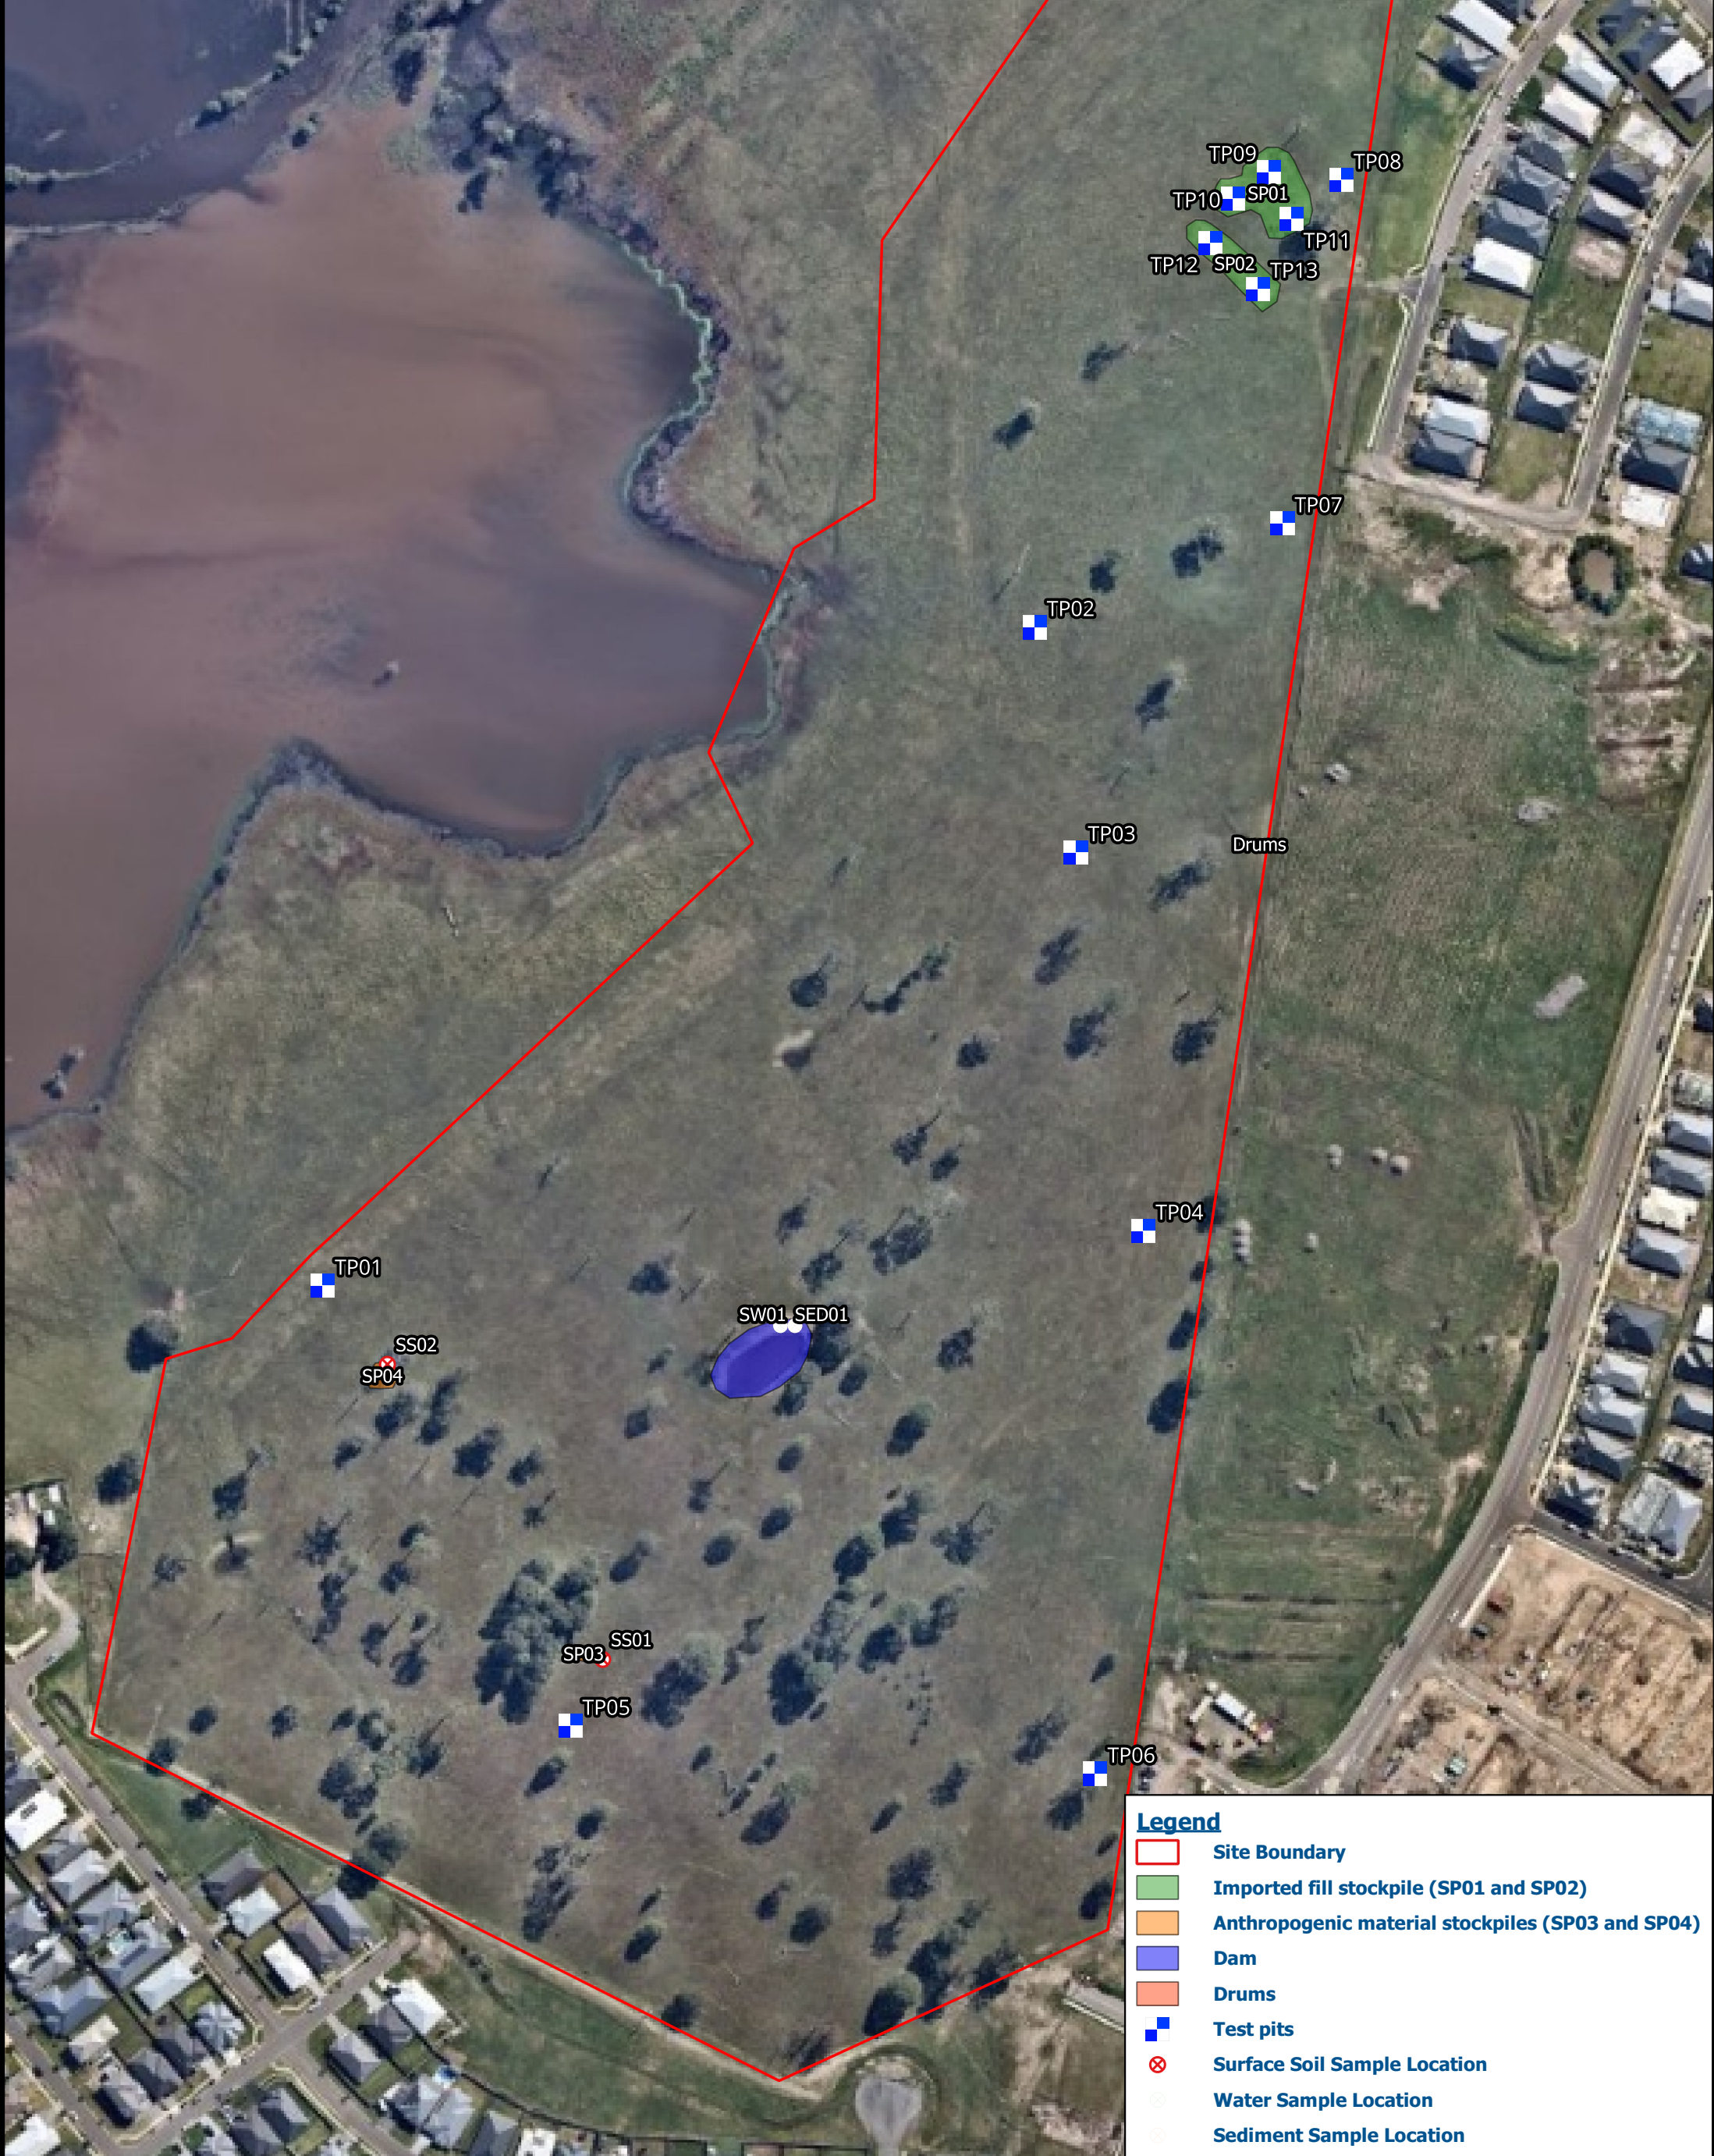
Figure 2 - Sampling Locations

General site features observed include two stockpiles (SP03 and SP04) of anthropogenic materials (wood, mattresses, metal, plastic) in the southern portion of the Site; two imported fill stockpiles (SP01 and SP02) were identified next to the eastern boundary of the Site (SP01 is located near a former dam that was backfilled around the year of 2006); scattered anthropogenic materials; a dam in the central portion of the Site; scattered native vegetation; and an existing underground water main runs along the western boundary of the Site. Several small excavations (<1m³) in the southern gully of unknown origin. A white silvery shape in the drainage line appears in the 1988 Aerial photo. Inspection did not show any reason for this occurrence and may be a surface reflection.

The subsurface conditions encountered in the Test Pits advanced across the Site (TP01 – TP13) are detailed on the attached log sheets in **Appendix C – Test Pit Logs**. These should be read in conjunction with the general notes preceding them, which explain the descriptive terms and classification methods used in the report. A summary of the subsurface conditions is presented in Table 2. In general, the subsurface conditions in the Test Pits (TP01 – TP08) can be summarised as follows:

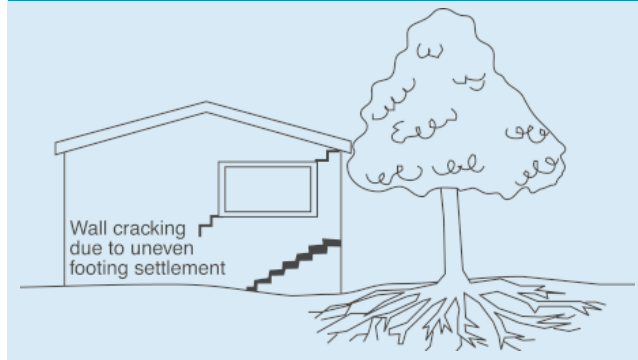
Trees can cause shrinkage and damage

As the weather pattern changes and the soil begins to dry out, the external footings will be first affected, beginning with the locations where the sun's effect is strongest. This has the effect of lowering the external footings. The doming is accentuated and cracking reduces or disappears where it occurred because of dishing, but other cracks open up. The roof lines may become convex.
