Report on
Geotechnical Investigation

Proposed New Building
75-81 Chelmsford Road, Metford

Prepared for
Paynter Dixon Constructions Pty Ltd

Project 102070.02
March 2023

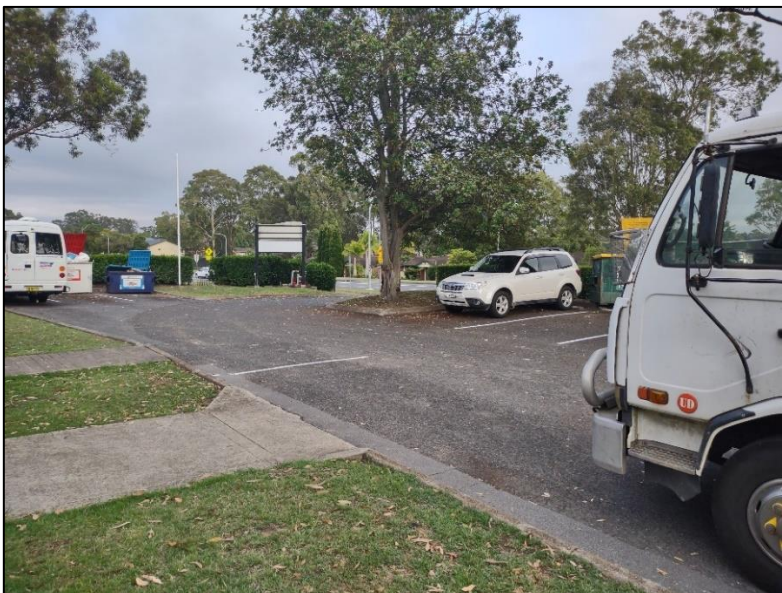
Figure 2: Existing car park on the north side of Block B, looking north-west

The site and relevant buildings are indicated in Figure 1, below. Photographs of the site taken during the field work are shown in Figure 2 to Figure 5.

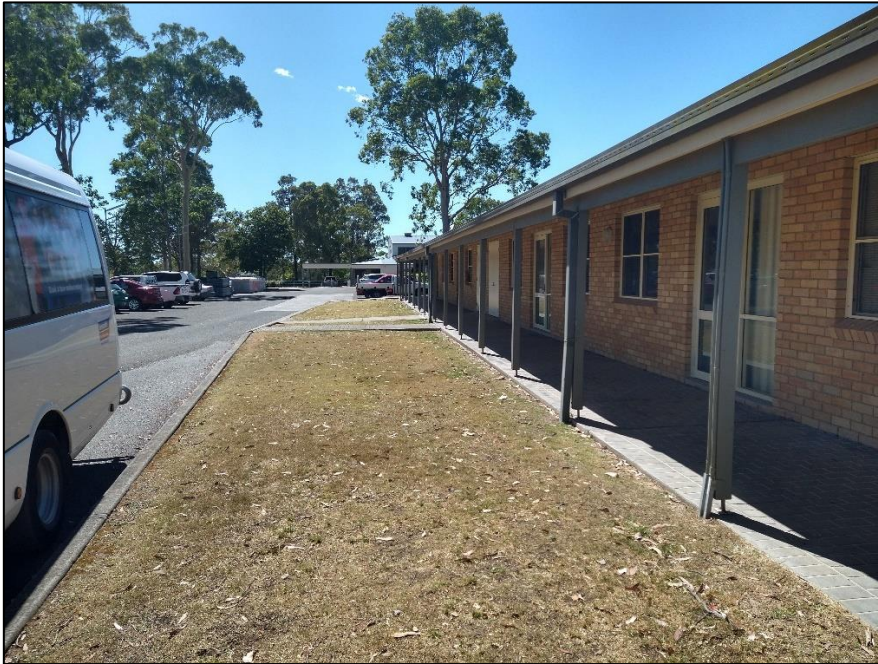
Figure 3: Car park and Block B frontage, looking east. Location of new parking spaces

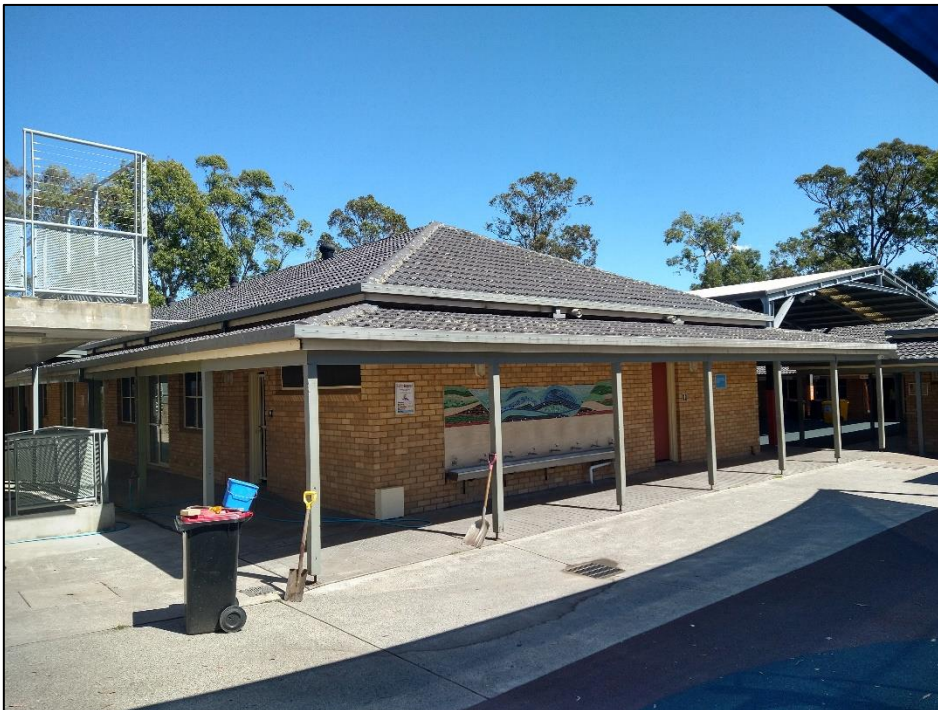
Figure 4: Rear of Block C, looking north-west. COLA beyond.

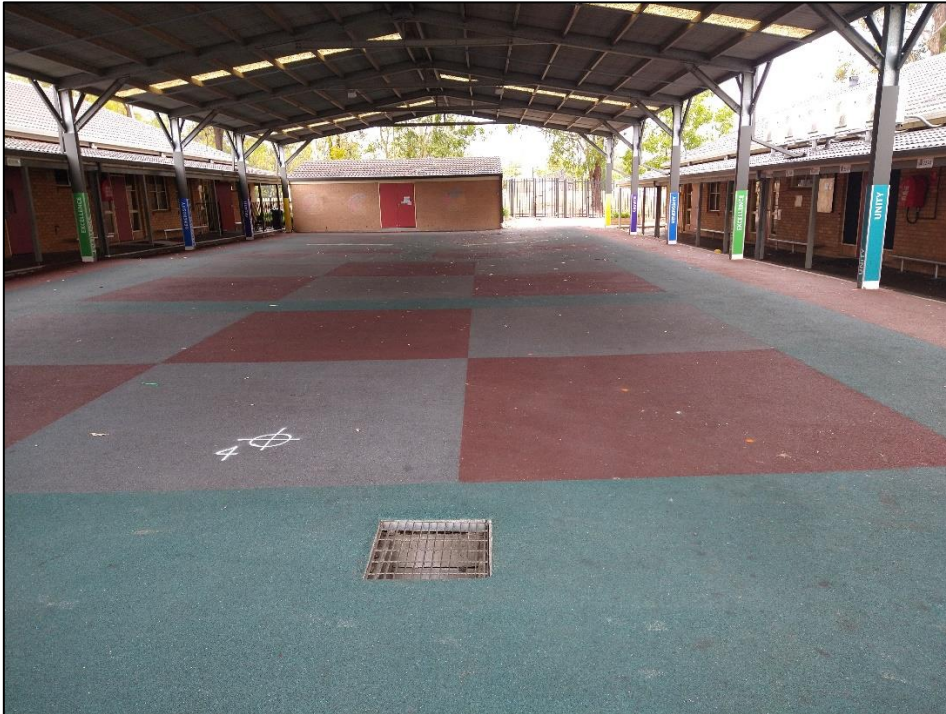
Figure 5: COLA, looking east. Block B visible on the left of the view, and Block C on the right.

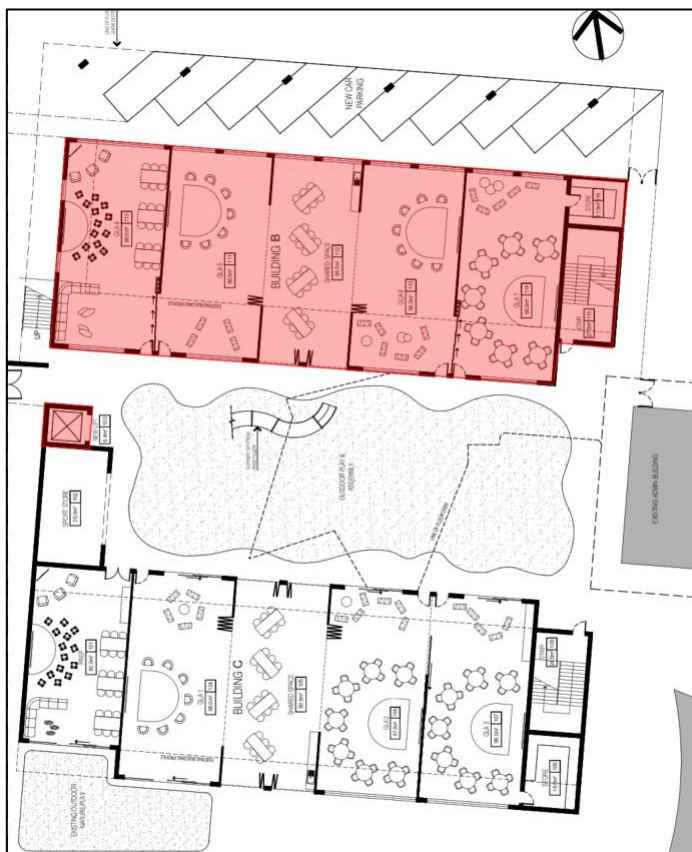
Figure 7: Concept plan provided by Paytner Dixon. First floor, Stage 1 shown by pink shading.

It is understood that Stage 1 of the proposed development will include the demolition of the existing Block B building (indicated in Figure 1) followed by the construction of a two-storey building with a rooftop playground and a lift structure.

The concept plan for the proposed new building is shown in Figure 7 below.

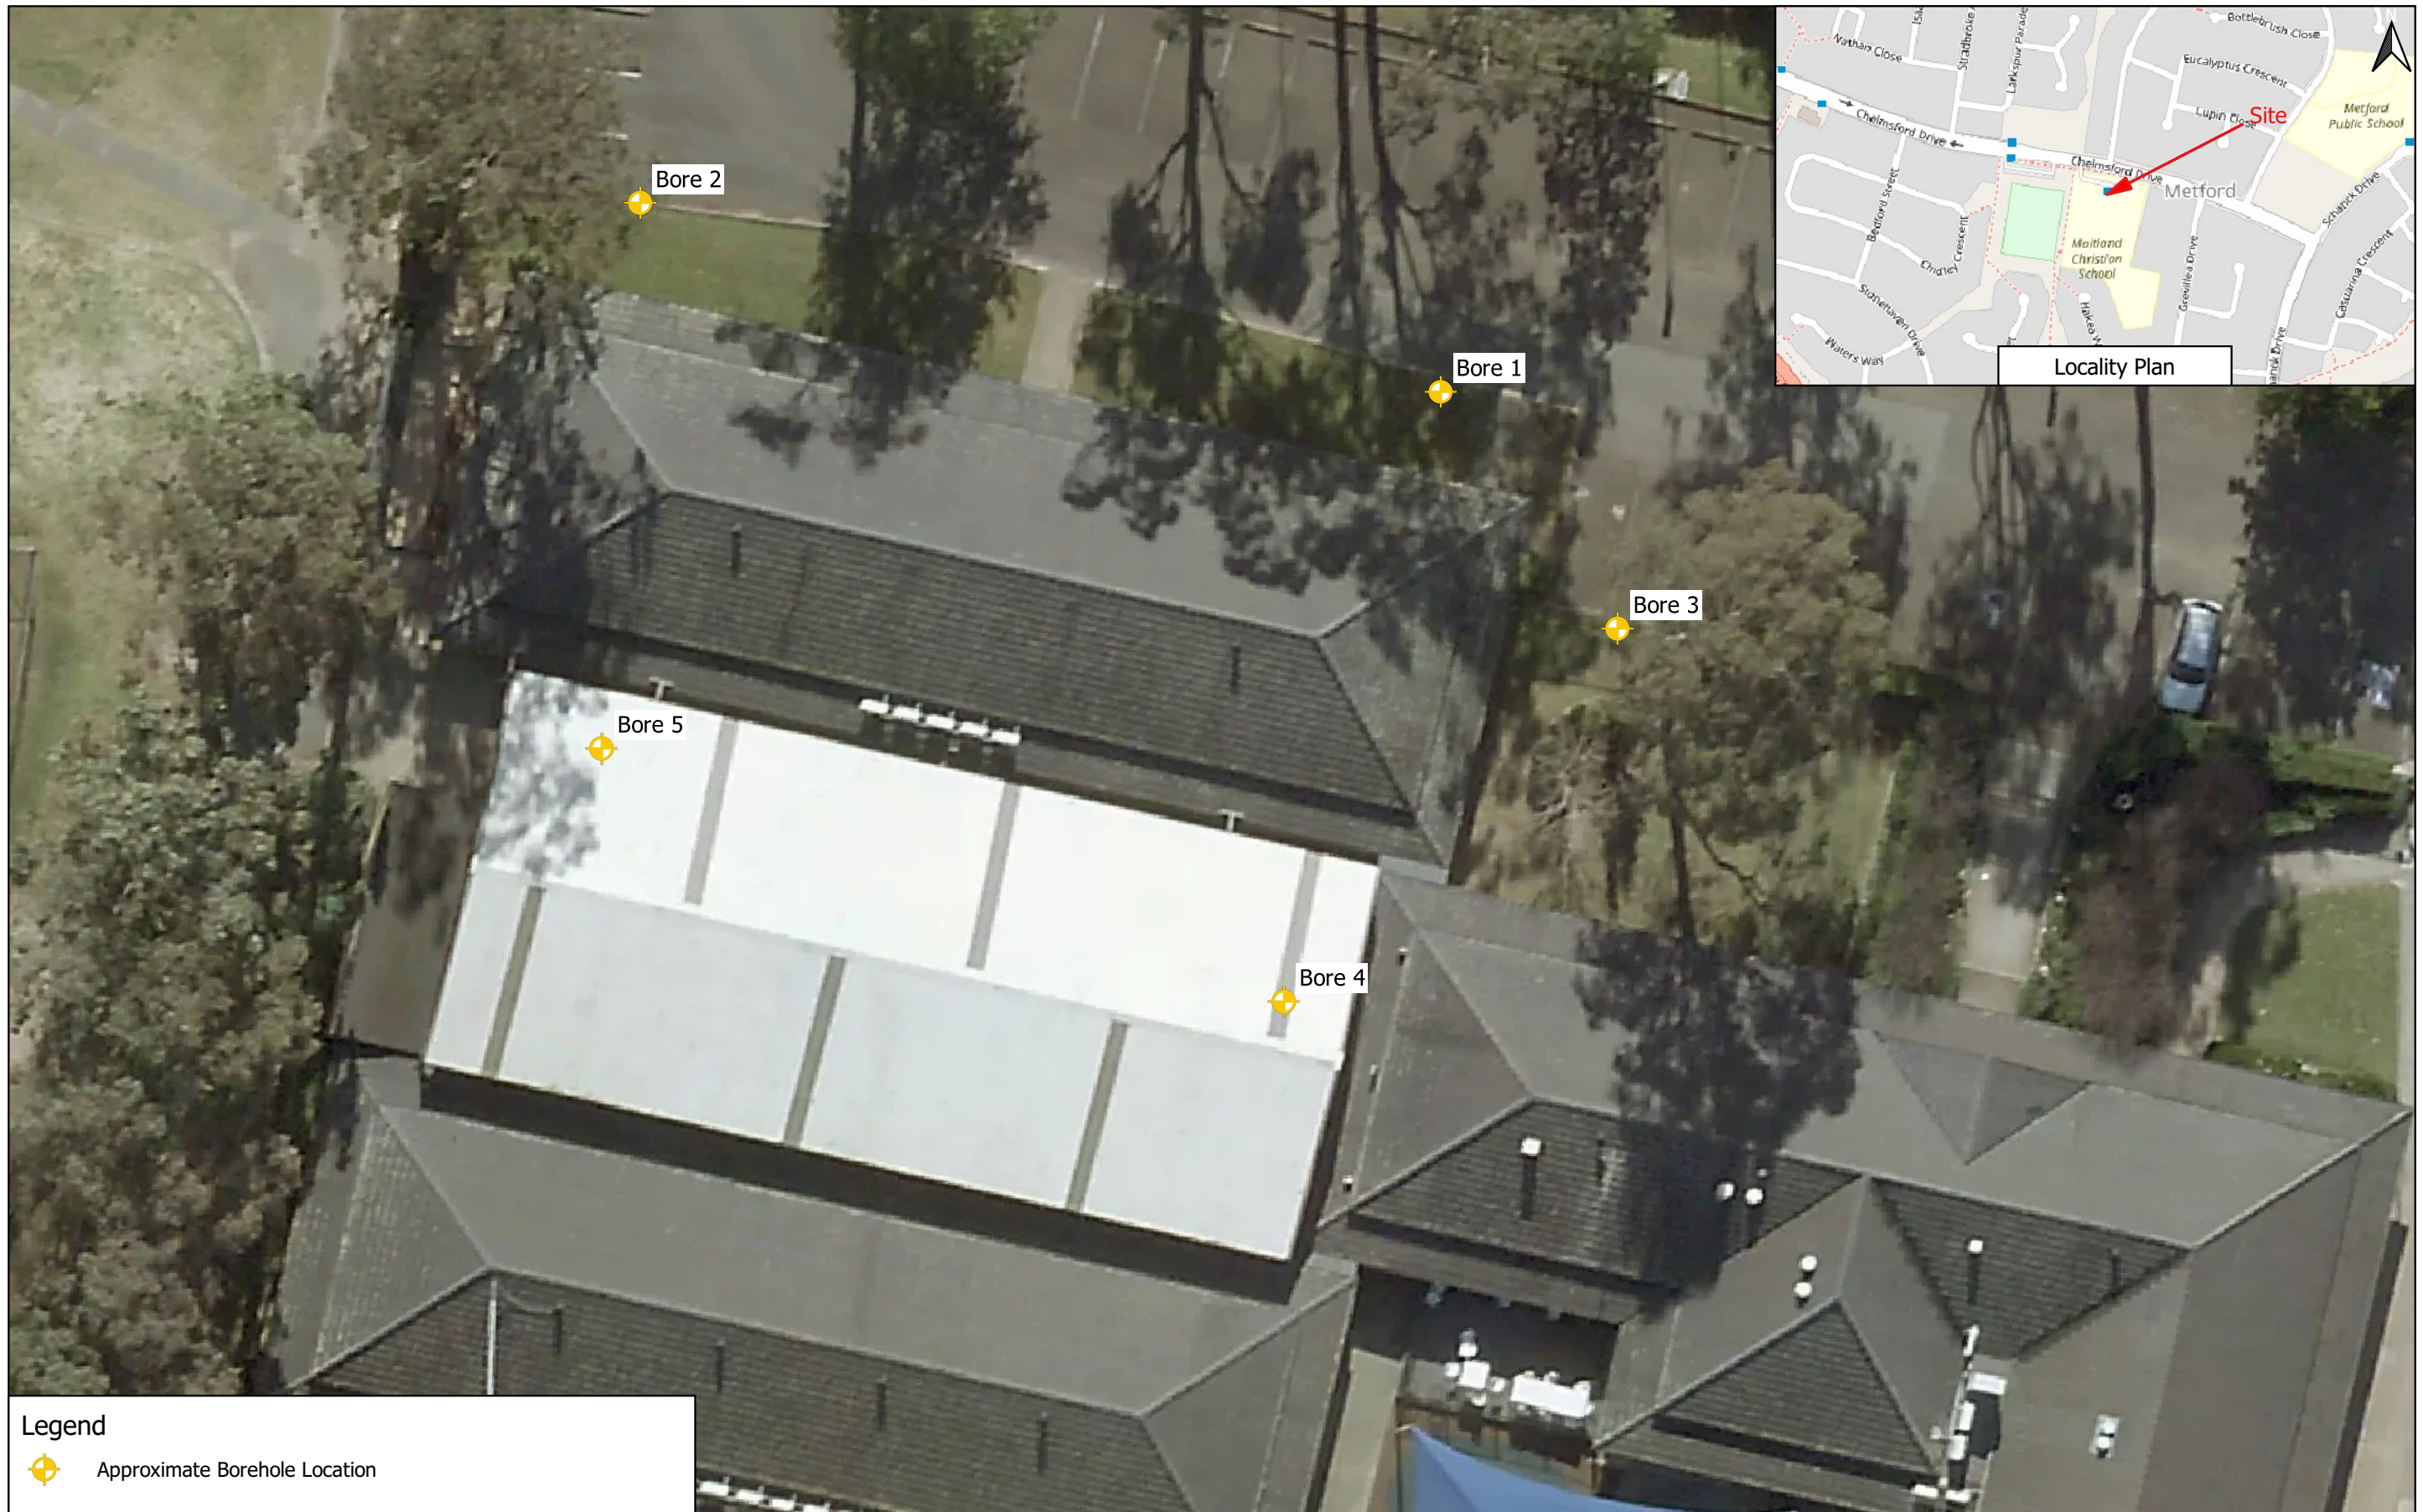
Drawing 1 – Test Location Plan

Legend
 Approximate Borehole Location

The investigation included the drilling of five (5) boreholes and laboratory testing of selected samples. The details of the field work are presented in this report, together with comments and recommendations on the items listed above. Although the investigation was targeted to the Stage 1 works, the investigation included positioning of boreholes to inform the Stage 2 works also.
