SITE CLASSIFICATION

**27-29 STRONACH AVE, EAST
MAITLAND**

Prepared for True Wealth Property
17/11/2022

RE: LIMITED SITE INVESTIGATION AT: Lot 27-29 Stronach Ave, East Maitland

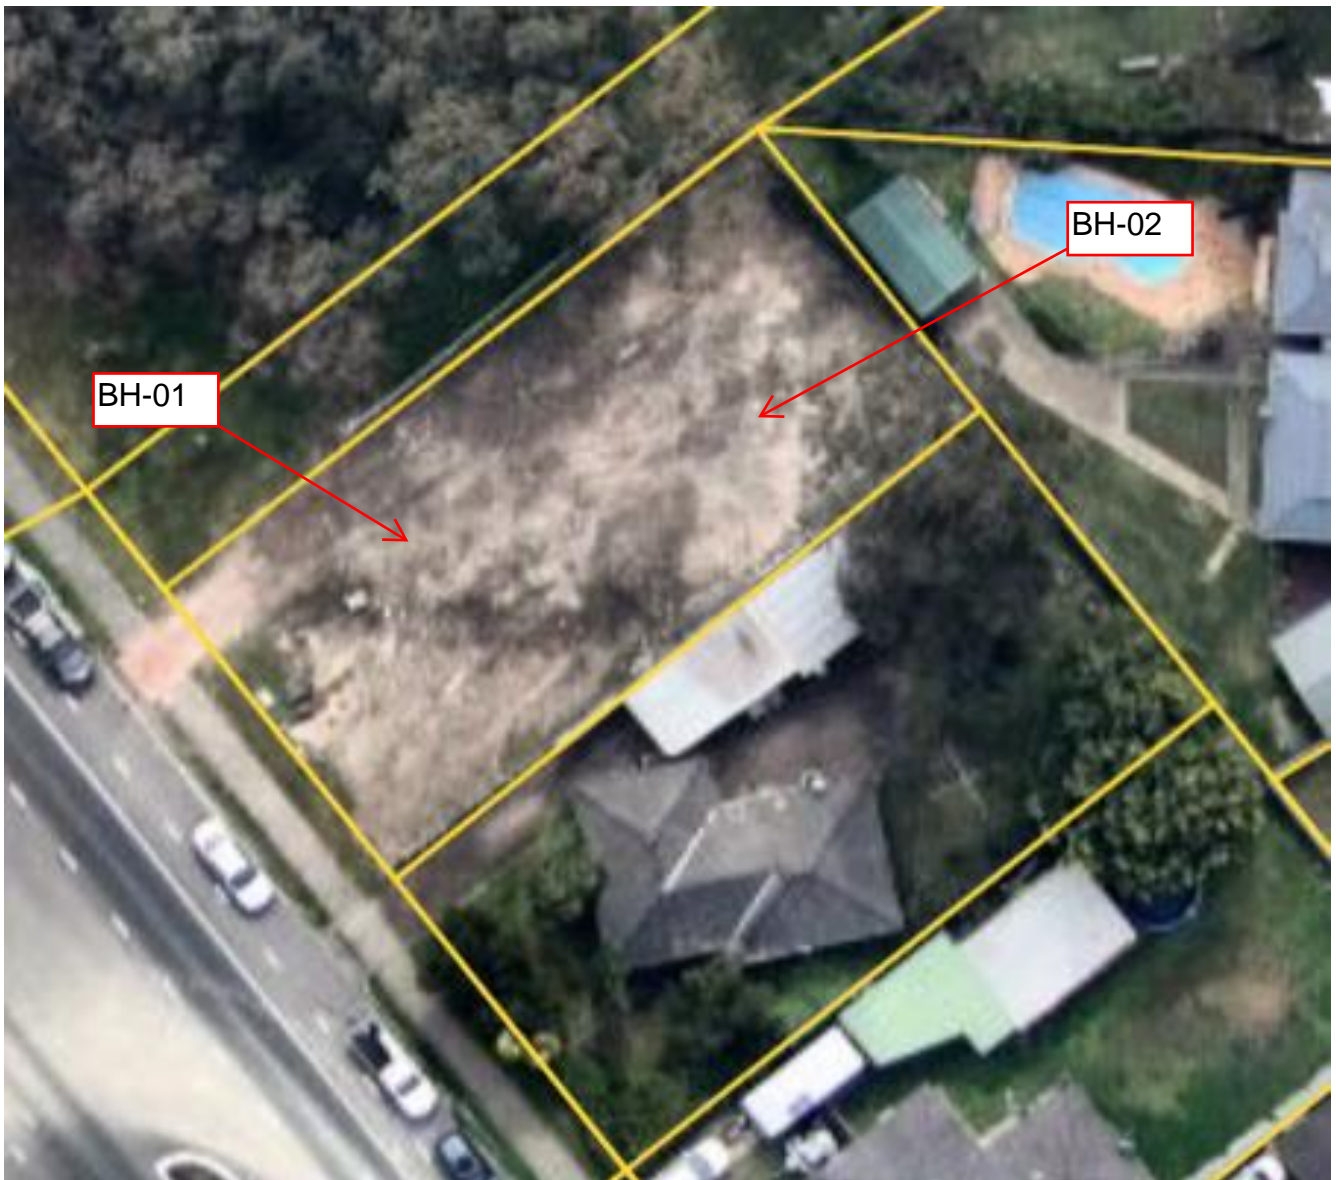
Borehole Locations: 16822/T/23010

Borehole Locations
