Report on
Geotechnical Investigation

Proposed Link Road and Residential Units
Closebourne Heritage Estate

Prepared for
Lend Lease Retirement Living

Project 81251.21
December 2018

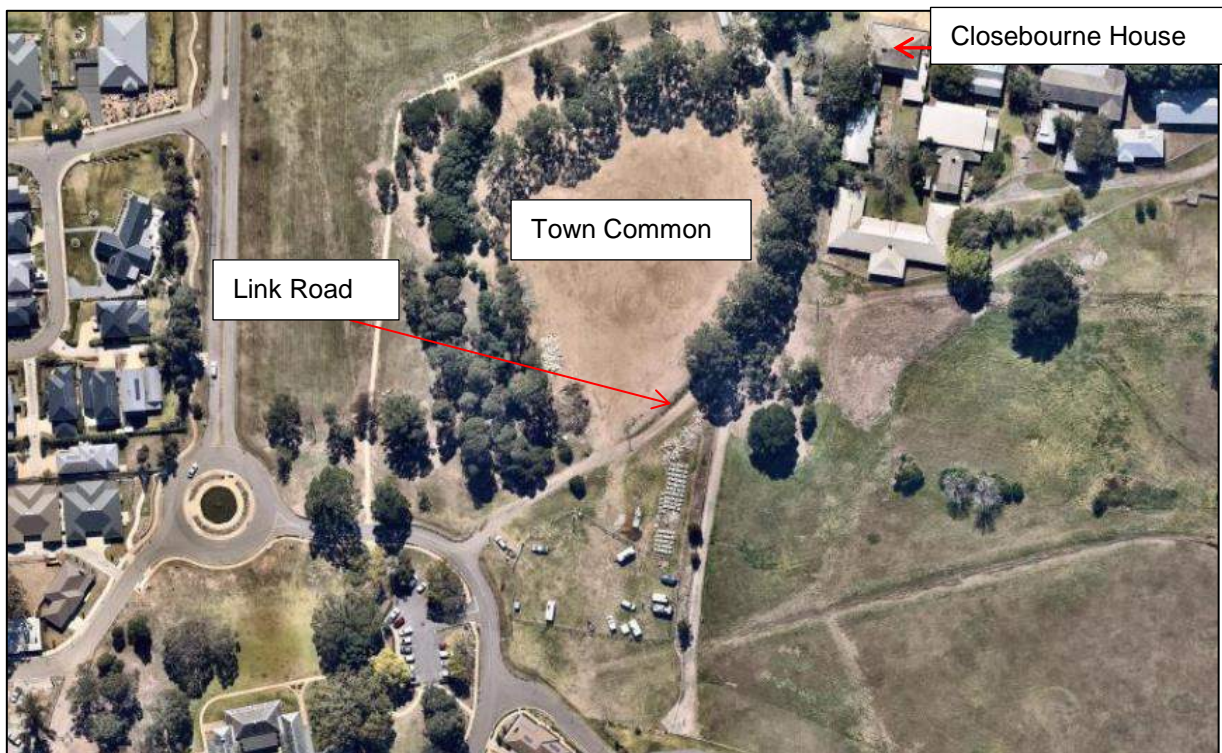
Figure 1: Aerial image of site with the main site features (sourced from NearMaps)

A number of existing buildings are located within the proposed aged care facility footprint to the north of the site (refer buildings around Closebourne House in Figure 1).
