Geotechnical Investigation

Lot 19 No.91 Gardiner Street

Rutherford

Report Ref: C1105-R-001-Rev0

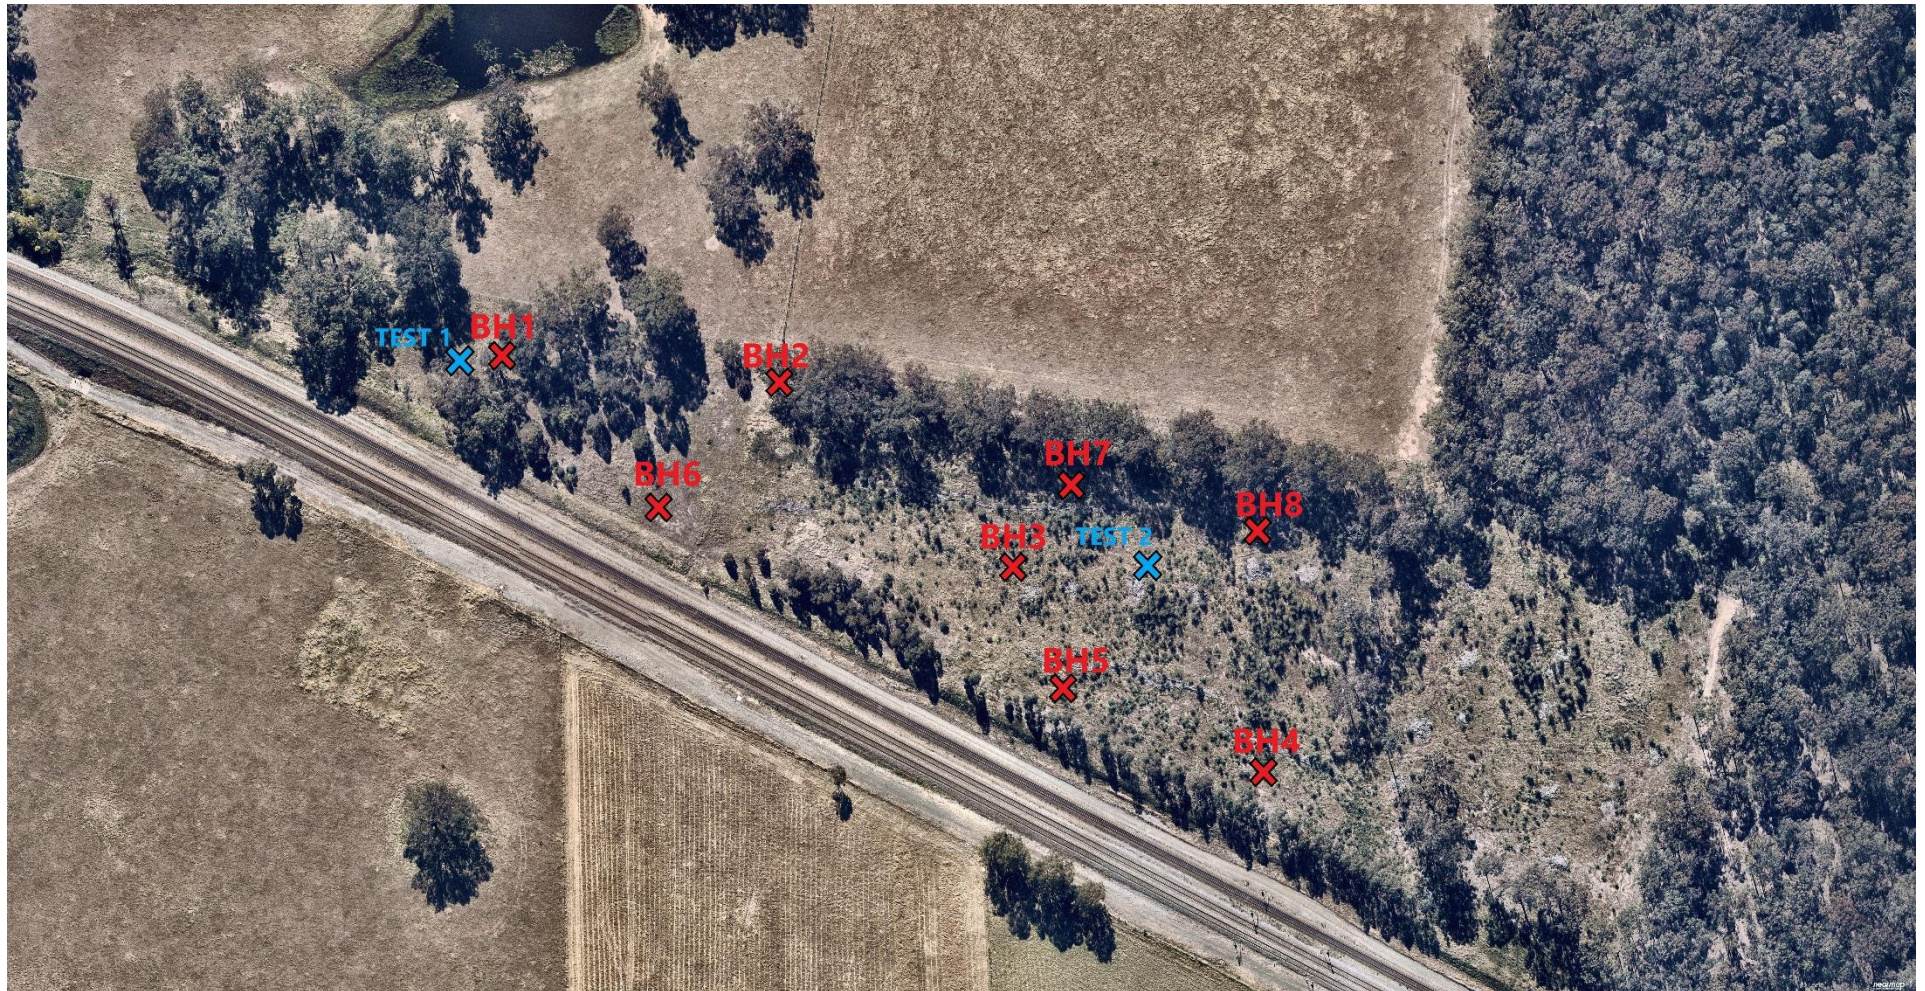
Figure 1 – Plan of the development at Lot 19 No.91 Gardiner Street, Rutherford showing the approximate location of the Geotechnical boreholes.

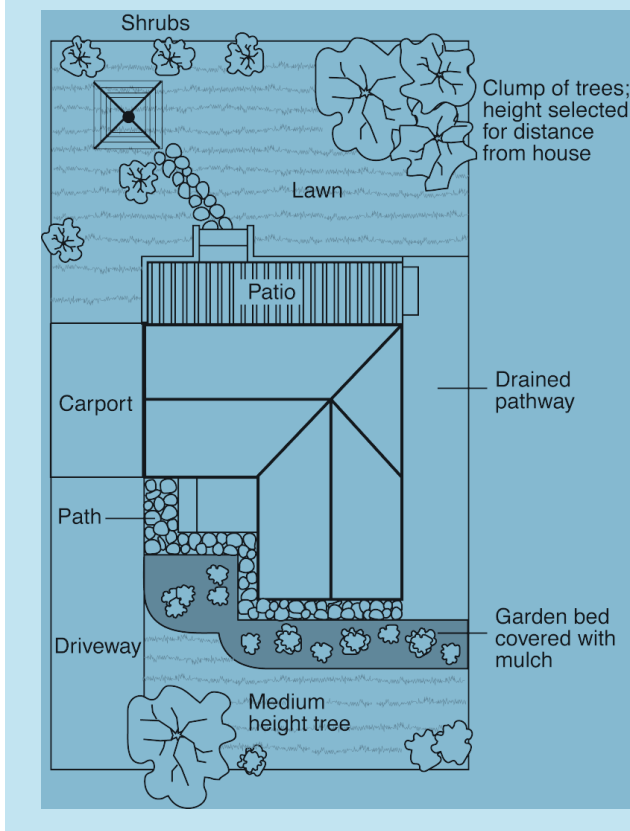
Gardens for a reactive site

extend outwards a minimum of 900 mm (more in highly reactive soil) and should have a minimum fall away from the building of 1:60. The finished paving should be no less than 100 mm below brick vent bases.
