Proposed Carpark -
Geotechnical Assessment

Woodberry Learning
Centre, Woodberry Road,
Woodberry

NEW21P-0138-AA.rev1
1 July 2022

**RE: PROPOSED WOODBERRY LEARNING CENTRE CARPARK
WOODBERRY ROAD, WOODBERRY
GEOTECHNICAL ASSESSMENT**

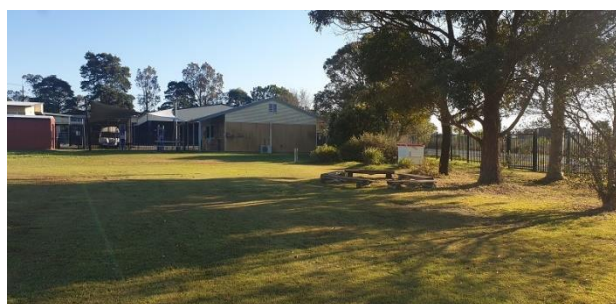
Photograph 1: From near southern end of proposed car park area, near BH3, facing north.

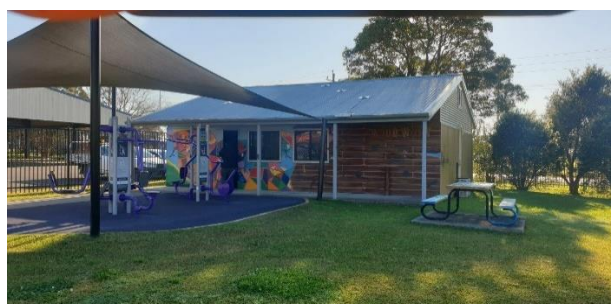
Photograph 2: From west of northern end of proposed car park area, facing northeast. Existing “D Block” visible.

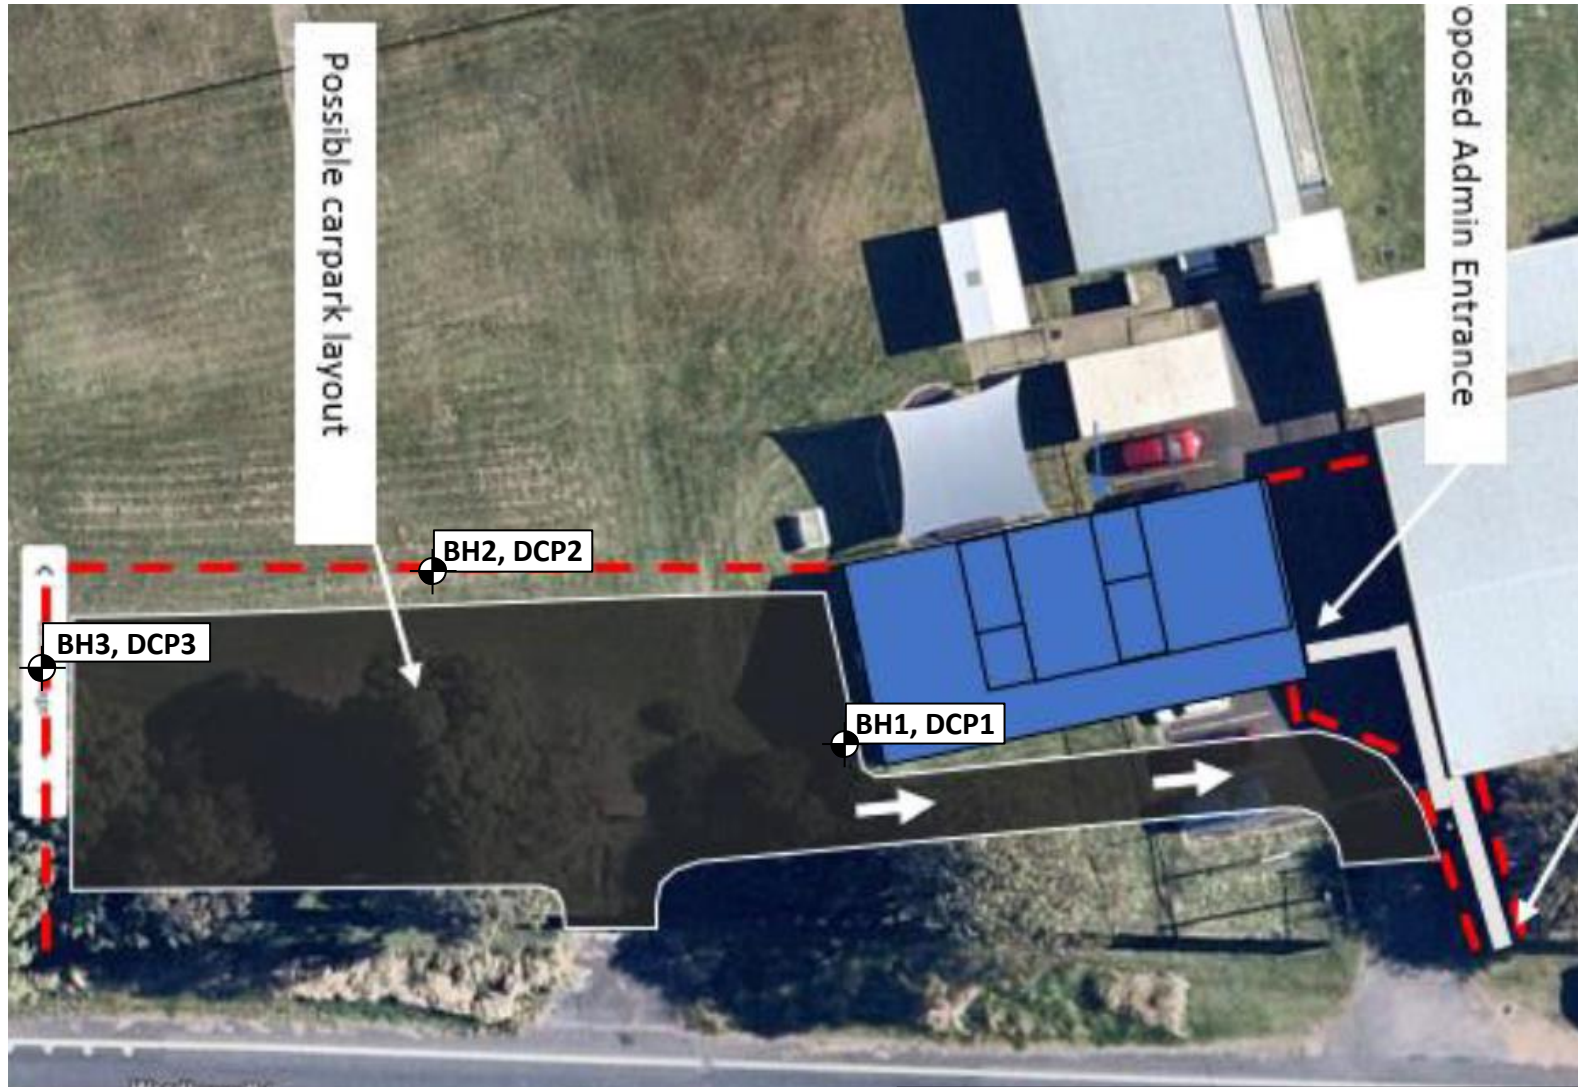
FIGURE AA1:

Site Plan and Approximate Test Locations

Based on site plan provided in School Infrastructure NSW request for tender (RFT No. SINSW-21-10605, dated July 2021)

The proposed development area at the Woodberry Learning Centre, as shown on Figure AA1, is preliminarily classified in its current condition in accordance with AS2870-2011 ‘Residential Slabs and Footings’, as shown in Table 5.
