# Geotechnical Investigation Report

Proposed Development at:

262 Aberglasslyn Road

G22572-1

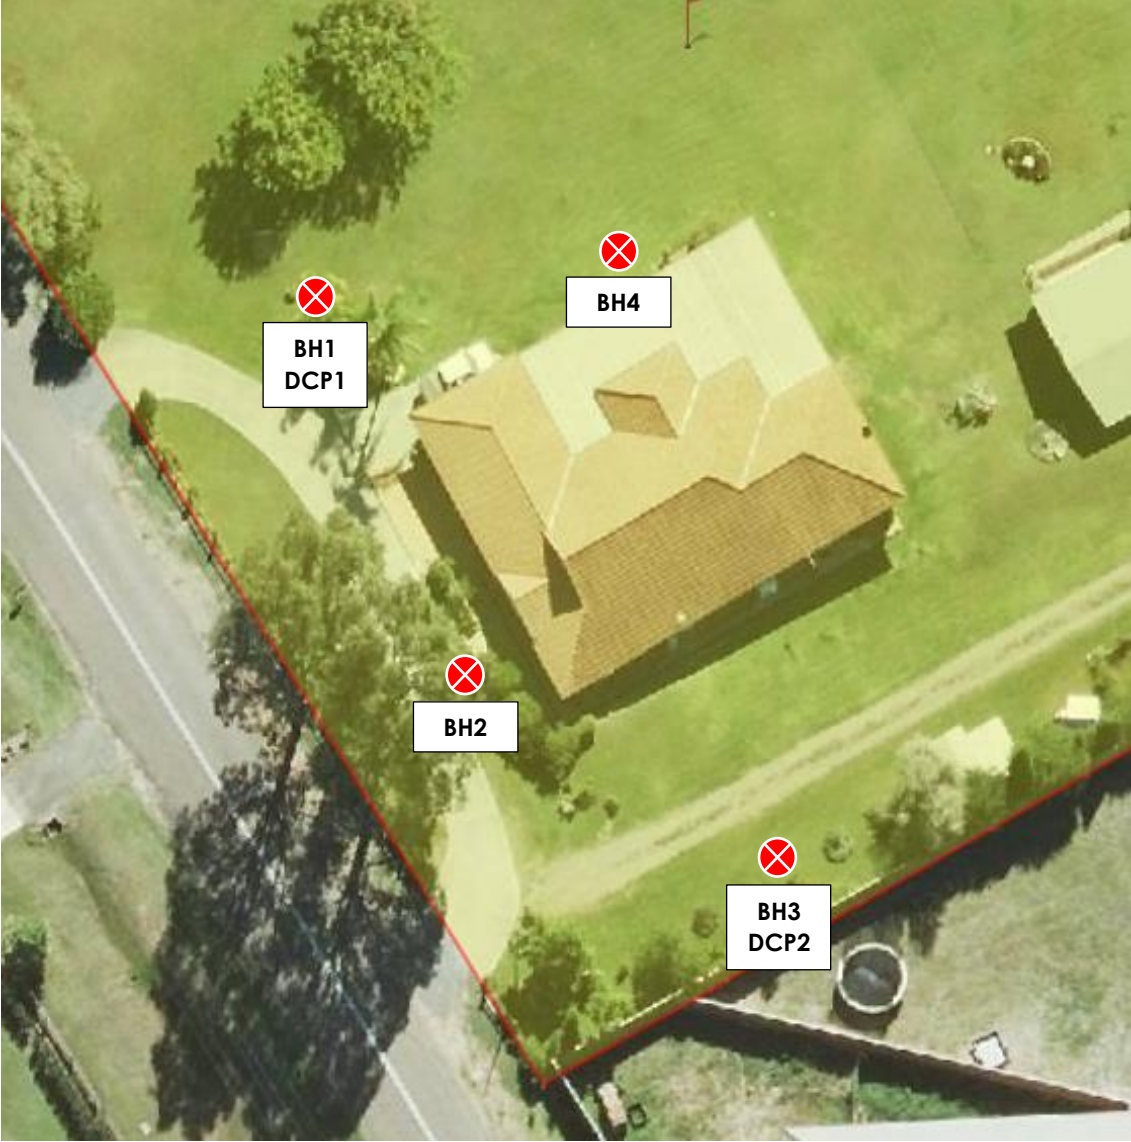
Figure 2  
Site Plan

Approximate Borehole/DCP Testing Location

- The approximate locations of the boreholes and DCP tests are shown on **Figure 2, Appendix B** of this report.
- Collection of soil and rock samples during drilling for the following laboratory testing required:
