Proposed Subdivision –  
Stage 3.1  
Site Classification

Sunset Drive, Thornton

NEW19P-0018H-AA  
3 August 2021

**RE: PROPOSED SUBDIVISION – STAGE 3.1  
SUNSET DRIVE, THORNTON, NSW  
SITE CLASSIFICATION**

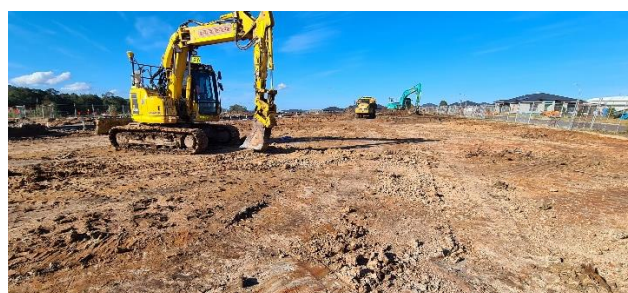
**Photograph 4:** Facing near western boundary of Lot 512, facing southeast. Showing 13 tonne excavator at TP505 location.

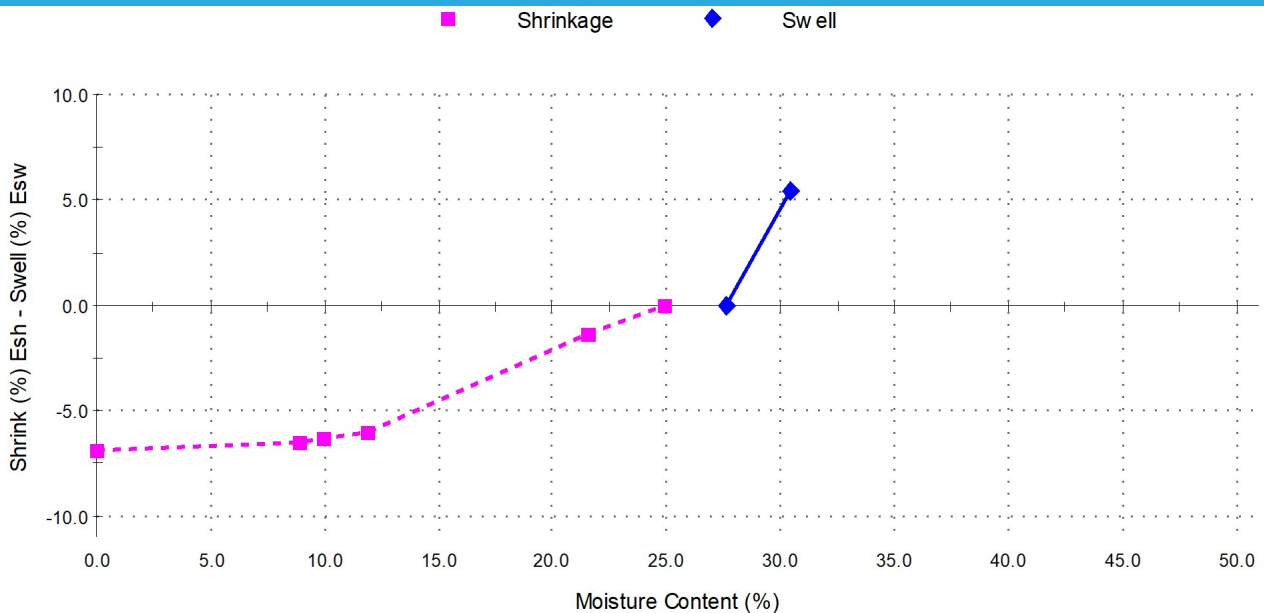
## Shrink Swell

Swell Test AS 1289.7.1.1		Shrink Test AS 1289.7.1.1	
<b>Swell on Saturation (%):</b>	5.4	<b>Shrink on drying (%):</b>	6.9
<b>Moisture Content before (%):</b>	27.6	<b>Shrinkage Moisture Content (%):</b>	24.9
<b>Moisture Content after (%):</b>	30.4	<b>Est. inert material (%):</b>	1%
<b>Est. Unc. Comp. Strength before (kPa):</b>	250	<b>Crumbling during shrinkage:</b>	Nil
<b>Est. Unc. Comp. Strength after (kPa):</b>	150	<b>Cracking during shrinkage:</b>	Nil

**Shrink Swell Index - Iss (%): 5.3**
