**Site Classification and  
Fill Assessment Report**  
Stage 4A, Sophia Waters,  
Chisholm NSW

Prepared for: Allam Development No1 Pty Ltd  
EP3162.003 8 December 2024

Stage 4A, Sophia Waters, Chisholm NSW

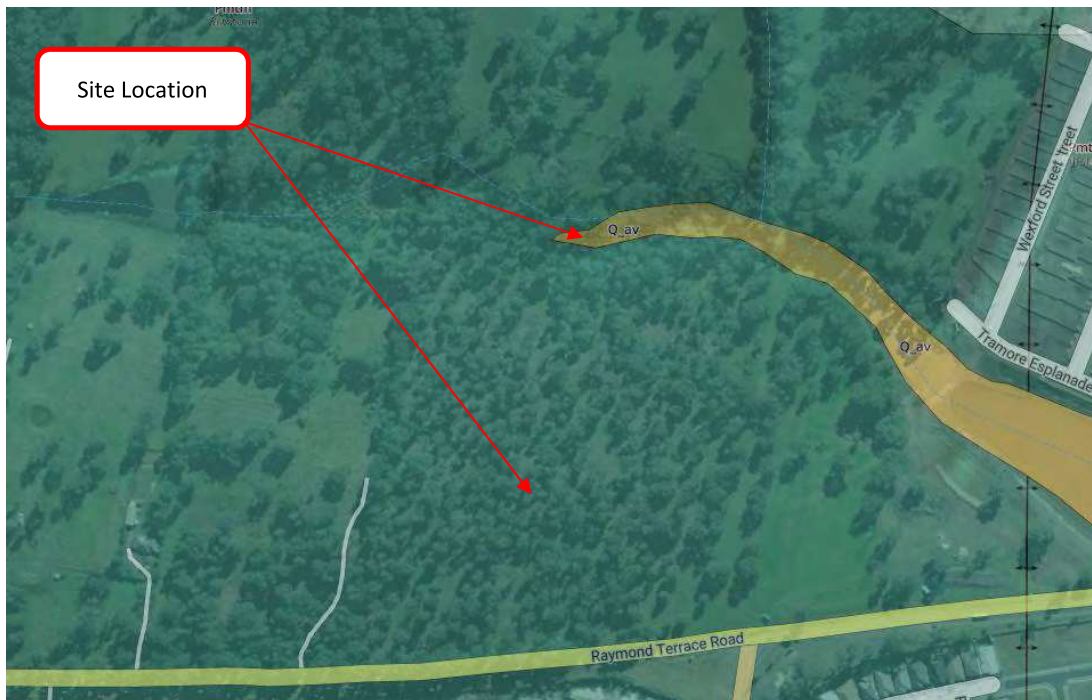
**Figure 1. Geological Map Excerpt (Pmtm-Mulbring Siltstone-green, Qav-alluvial clastic sediments-yellow)**

Based on the geological data sourced from the NSW Department of Industry, Resources and Energy ([www.minview.geoscience.nsw.gov.au](http://www.minview.geoscience.nsw.gov.au)) the Site is underlain by two main geological units. Most of the Site is underlain by Guadalupian aged Mulbring siltstone (**Pmtm**), with a dominant siltstone lithology consisting of medium to dark grey siltstone, minor claystone, sporadic thin cherty beds, rare thin sandstone and limestone beds and sporadic marine fossils. A small northern portion of the Site is underlain by quaternary aged alluvial valley deposits (**Q\_av**) with the dominant lithology being clastic sediment described as silt, clay (fluvially deposited), lithic to quartz lithic sand and gravel. An excerpt of the geological map with the geological units is shown in **Figure 1**.
