Clearance Certification following the removal of Non-Friable Asbestos Containing Building Material:

The Site at 175 Wollombi Road Farley NSW 2320

Asbestos Clearance Inspection

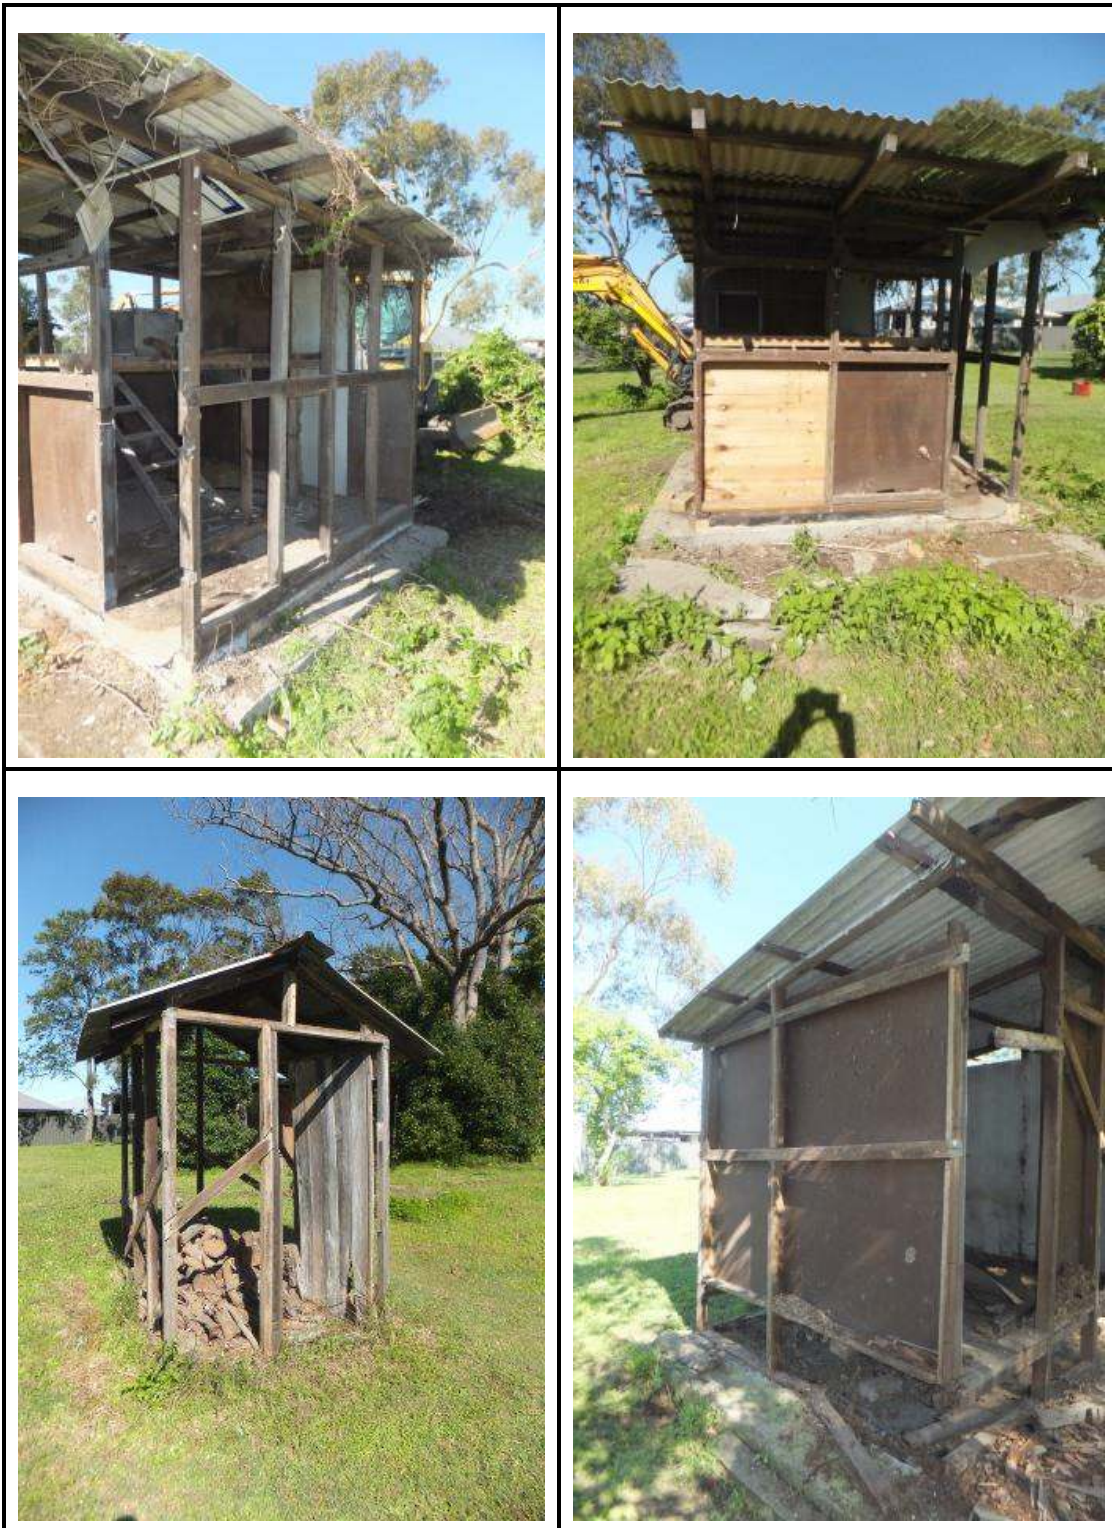
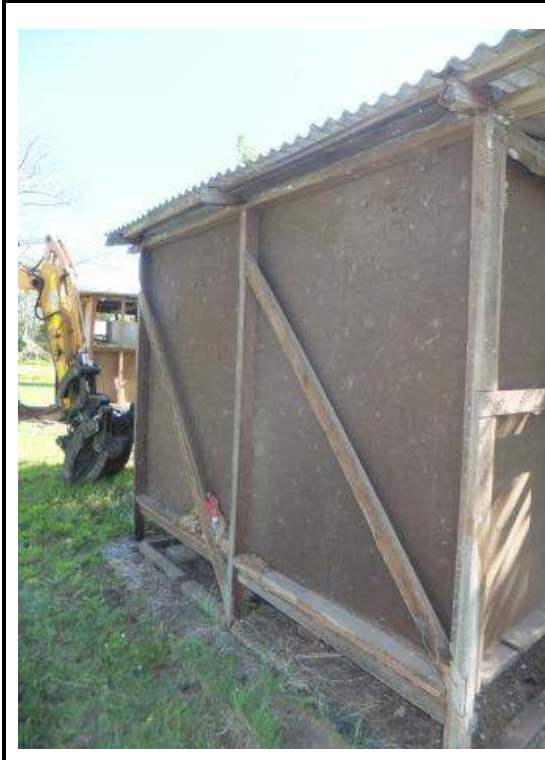
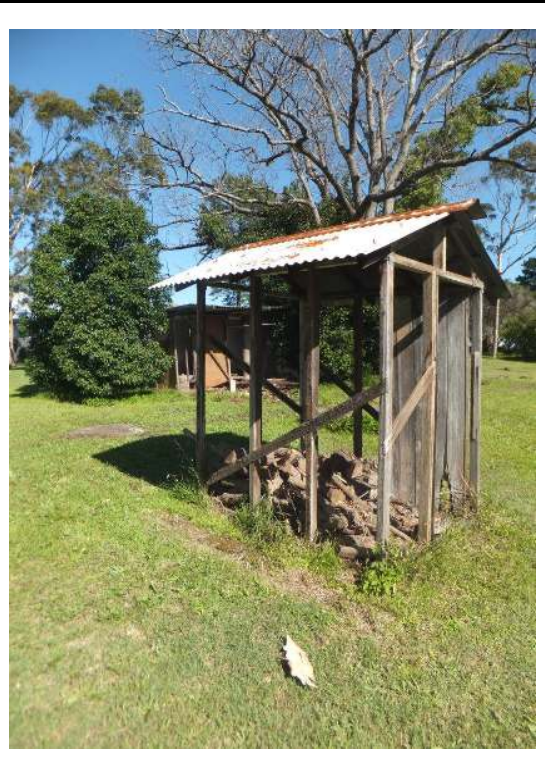
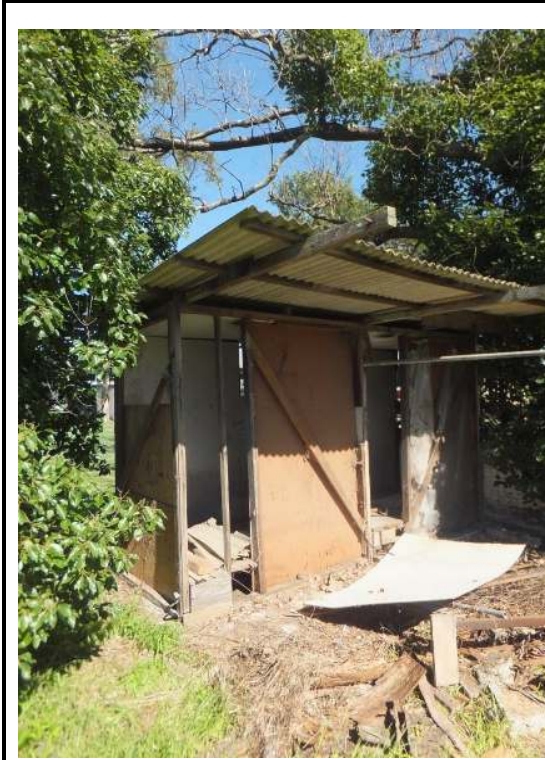
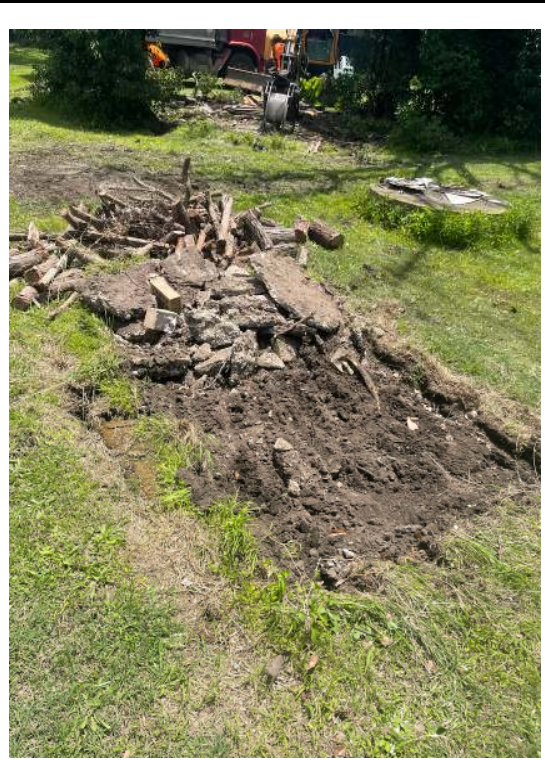
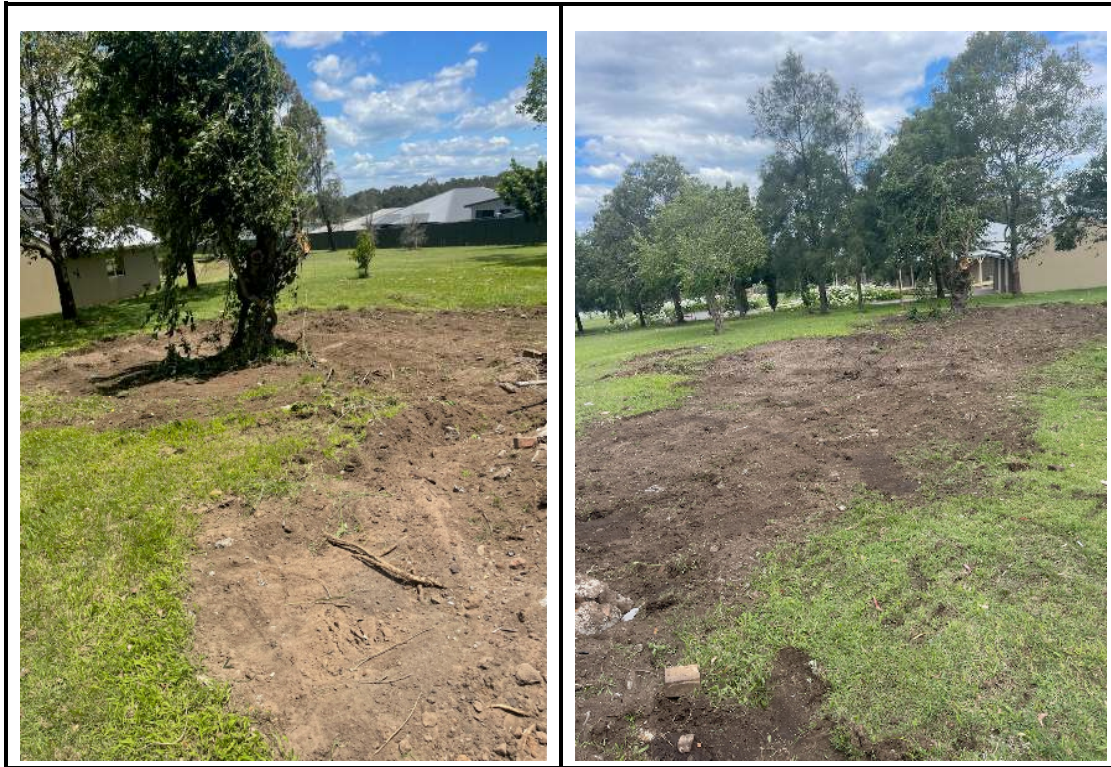
Post-Removal Photos:

Removal Work Details.			
Date removal work was carried out	10 th December 2021		
Site address where removal work being undertaken:	175 Wollombi Road Farley NSW 2320		
Details of specific asbestos removal work area(s):	Exterior wall cladding and roofing from wood and chicken sheds.		
Name of Licensed Asbestos Removalist:	All Good Demolition and Asbestos Removal		
Name of Licensed Asbestos Removalist Supervisor:	Scott Whatley		
Inspection Details.			
Date of clearance inspection	Friday 10 th December 2021		
Time of clearance inspection	approximately 2:30 pm		
Asbestos Removal Work Area		YES	NO
Inspection of the specific area(s) detailed above found no remaining asbestos material from this removal		x	
Can this area(s) be reoccupied:		x	
Has any additional information been attached (e.g, photos, plans etc):		x	
Limitations: Detail of any trapped or inaccessible ACM unable to be removed at this time:			
Site specific comments:		Asbestos Containing Materials, concealed in/under adjacent areas, or that are buried at this time and may be exposed in future works do not form part of this clearance.

Clearance Declaration		YES	NO
The removal area and surrounds are free from any visible ACM associated with this removal work:		x	
The transit and waste routes are free from any visible ACM:		x	
All asbestos in the scope of this removal works has been removed:		x	
Asbestos Removal Documentation		YES	NO
Do you have a copy, have you sighted/discussed the ARCP:			x
Do you have a copy of the notification form:			x
