Preliminary Site Investigation

Maitland Gaol Redevelopment

Prepared for Maitland City Council

E221249 RP1

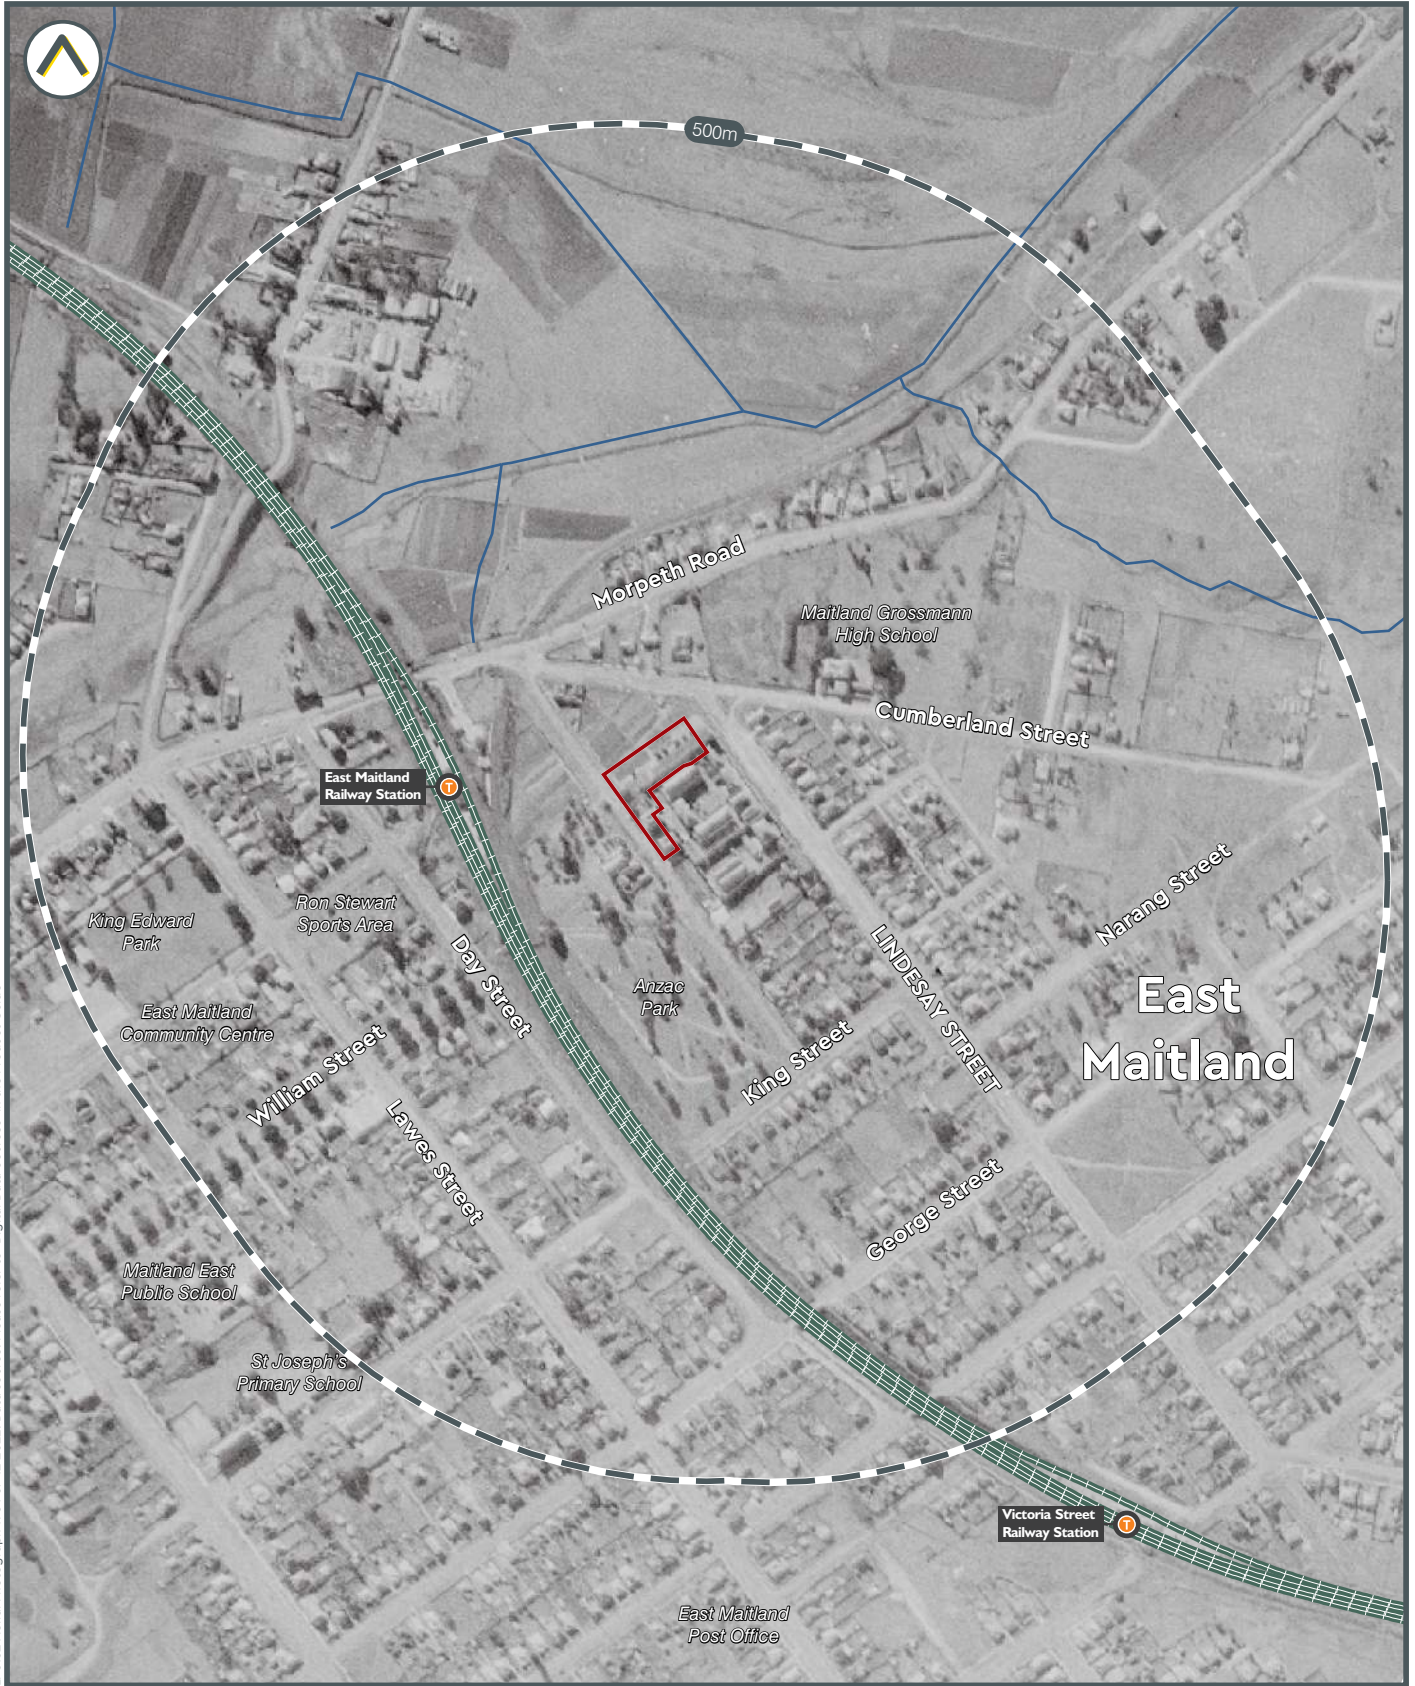
Historic Aerial Photograph - 1954

| Year/Image quality | Site | Surrounding area |
|---|--|--|
| 1954 Black and white | The Building 2 and Building 3 are both visible. Building 14 and Building 22 are not present. The north-west border section of the Site appears to be used for agricultural activities. | The area surrounding the Site is generally consistent with present day conditions (predominantly low density residential with agricultural land use north of the Site) with key differences being: <ul style="list-style-type: none"> • Building 18 – 5 Wing Maximum Security and Building 36 – Visits Processing Centre within the south-east portion of the Gaol are not visible; • agricultural land use is present to the immediate north-west of the Site; • the Pender and Foster Sawmill located approximately 400 m north-west of the Site appears to be operational; • current industrial land use west of the Main Northern Railway is not present; • the Maitland Grossman Highschool is much smaller than its present size; and • areas currently occupied by low density residential properties east of the Site appear to be used for agricultural activities. |

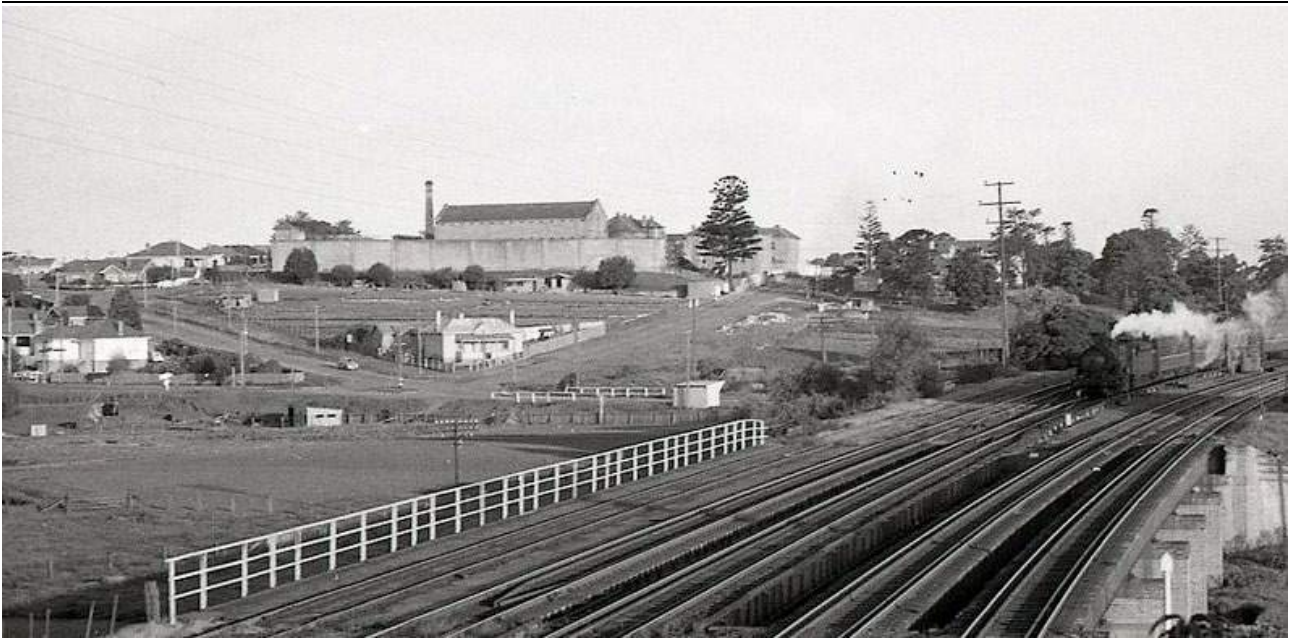
Photo 1

Photograph 1 shows the Site viewed from the west. Building 14 and Building 22 are not present however several smaller buildings are present within the north-west portion of the Site.

View from west of Maitland Gaol looking east. Photo taken from near current Pitnacree Road overpass of Main Northern Railway

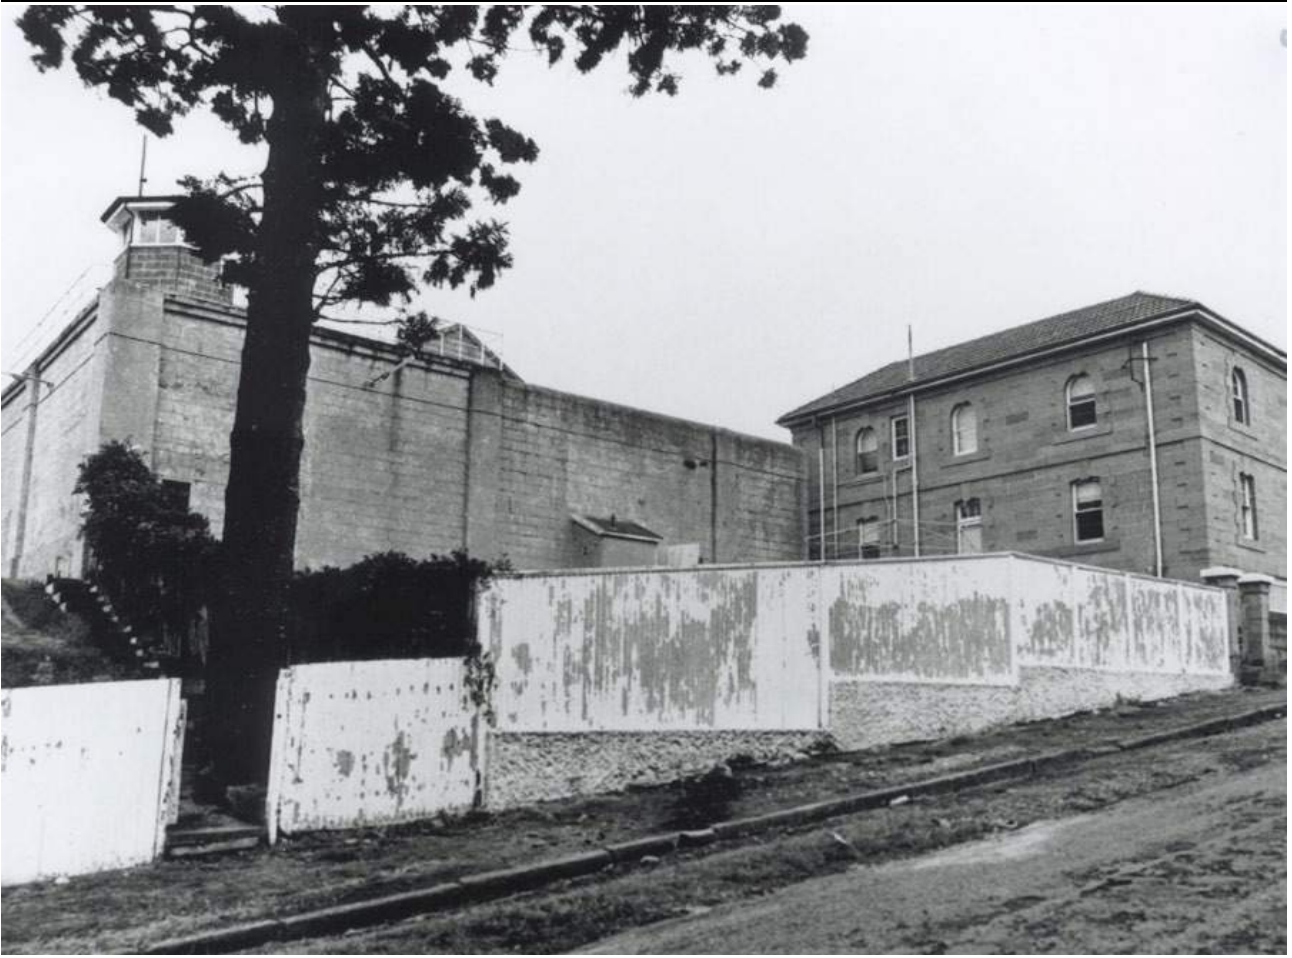
Photo 3

Photograph 3 has been taken from near the western boundary of the Site, looking east towards the present location of Building 22. Building 14 and Building 22 are not present in the photograph however Building 2 is visible.

View of Maitland Gaol from southwest boundary of the Site looking east. Building 2 is visible in the photograph. Building 14 and Building 22 are not extant in the photograph.

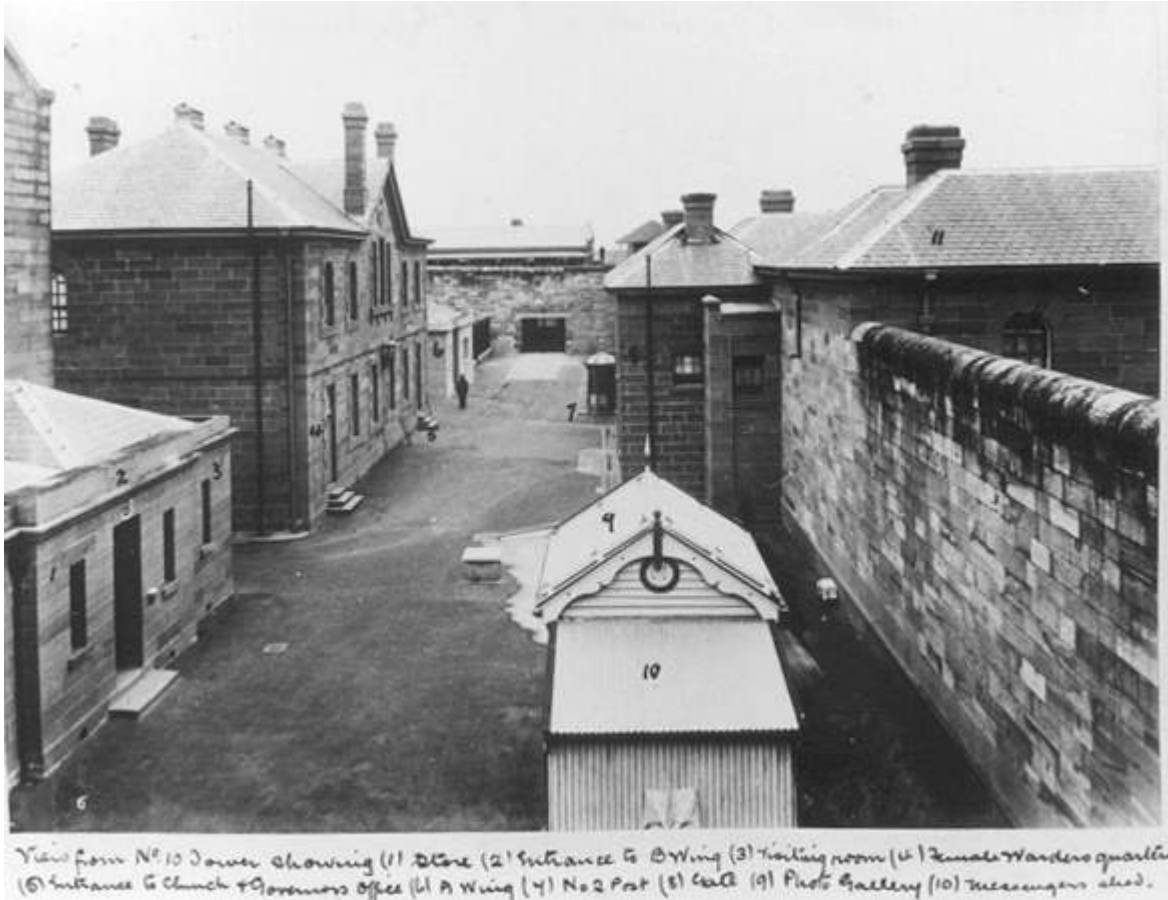
Photo 4

Photograph 4 shows the Gaol from the watchtower located within the central area of the Site, looking south-east. A building, labelled as being the Photo Gallery/Messenger's Shed, is present within the brick courtyard area within the central portion of the Site. Building 2 is also visible in the photograph.

Photo taken from watchtower located on the southern corner of Building 14 looking south-east. Inscription reads "View from No. 10 Tower showing (1) Store (2) Entrance to B Wing (3) Visiting Room (4) Female Wardens Quarters (5) Entrance to Church and Governor's Office (6) A Wing (7) No. 2 Post (8) Gate (9) Photo Gallery (10) Messengers Shed".

Building 2 is visible in the right of the photograph (marked as "11"). The Photo Gallery/Messengers Shed (marked as "9" and "10") is located within the Site however has since been demolished.

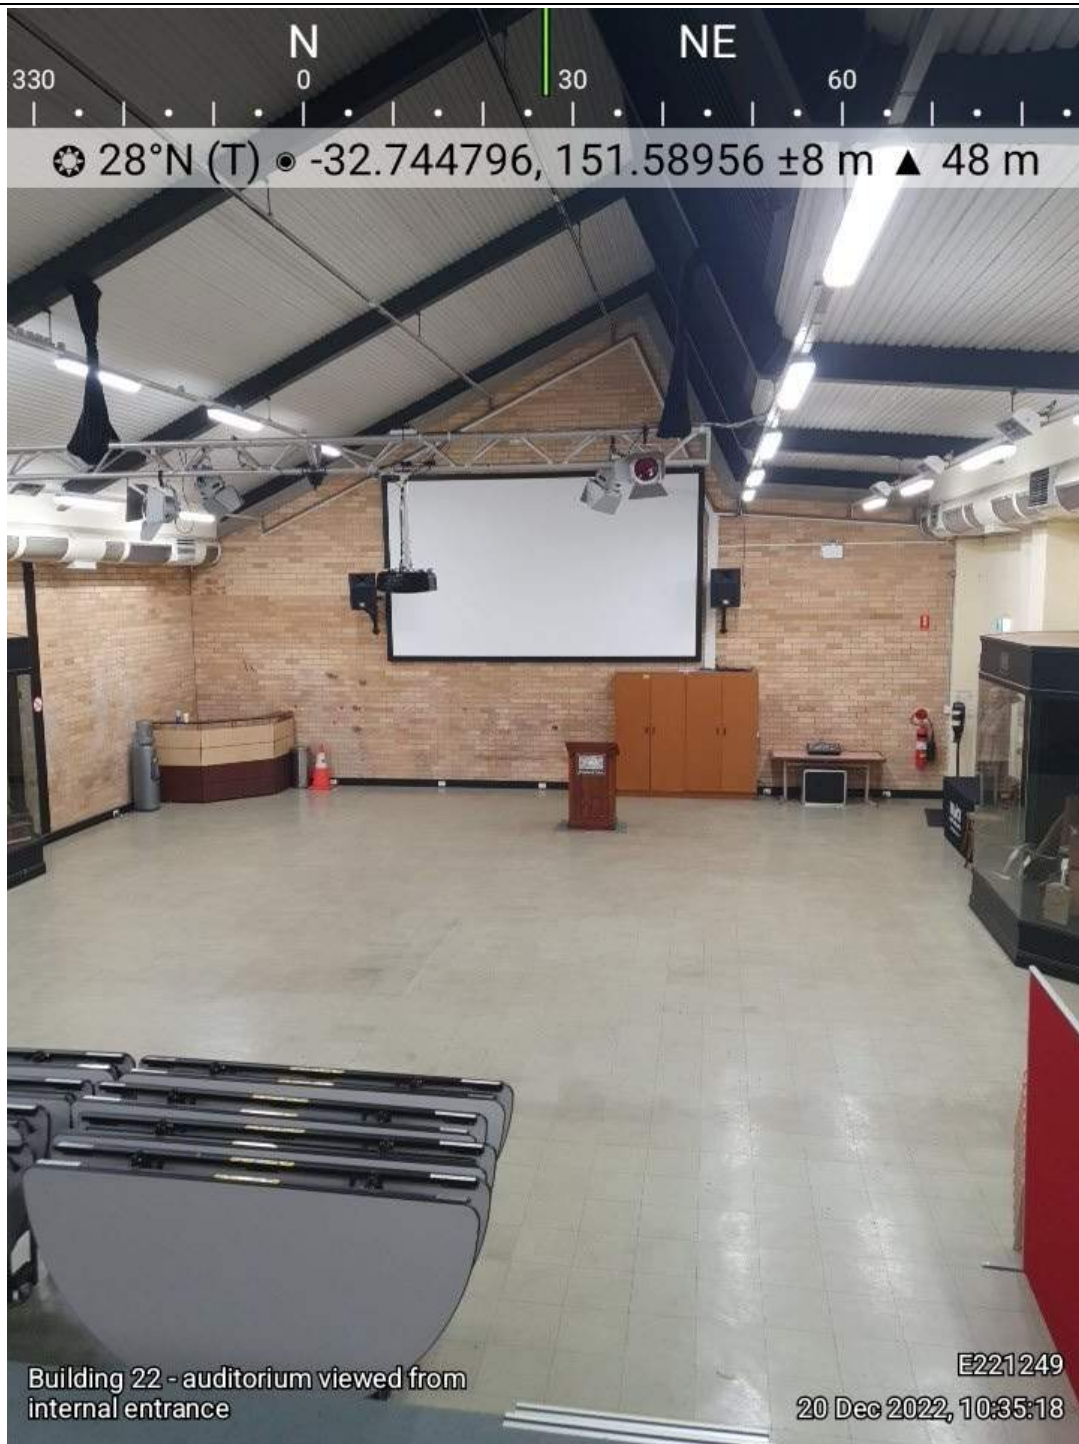
Photo 8

Auditorium viewed from internal entrance

Location: Building 14

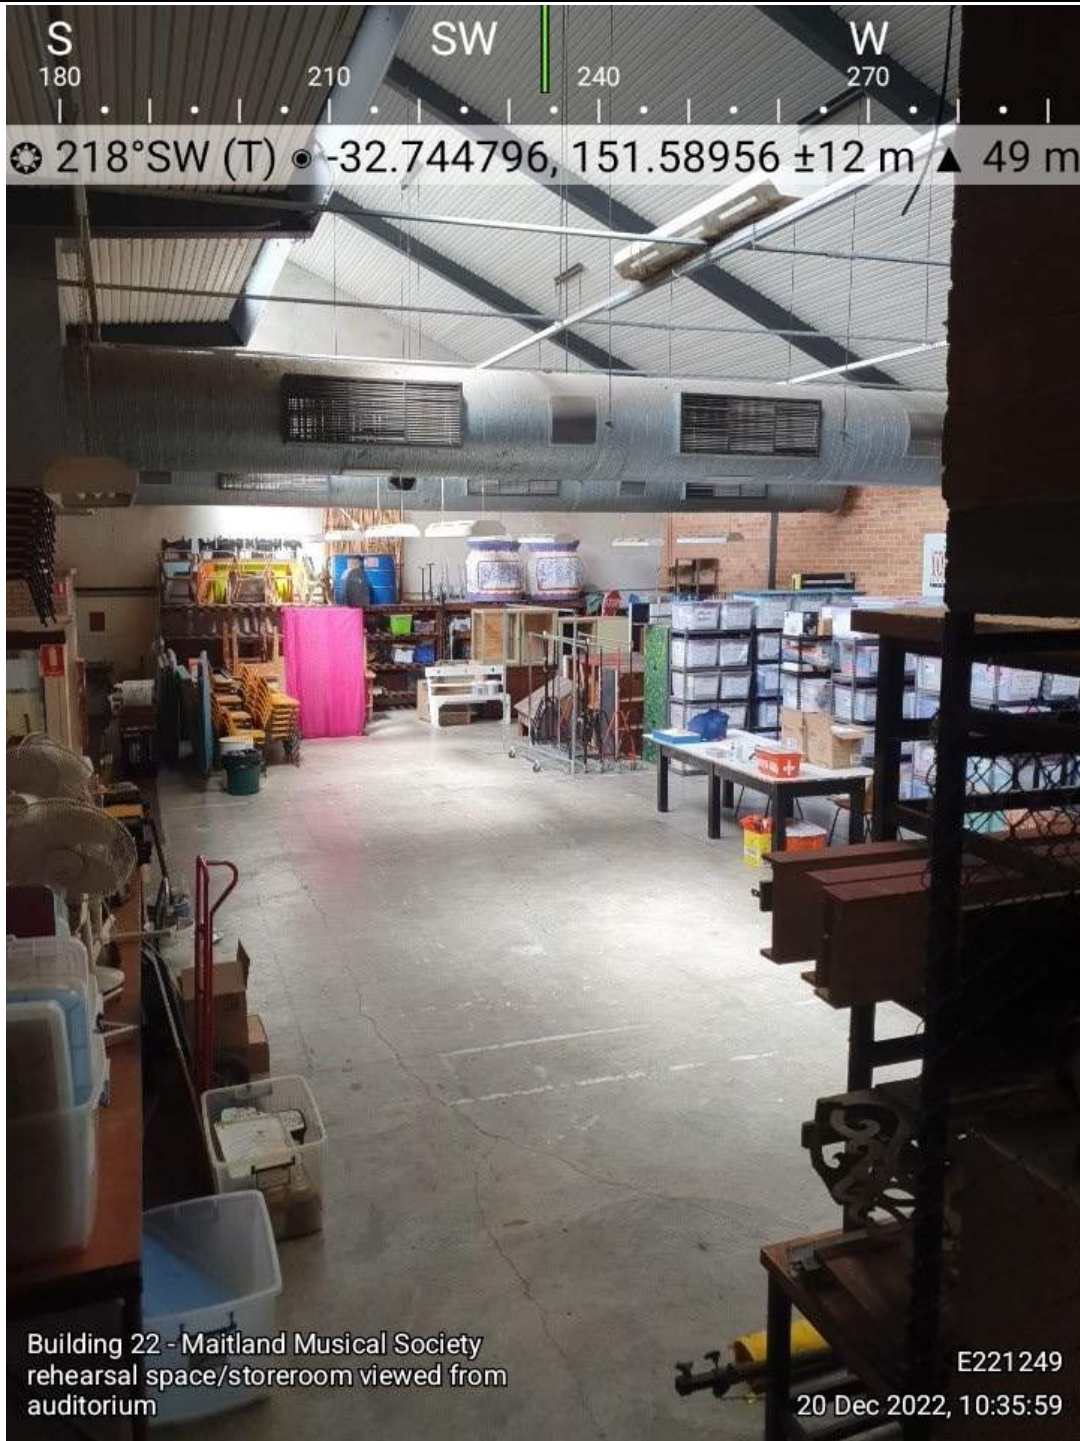
Photo 9

Maitland Musical Society rehearsal space/storeroom as viewed from auditorium entrance

Location: Building 14

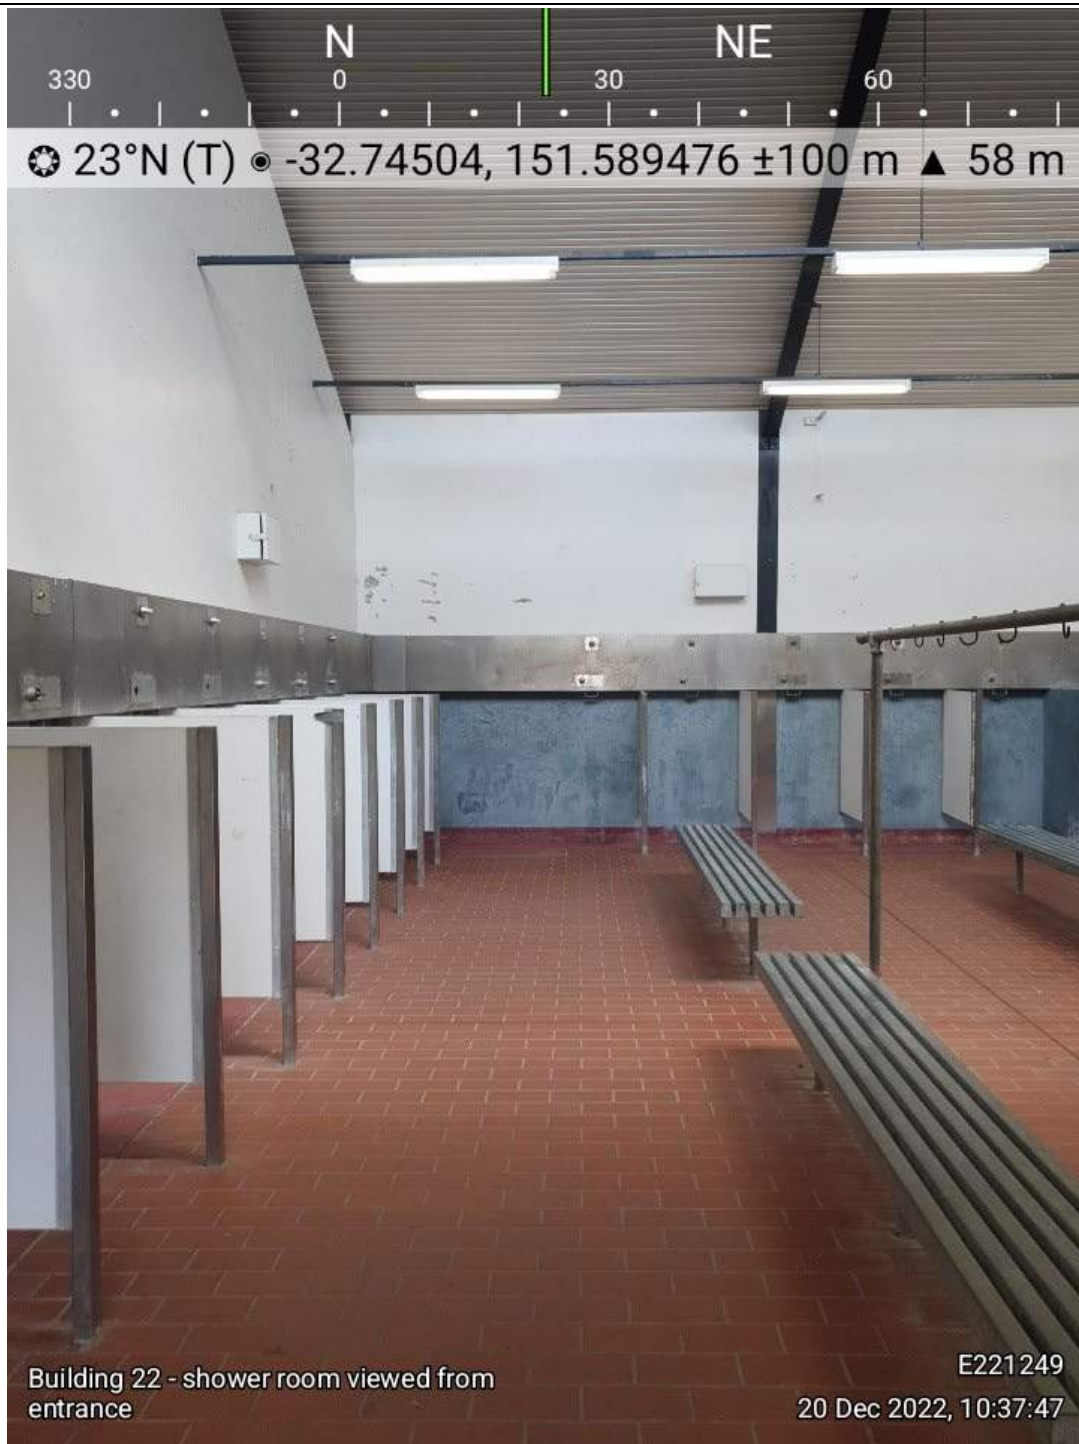
Photo 10

Shower room as viewed from entrance

Location: Building 22

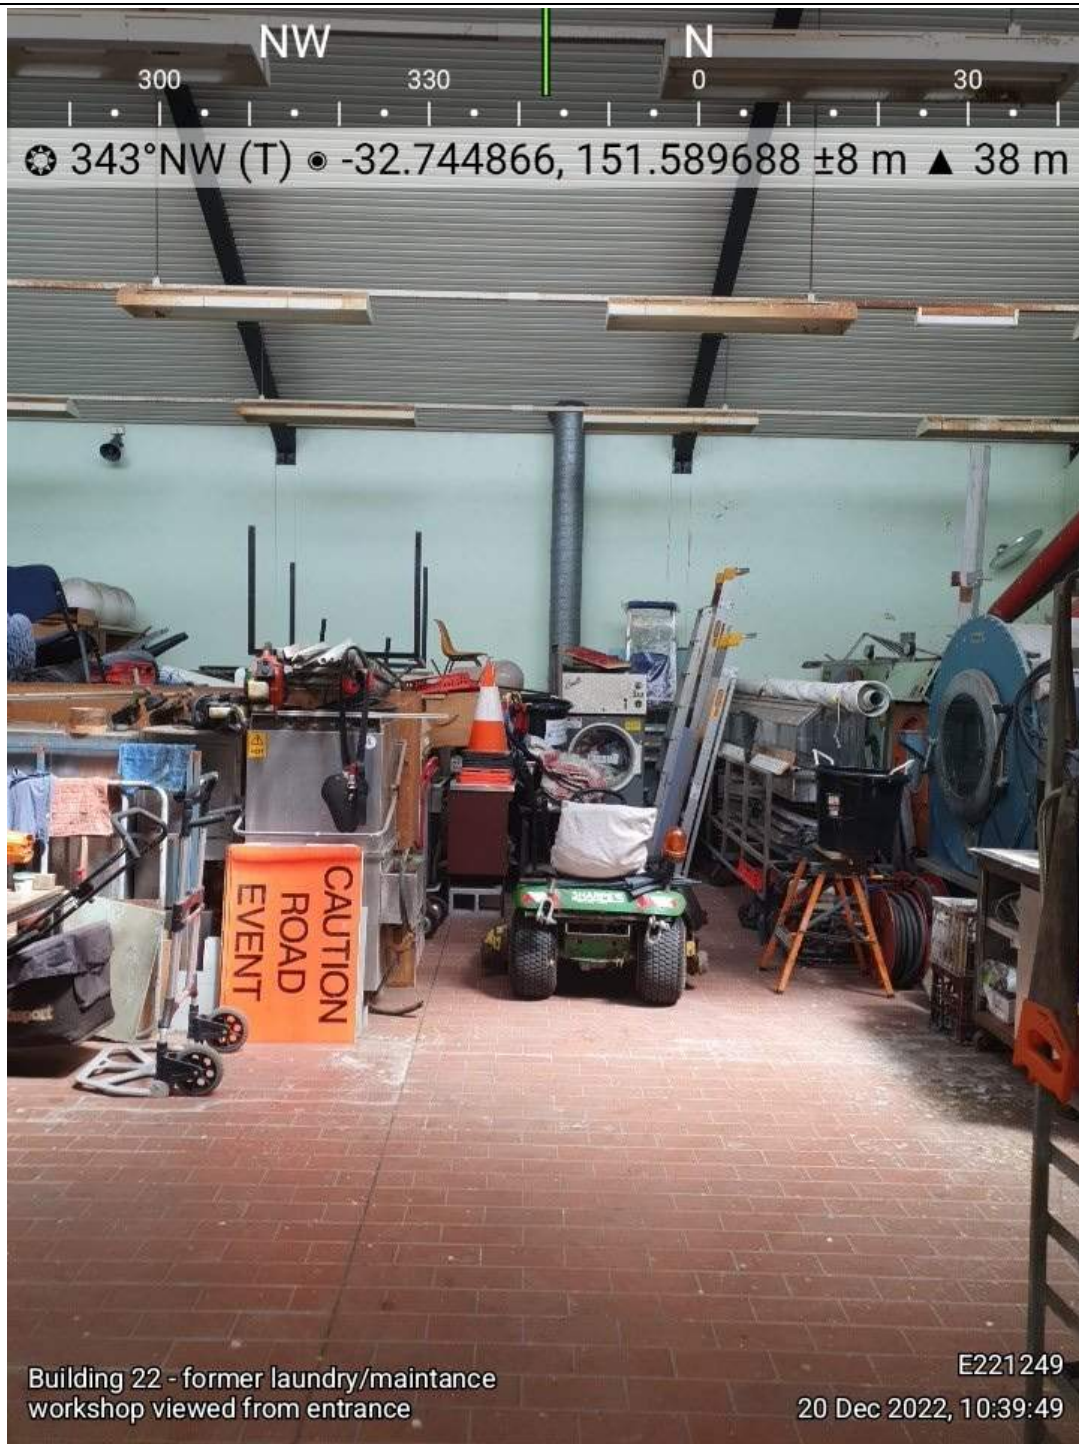
Photo 11

Former laundry/current maintenance workshop as viewed from entrance

Location: Building 22

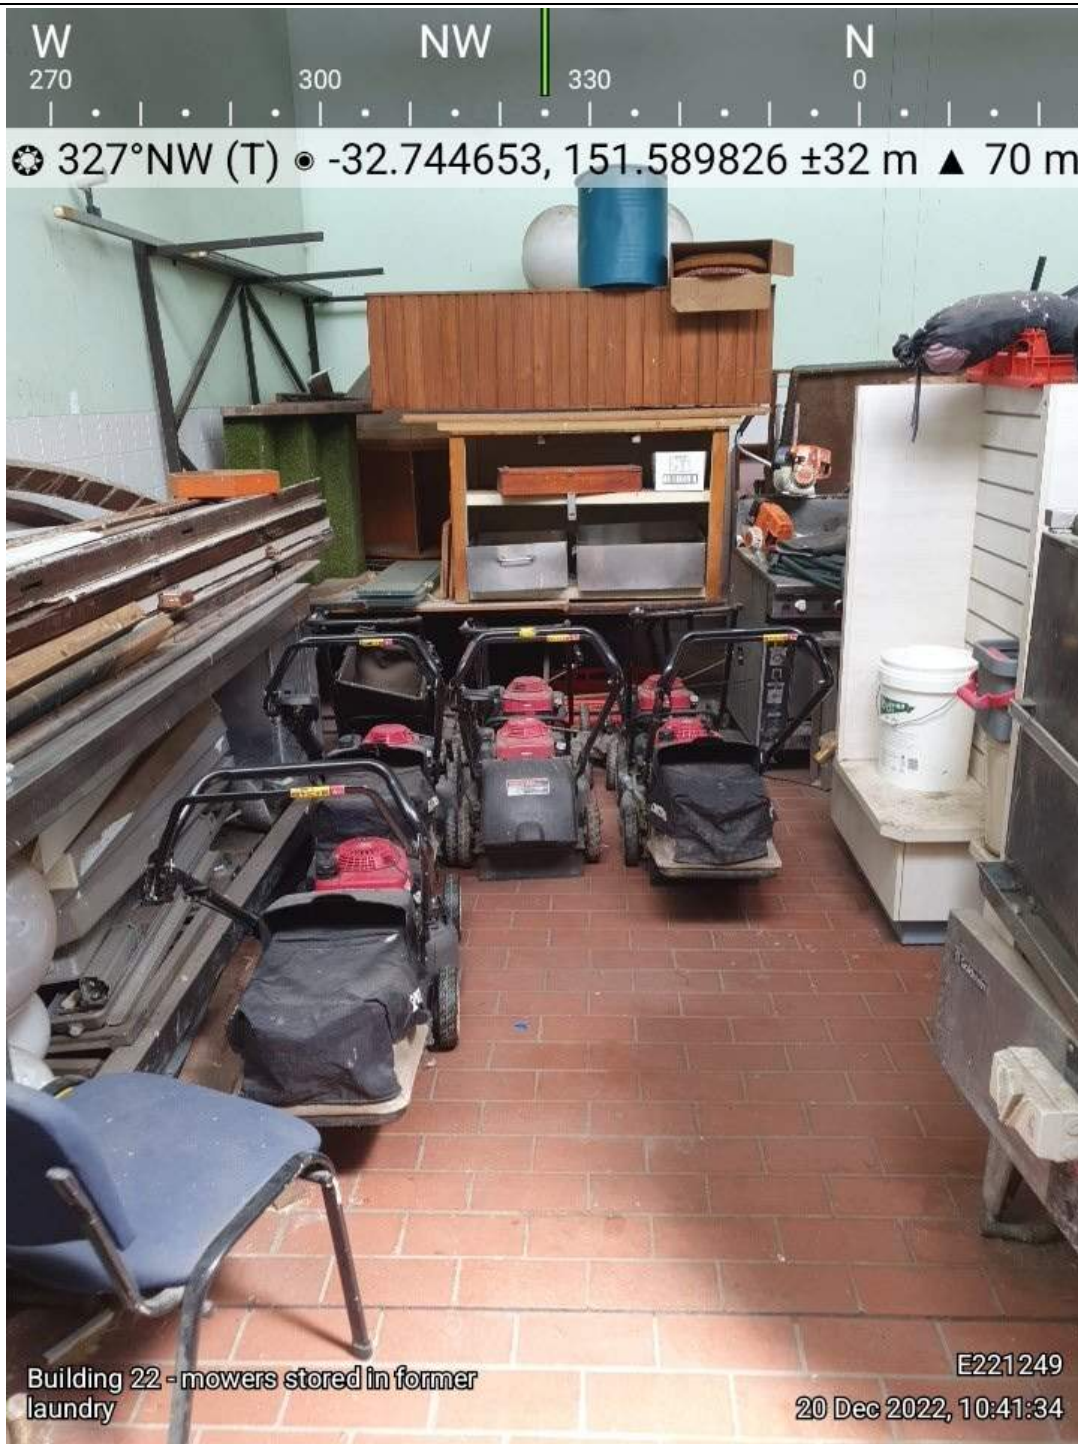
Photo 13

Mowers stored in former laundry

Location: Building 22

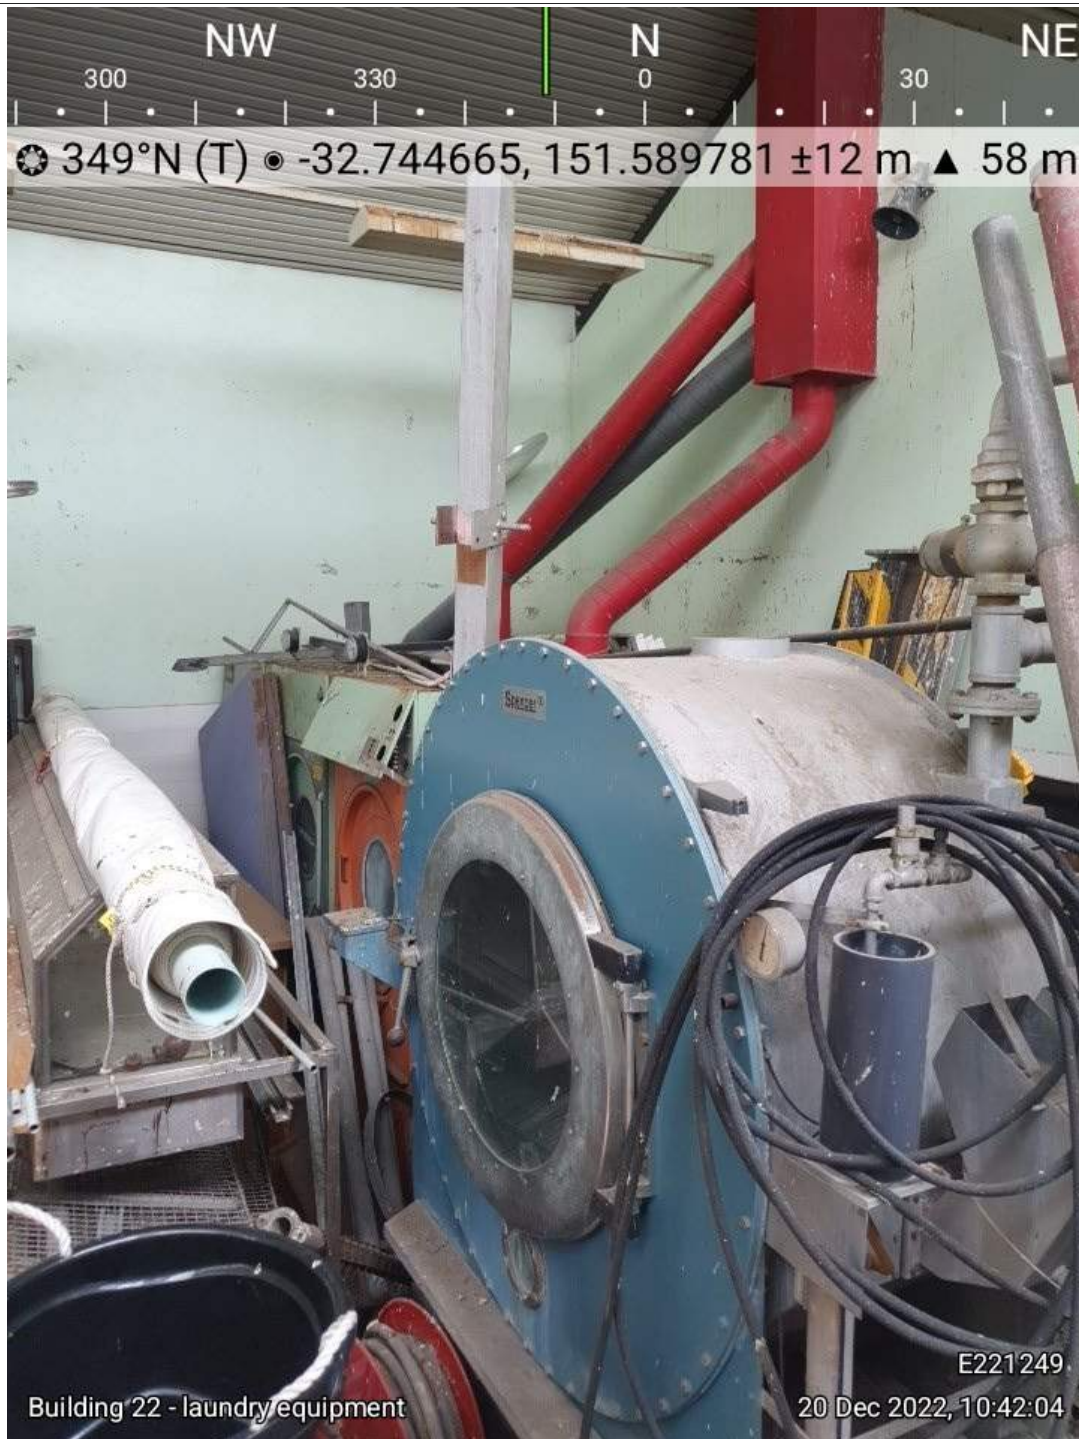
Photo 14

Disused laundry equipment

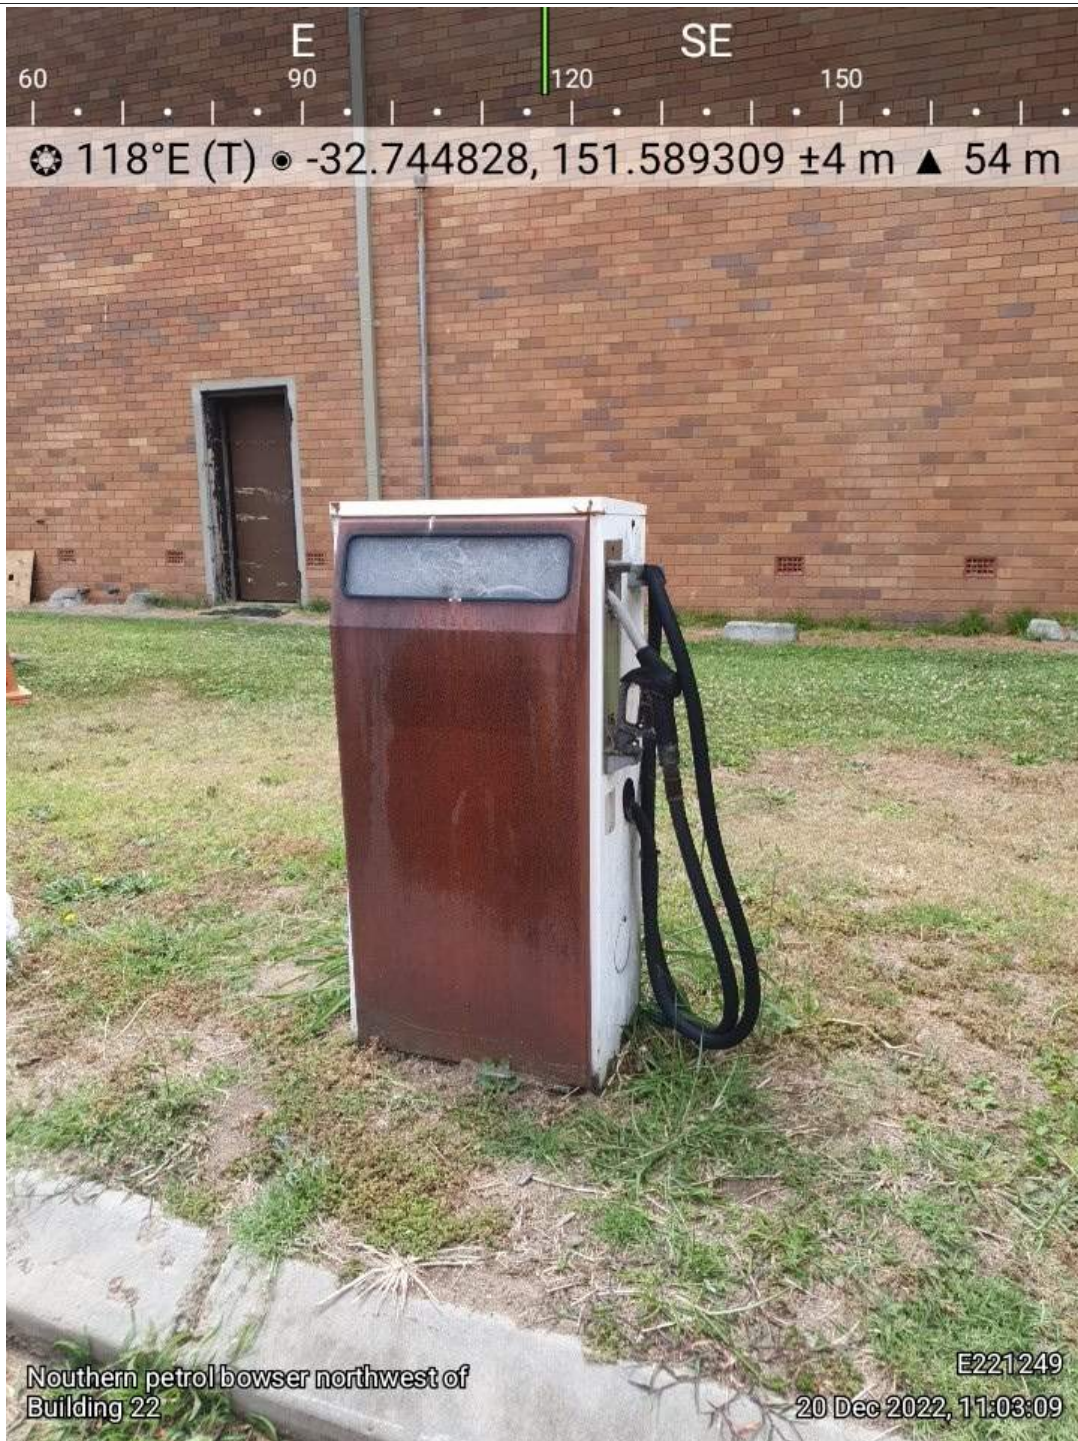
Photo 21

Northern petrol bowser. Building 22 is visible in the background

Location: North-west of Building 14

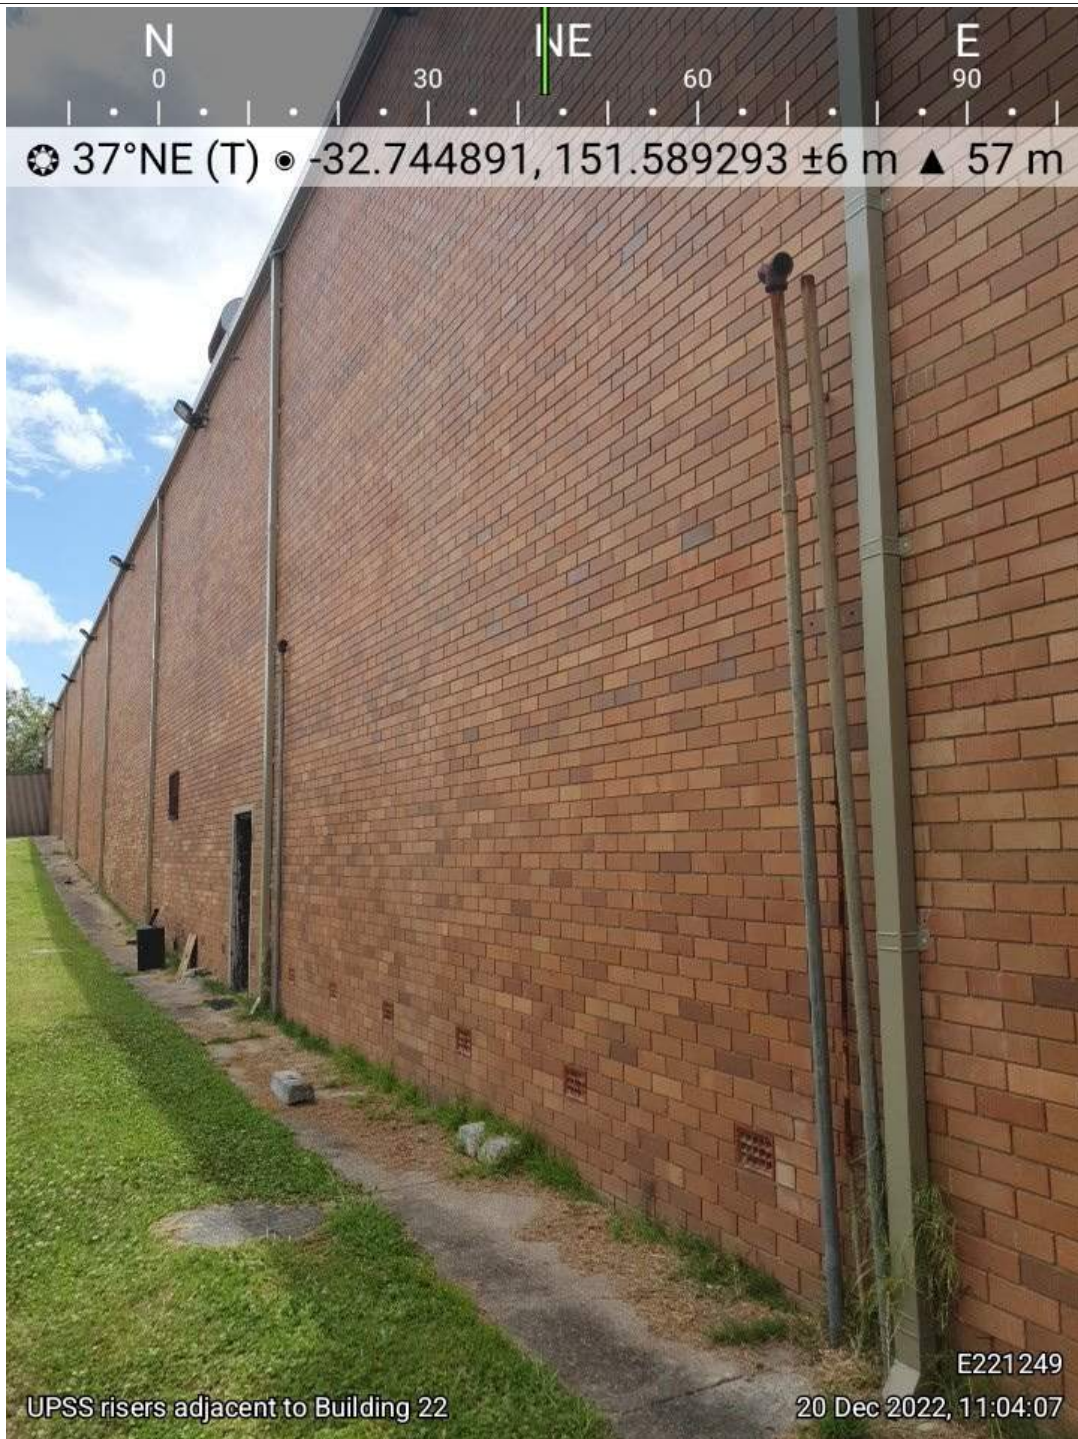
Photo 22

UPSS ventilation risers against the wall of Building 14

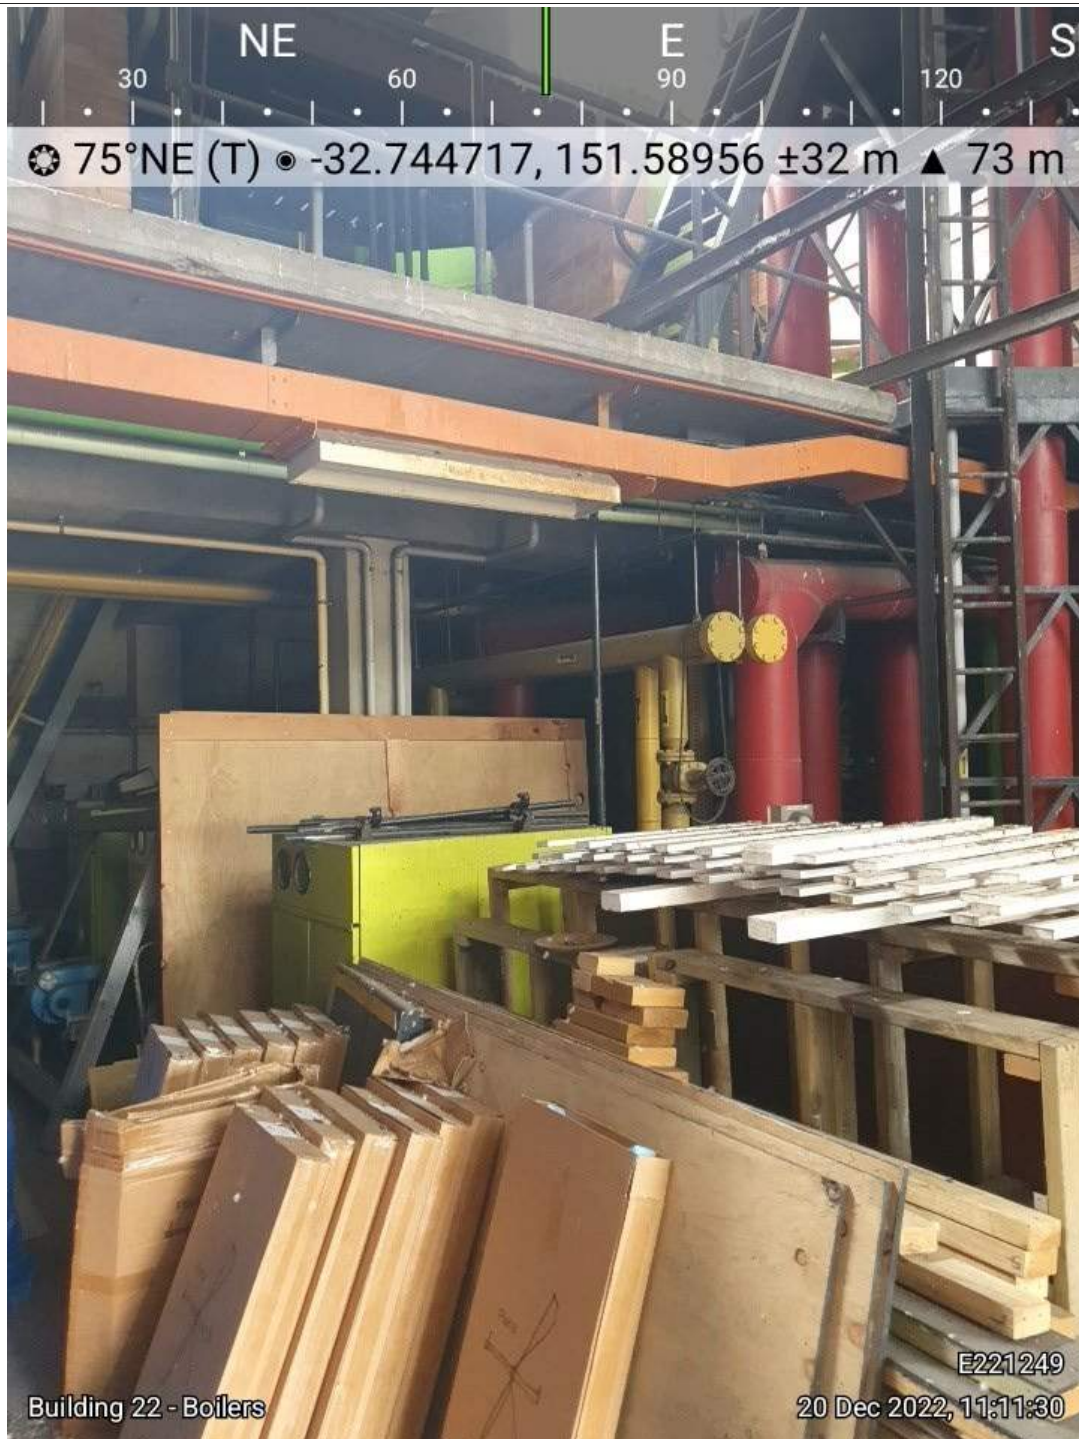
Photo 25

Disused boilers (yellow units) and associated pipes. Note that these are outside of the Site boundary

Location: Northern portion of Building 14

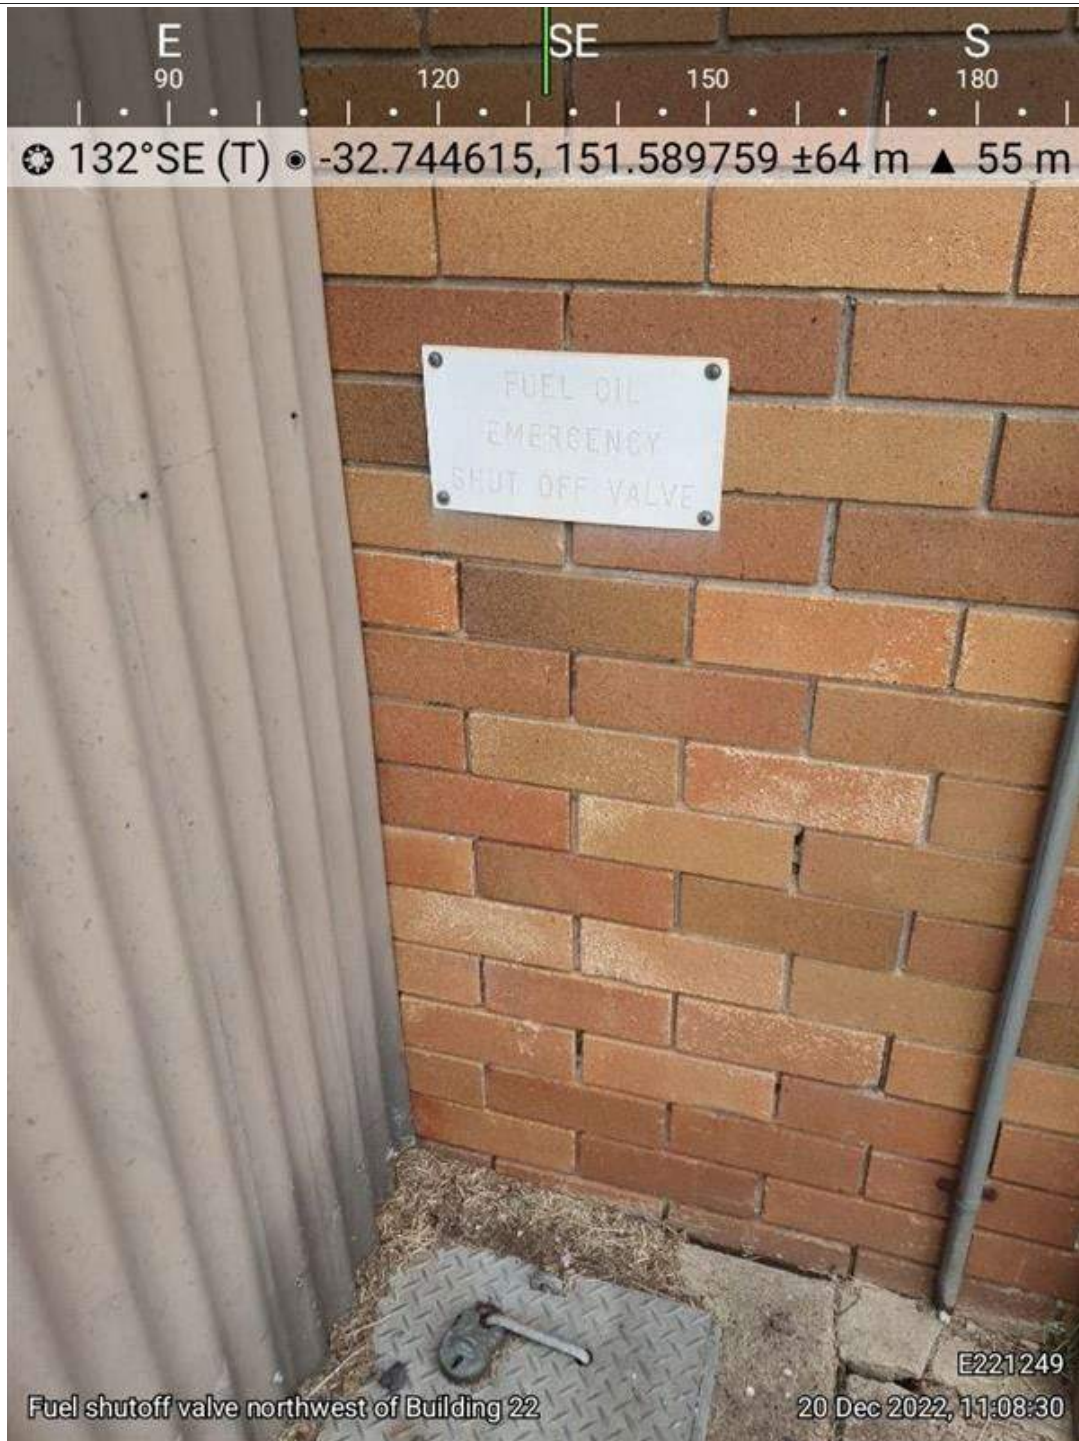
Photo 26

Fuel/oil emergency shutoff valve located on corner of boiler room

Location: North-west wall of Building 14
