Preliminary Site Investigation

Maitland Gaol Redevelopment

Prepared for Maitland City Council

E221249 RP1

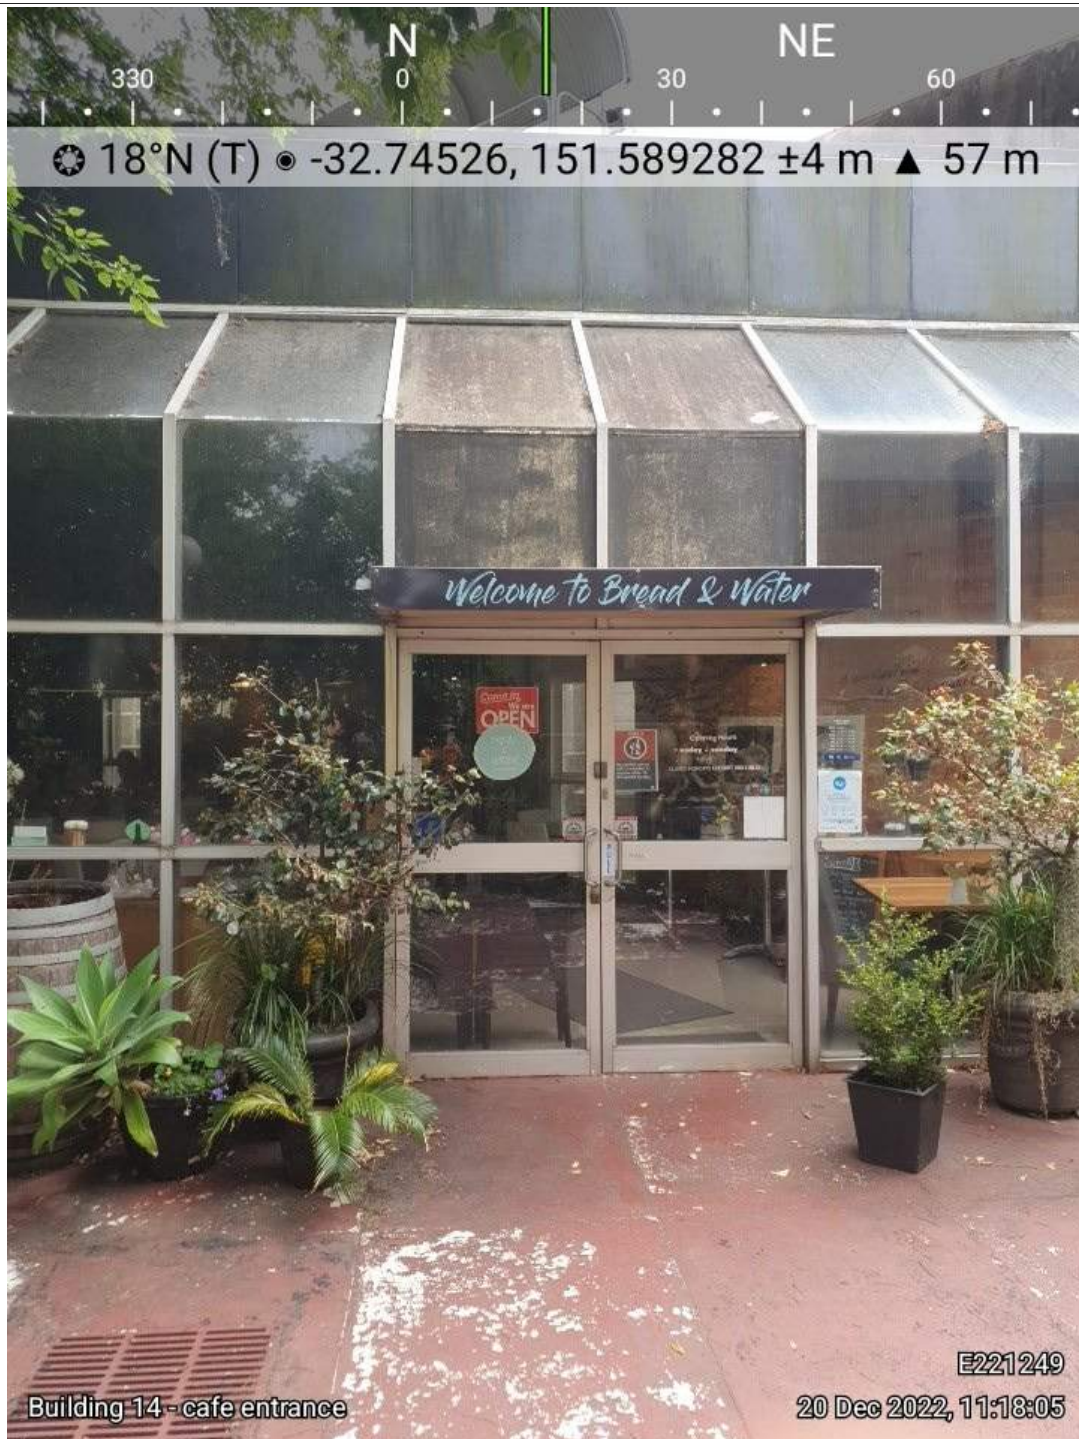
Photo 27

Bread and Butter Café entrance
